DATE: January 8, 2020

<u>Certificate of Appropriateness Request:</u>	H-01-20
<u>Applicant:</u>	Aavis Jaye Clark Jr.
<u>Location of subject property:</u>	17 Georgia St. SW
<u>Staff Report prepared by:</u>	Kristen Boyd-Sullivan, Sr. Planner

- ***Applicant is seeking to remove and replace two (2) trees on the subject property*** (Exhibit B).

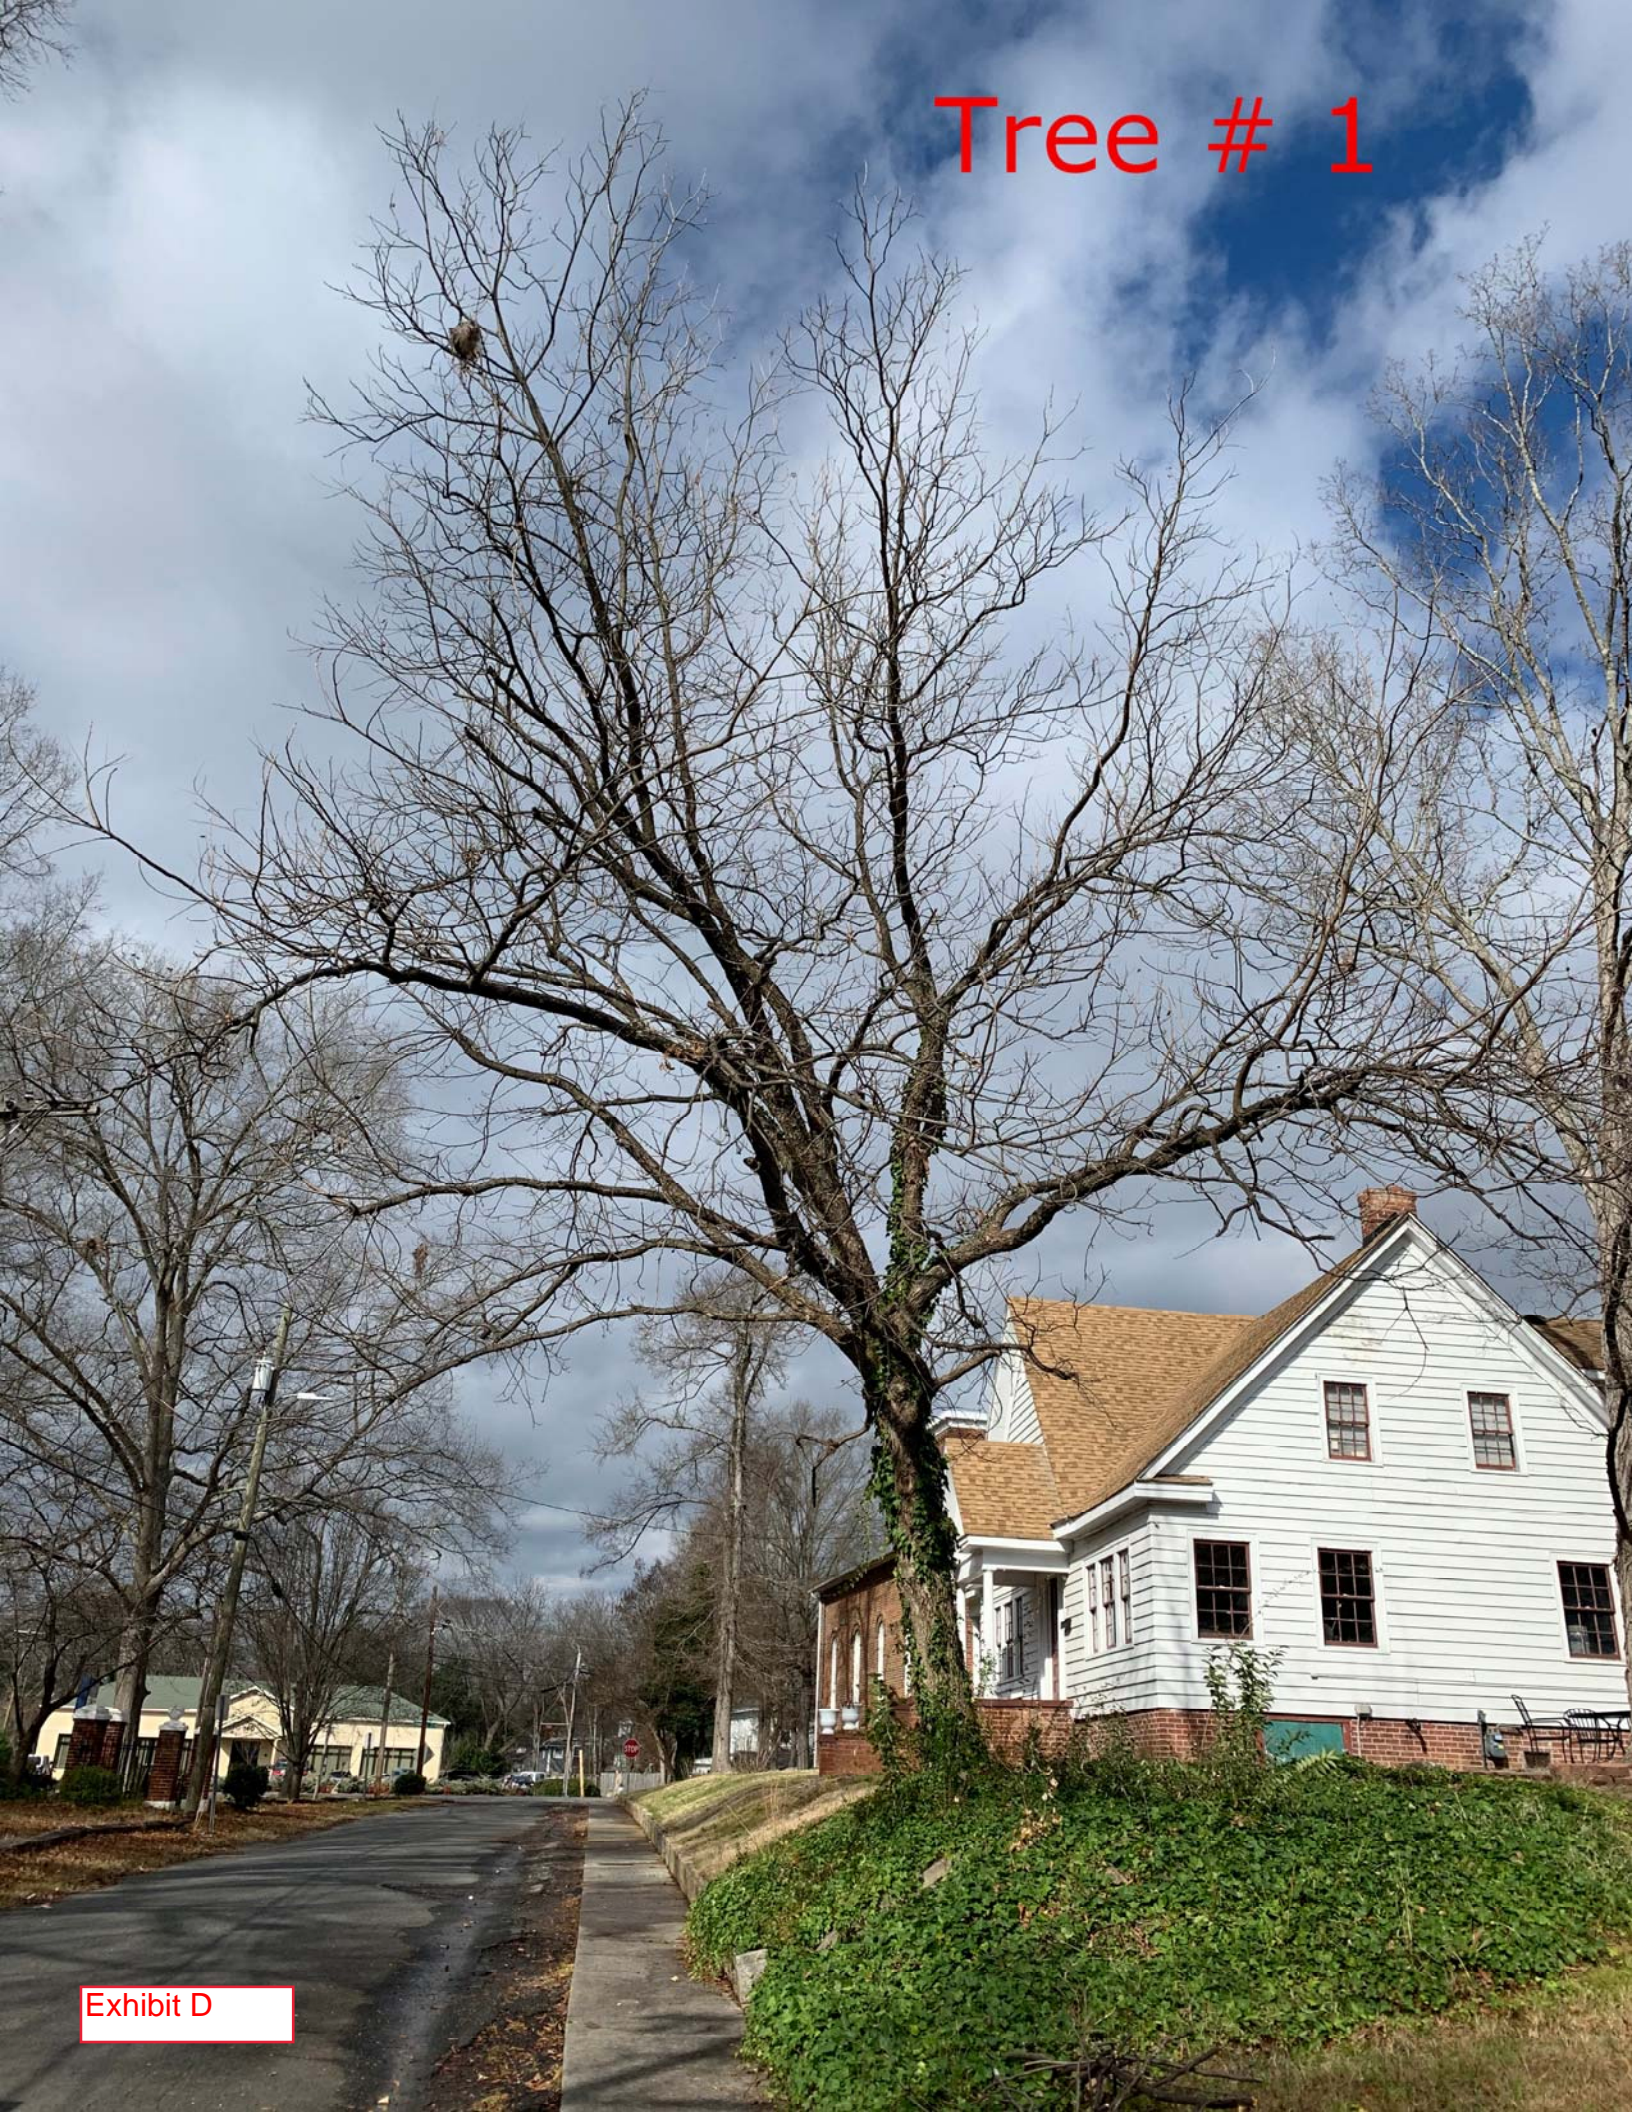
Tree # 1

“Tree #1” is a 45ft tall pecan with a hazard rating of “4.” This tree currently exhibits no structural defects but grading will negatively impact the root system. This rating requires HPC approval in order for the applicant to remove the tree.

This tree has no structural defects. It will require utility pruning over its life span. The proposed grading may impact the root system of this tree.

If approved for removal, the applicant has agreed to work with the City Arborist to replace the trees with two (2) new shade trees in appropriate locations to ensure long-term sustainability.

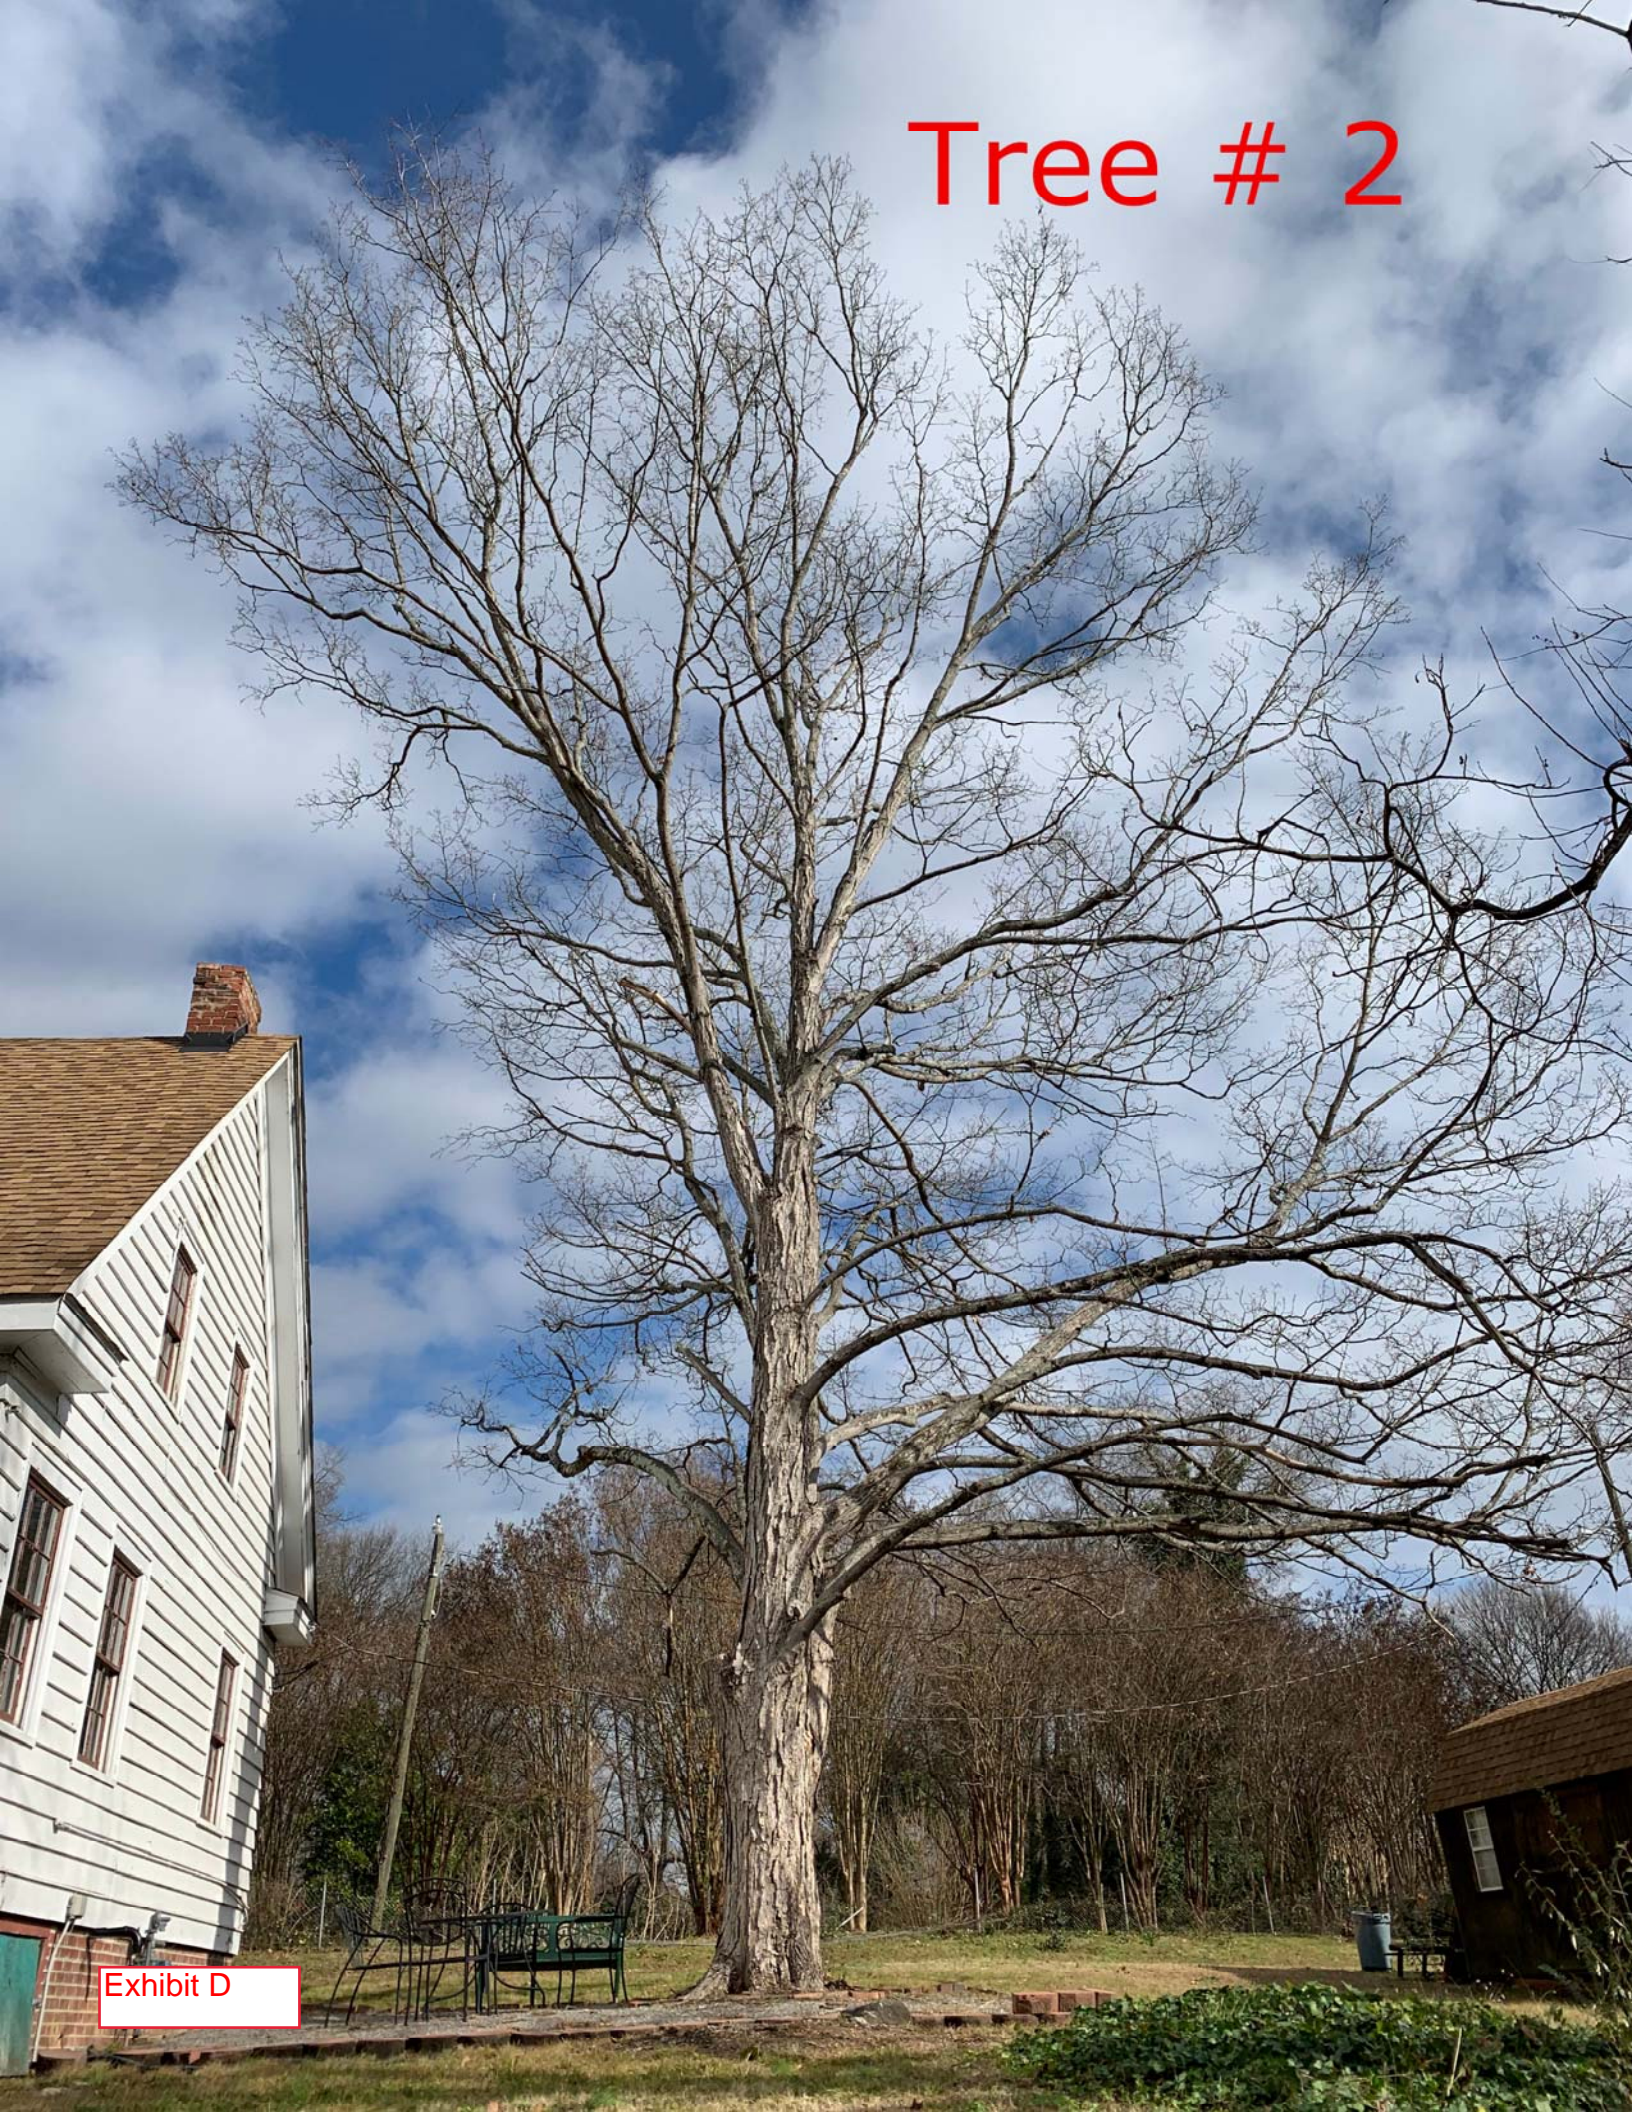
Tree # 2

“Tree #2” is a 60ft tall sugar maple with a hazard rating of “4.” This tree currently exhibits no structural defects but grading will negatively impact the root system. This rating requires HPC approval in order for the applicant to remove the tree.

This tree has a no structural defects. The proposed grading may impact the root system of this tree.
