**DATE:** February 12<sup>th</sup>, 2020

<u>Certificate of Appropriateness Request:</u>	H-03-20
<u>Applicant:</u>	Philip Curley
<u>Location of subject property:</u>	24 Franklin Ave. NW
<u>Staff Report prepared by:</u>	Kristen Boyd-Sullivan, Sr. Planner

# TREE RISK ASSESSMENT FORM

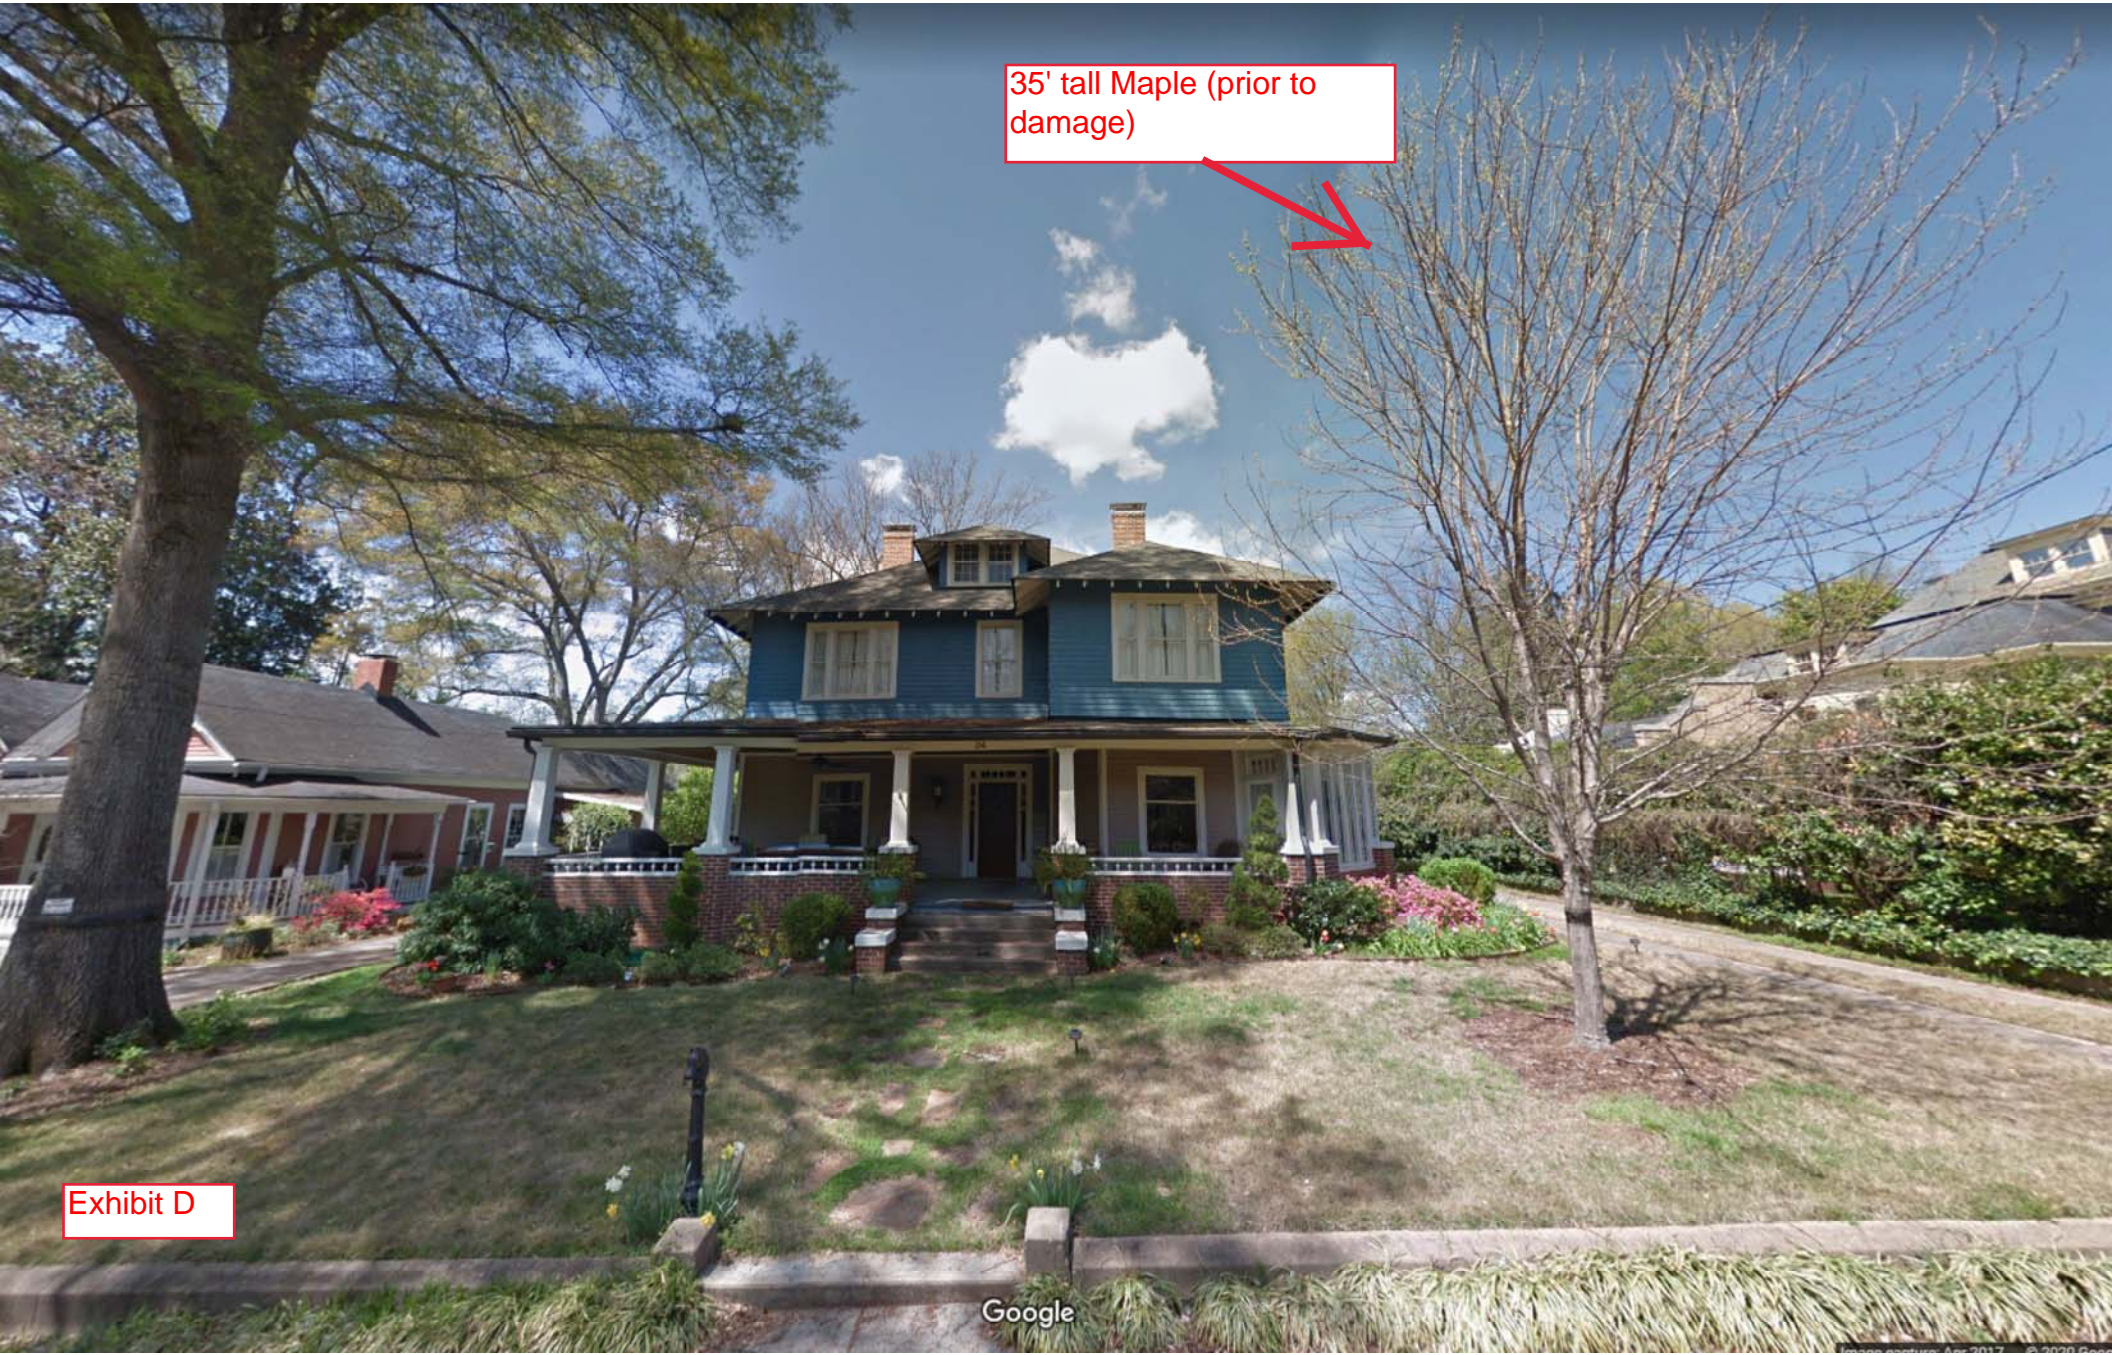
35' tall Maple (prior to damage)

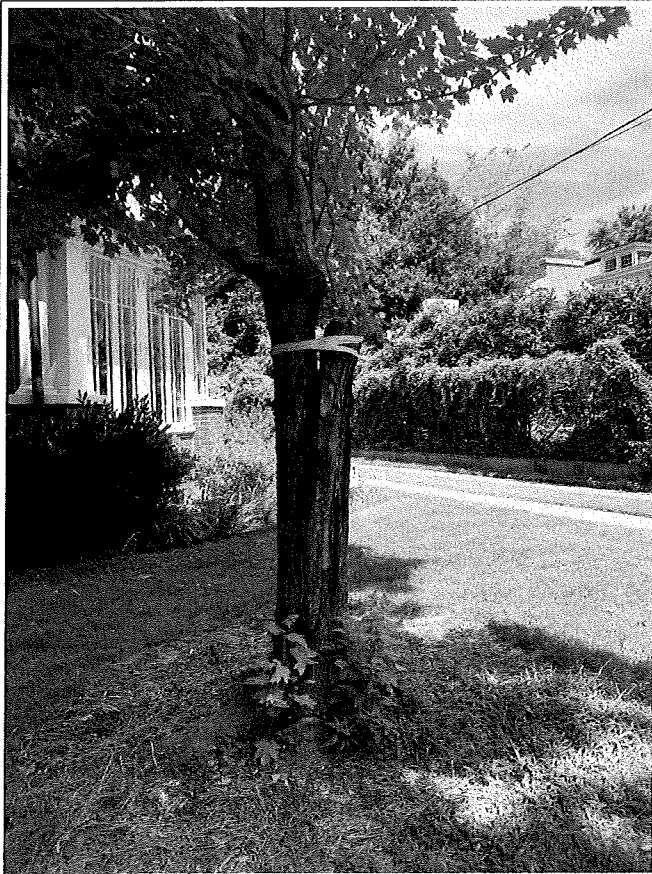
Half of this tree has broken leaving an unbalanced crown that is exposed to new wind load stress. The remaining trunk has a vertical crack in the center that reduces the structural integrity of the first five feet of trunk. I recommend this tree be removed. This location would be appropriate for another similar sized tree.

Photograph of the damaged maple tree on the SE section of the front lawn.

Remove tree  When replaced, a similar sized tree species would be appropriate in same location

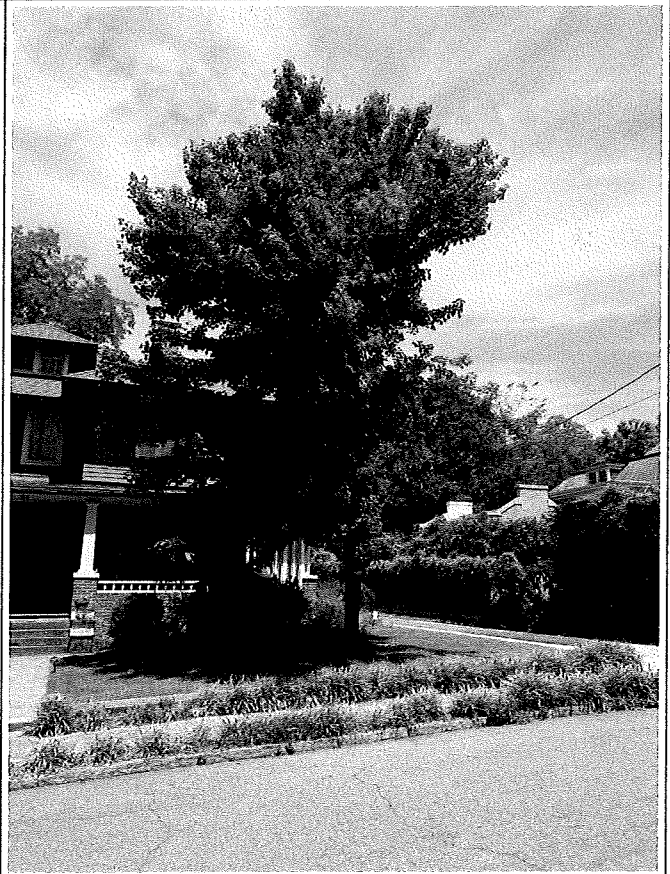
Photograph of 24 FRANKLIN street-front, the damaged maple tree. Looking at the SE section of the front lawn.
