April 13, 2022

Certificate of Appropriateness Request: Applicant: Location of Subject Property: PINs: Staff Report Prepared by: H-03-22 Thomas Duquette & Aimee Cain (joint request) 148 & 154 Union Street S 5620-79-9327 & 5620-96-7858 Brad Lagano, Senior Planner

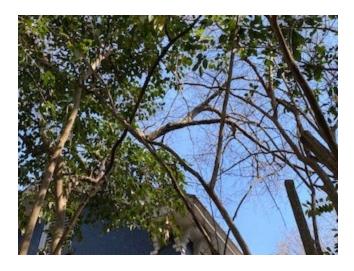
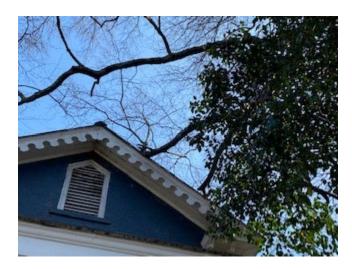
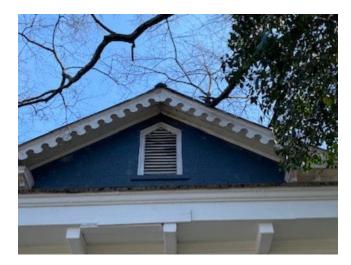
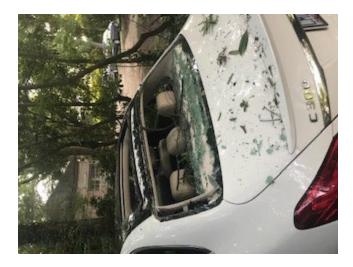
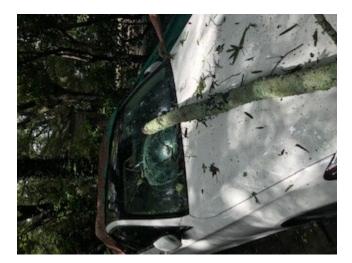
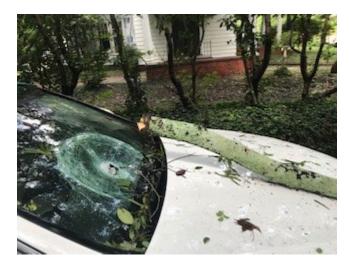
According to the Tree Risk Assessment Form (Exhibit D), the subject tree was inspected and evaluated by Bill Leake, City Arborist, on January 26, 2022. Bill notes the subject tree has no above normal structural risk issues to the trunk and crown. The exposed roots have been subject to years of vehicle and lawnmower damage. Any attempts to repair either driveway will require significant root cutting and damage.

The applicants note the tree presents an ongoing challenge due to the roots growing underneath and breaking apart the concrete driveways, primarily on the 148 Union Street S property, as well as the limbs rubbing against the structure and growing over the roof on the 154 Union Street S property. The applicants also note the tree presents a potential hazard due to falling limbs as demonstrated by previous automobile damage incurred (Exhibits E and F).

If removal is approved, the applicants would like to replant one (1) similar shade tree in the general vicinity of the tree removed, but away from the driveway areas to prevent a repeat situation in the future. The stump will be removed below ground level as it is visible from the street.
