DATE: February 13, 2019

<u>Certificate of Appropriateness Request:</u>	H-04-19
<u>Applicant:</u>	Erwin Spainhour
<u>Location of subject property:</u>	87 Edgewood Ave NE
<u>Staff Report prepared by:</u>	Scott Sherrill, Sr. Planner

TREE RISK ASSESSMENT FORM

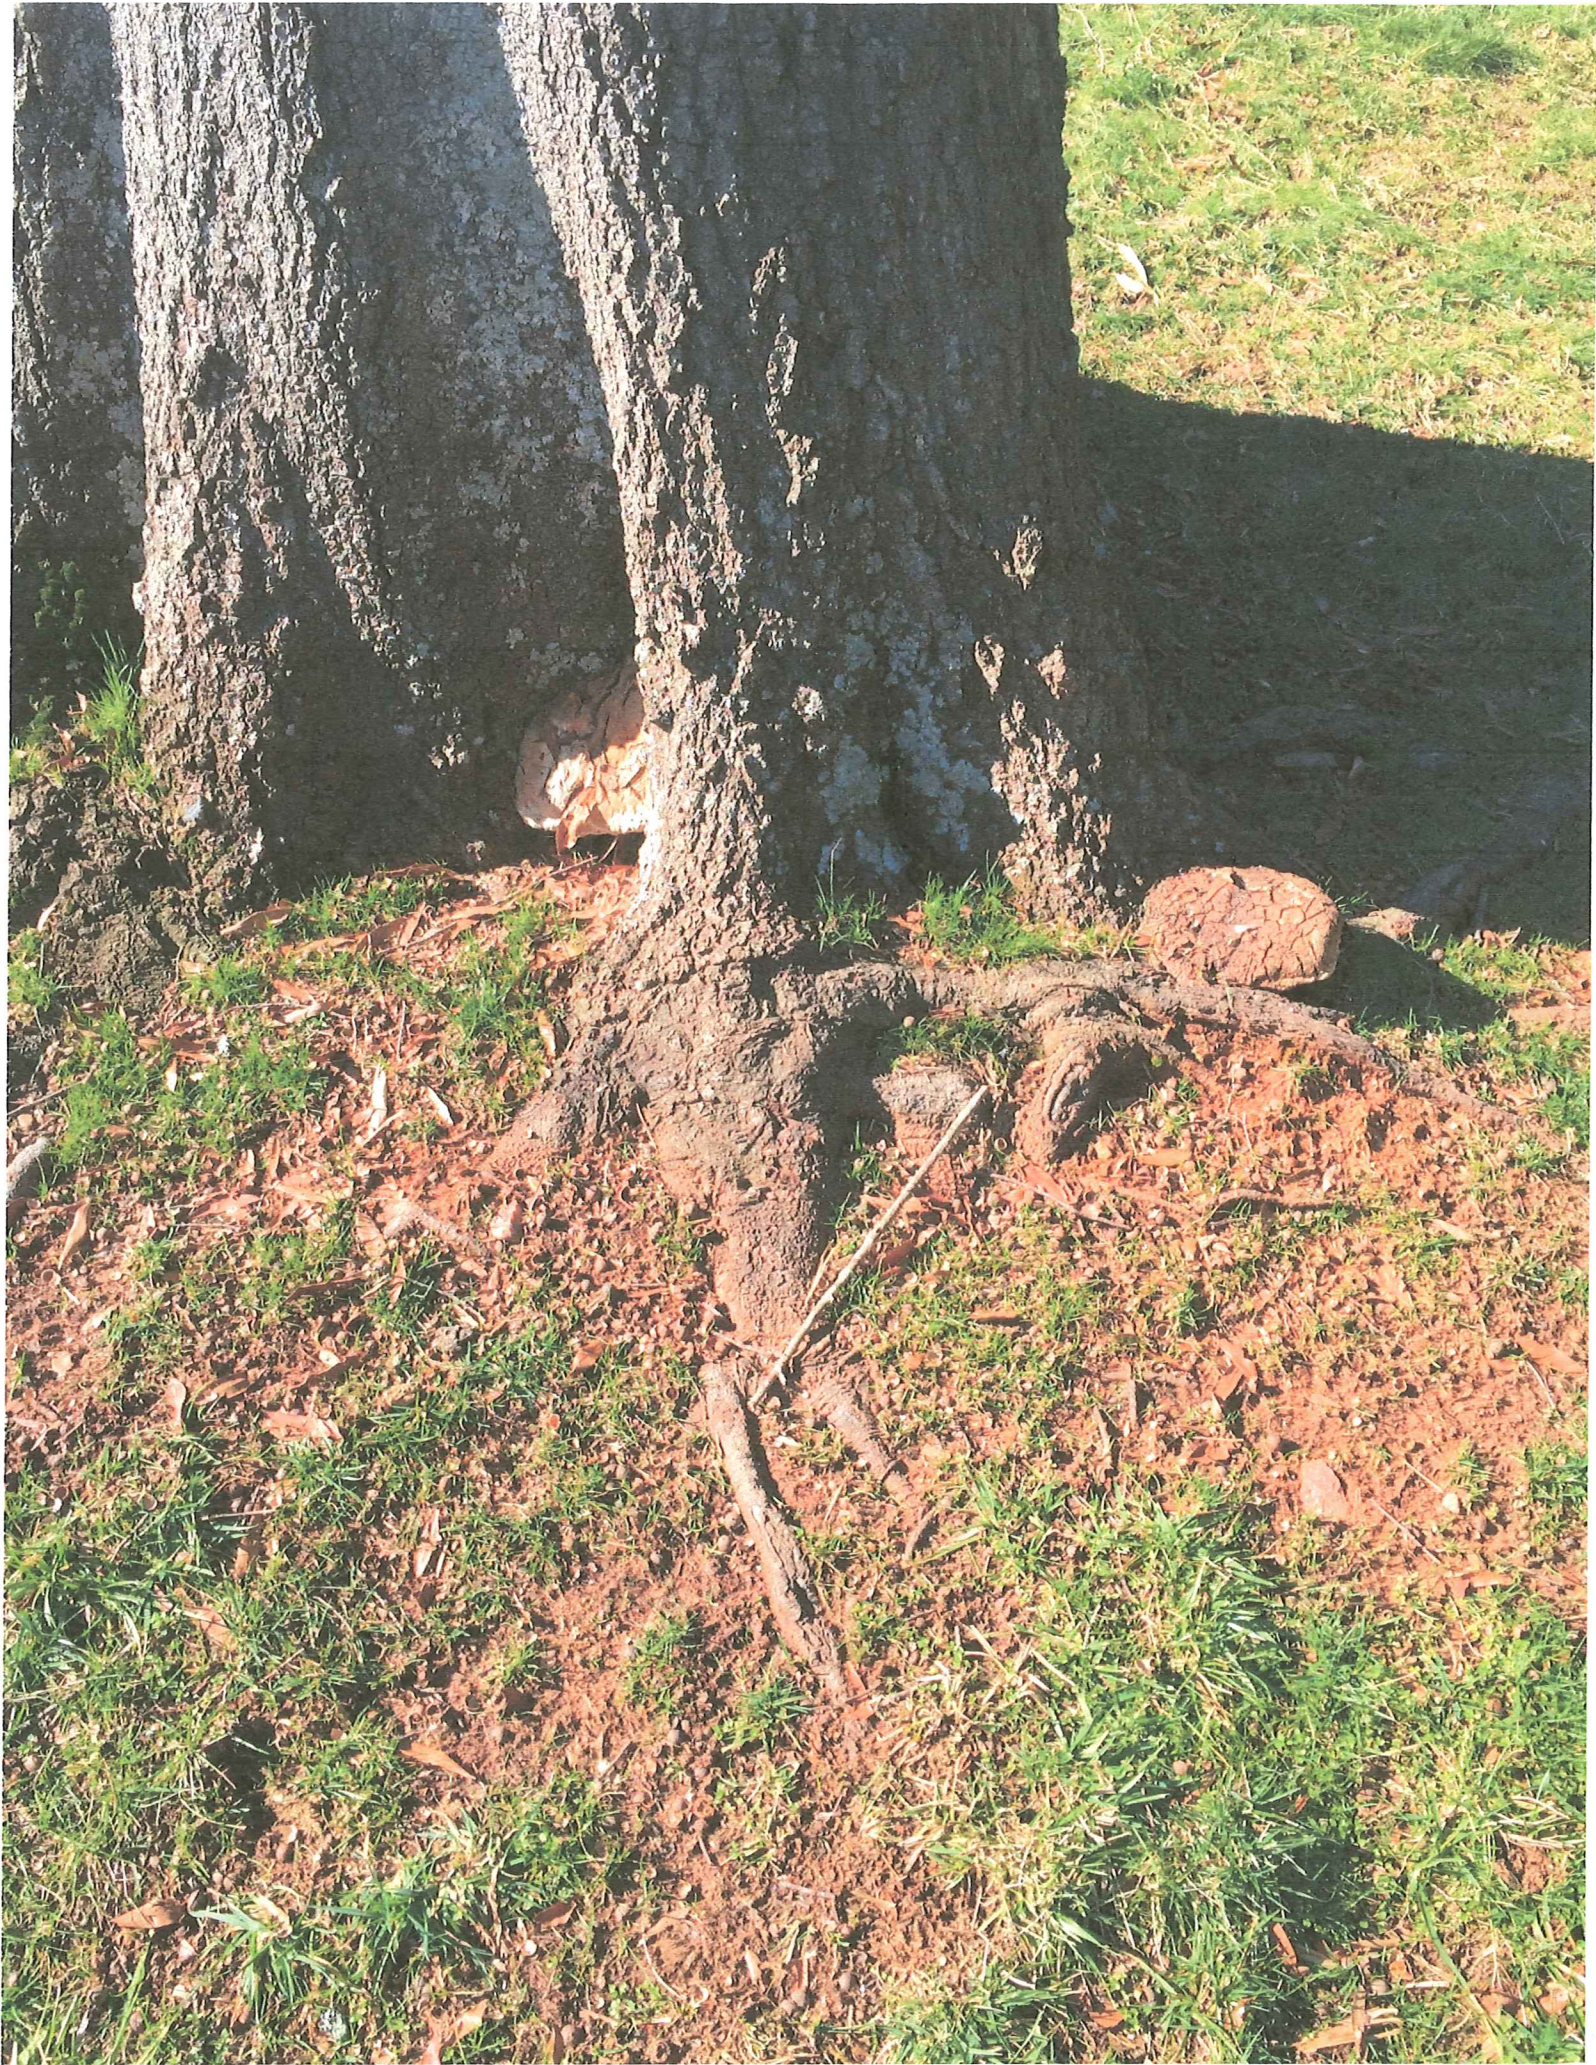
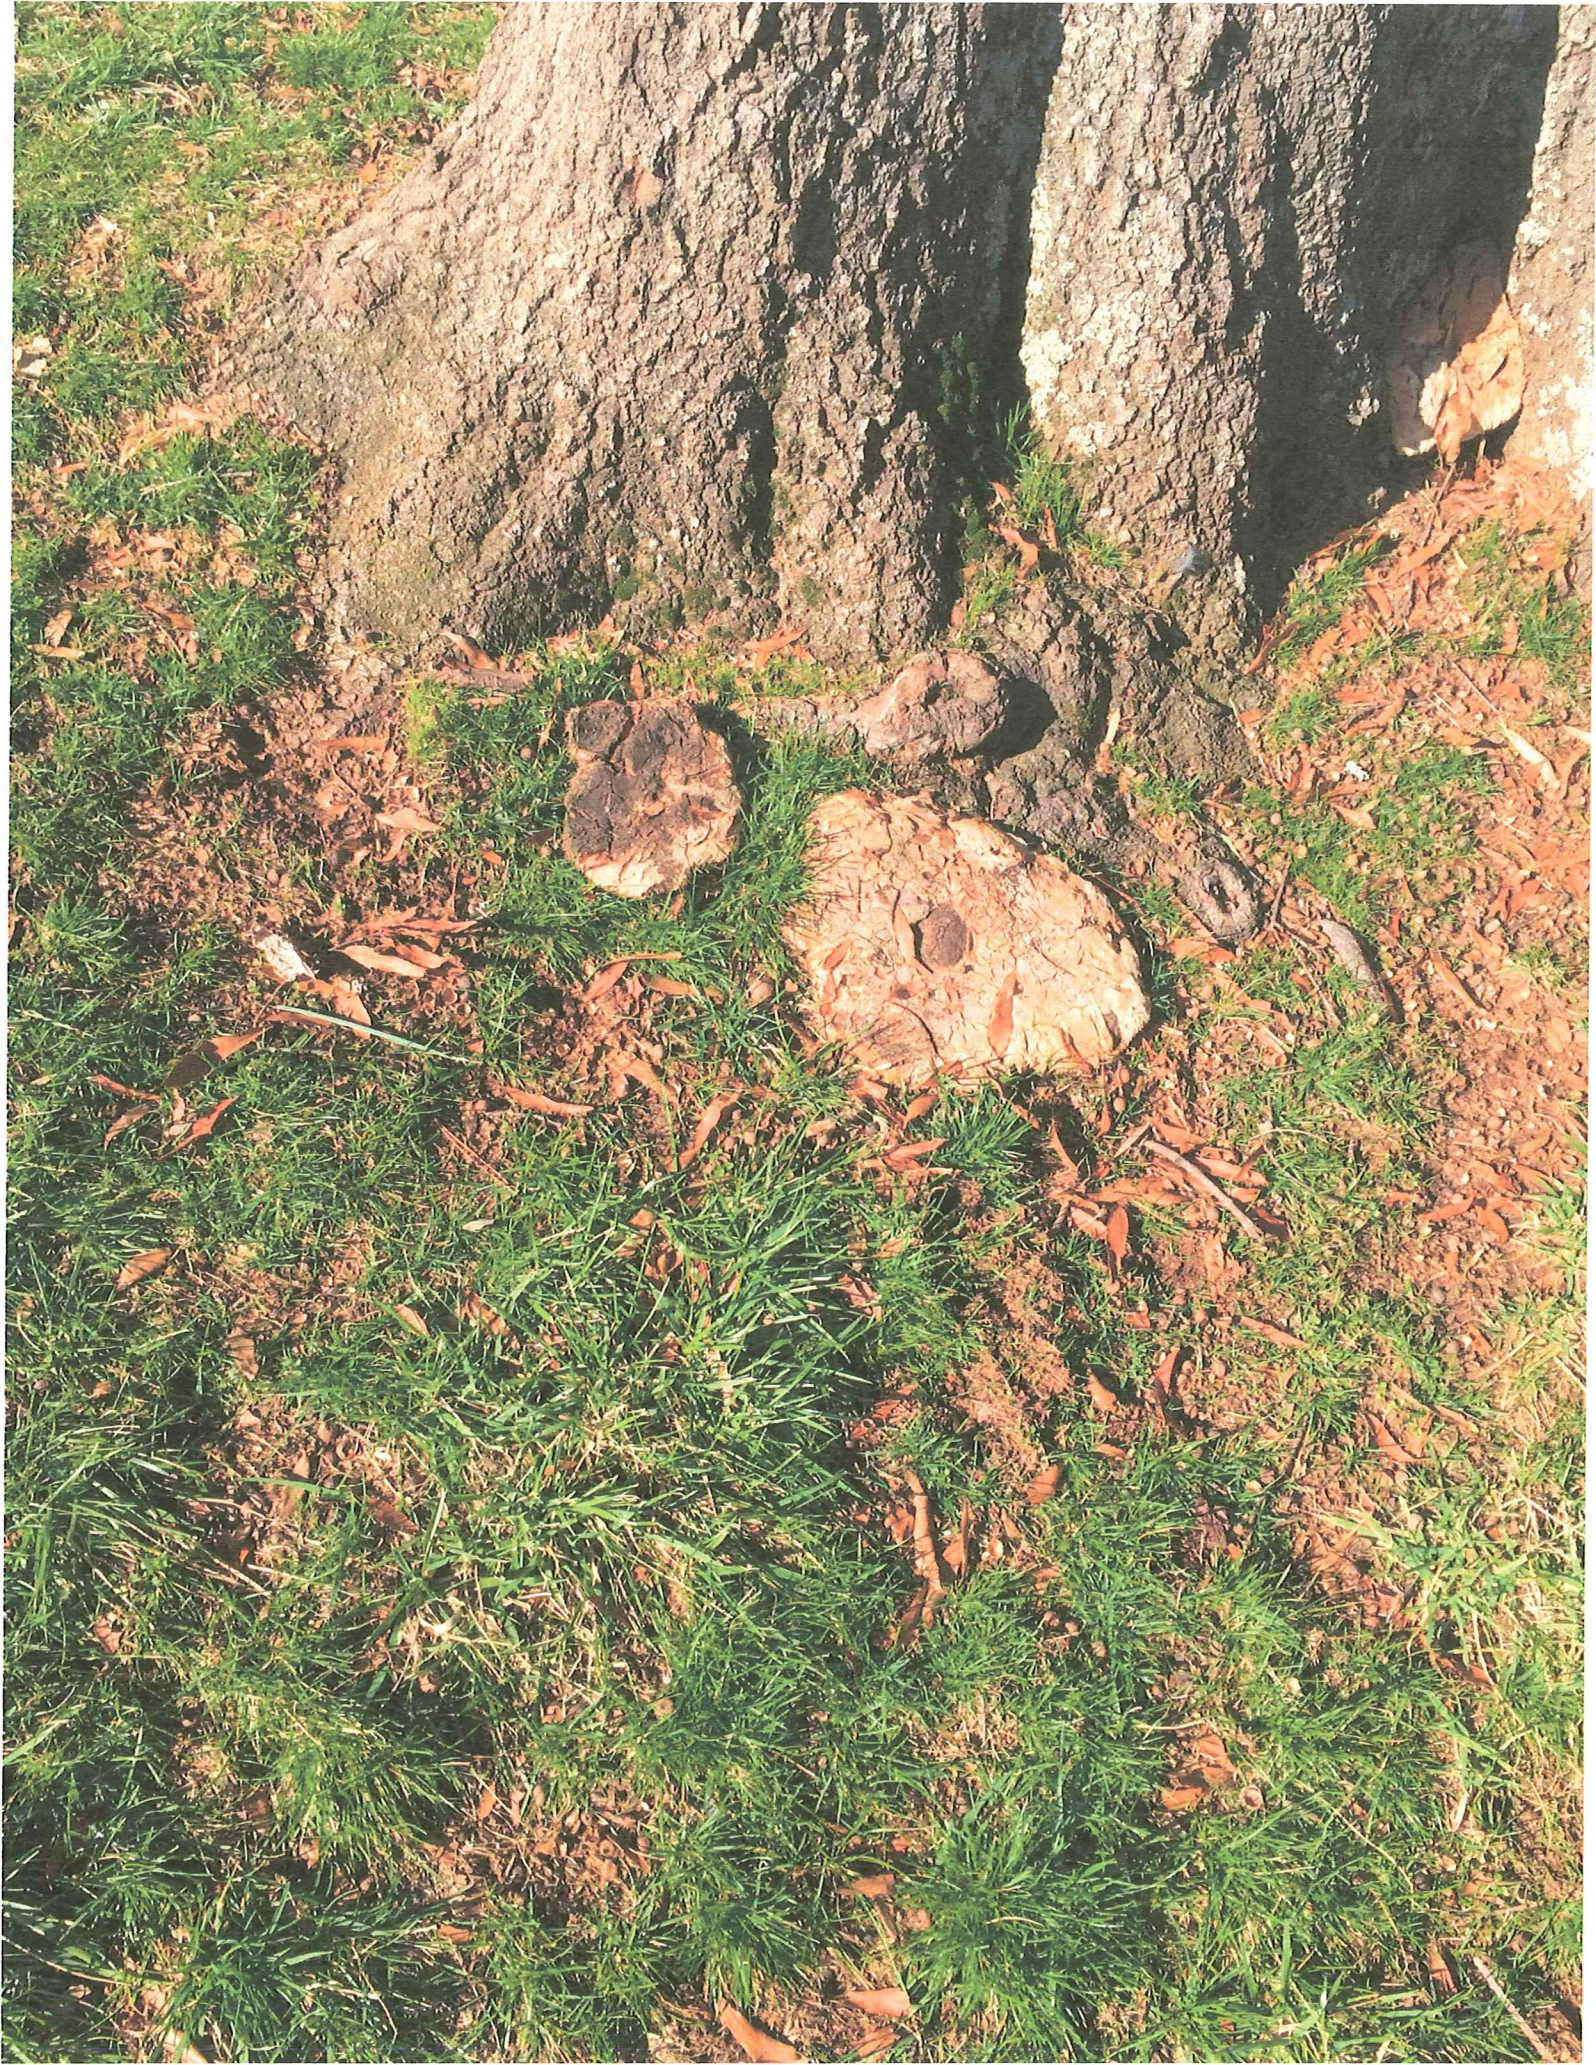
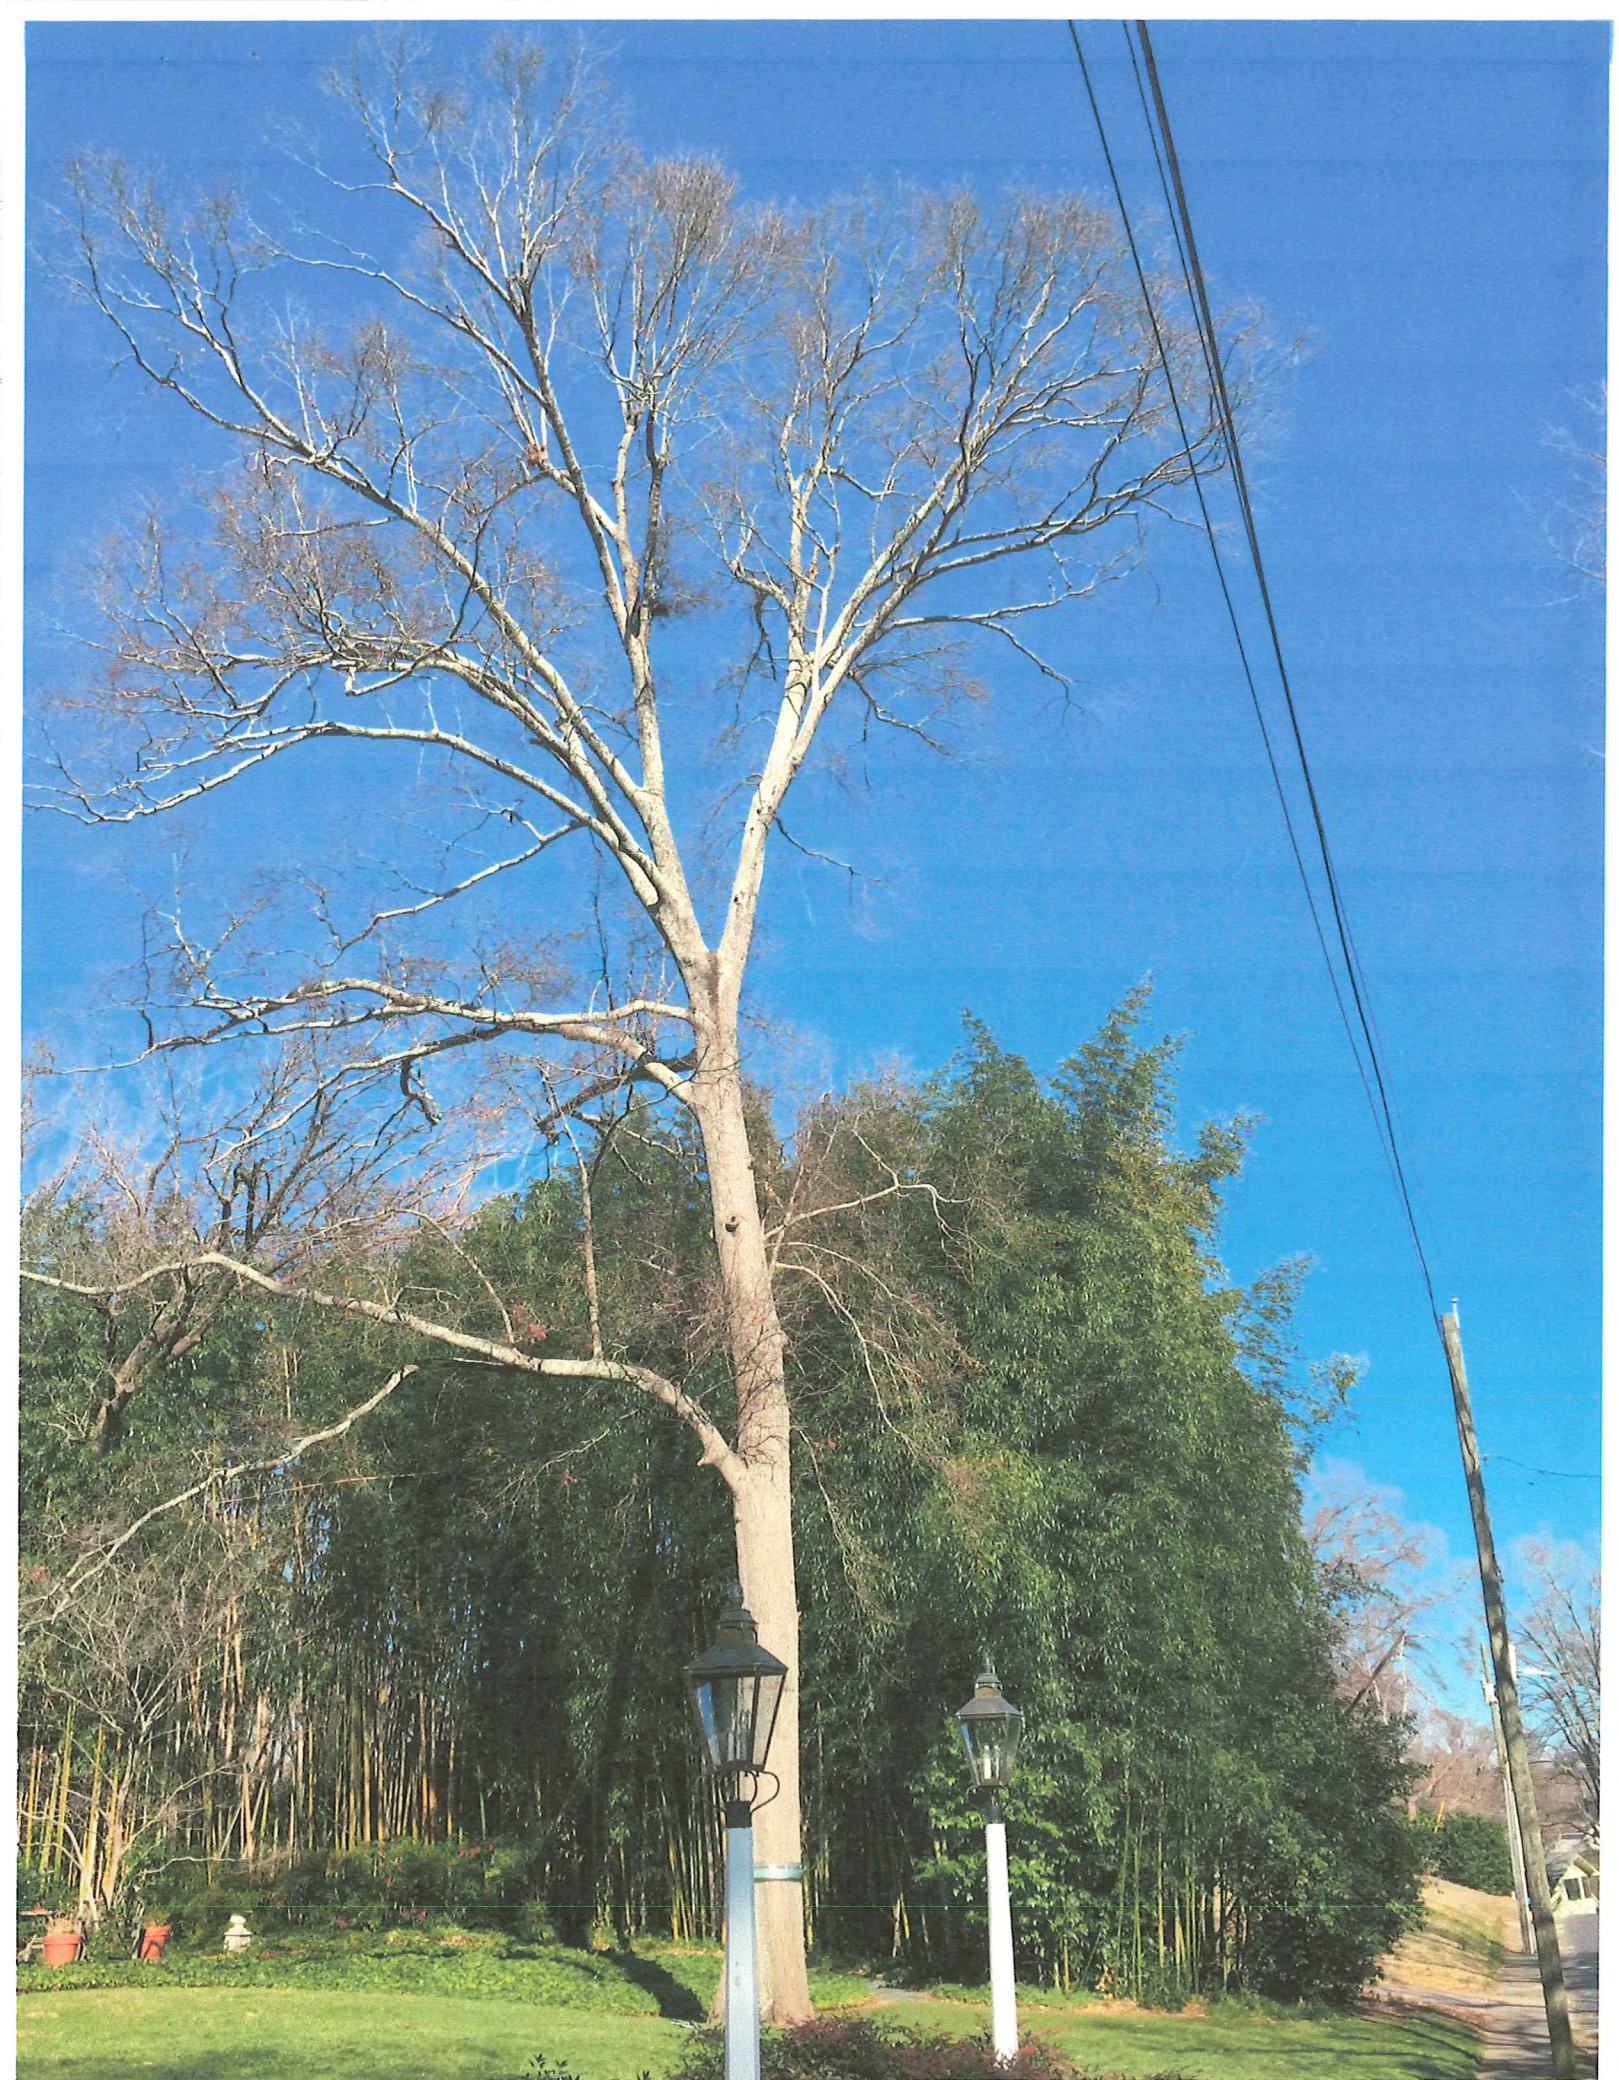
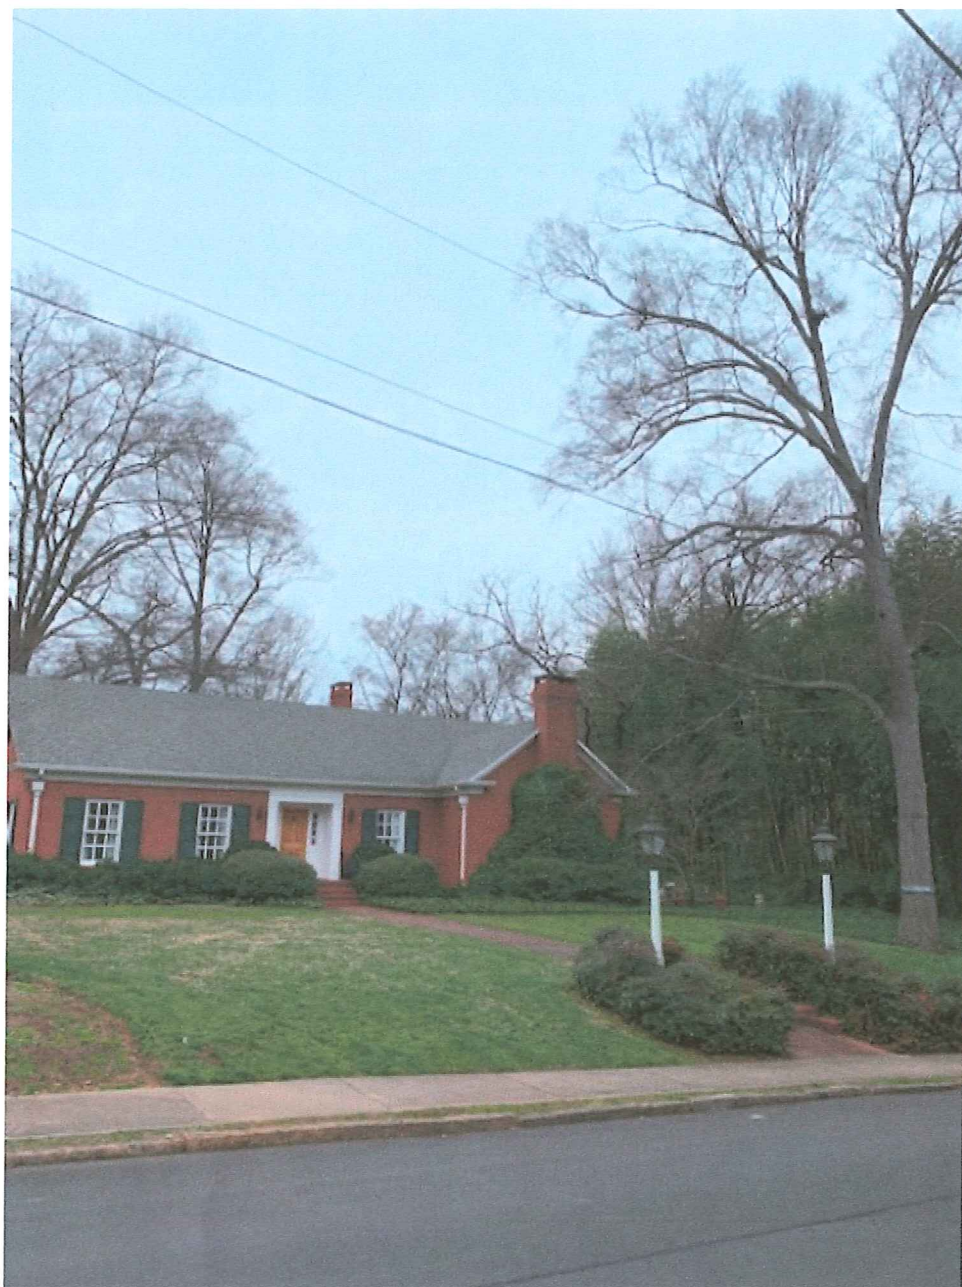
The applicant seeks to remove and replace a 100’ tall willow oak with a hazard rating of “4”.

Major pests/diseases: Root Crown Decay

Suspect root rot: YES Mushroom/conk/bracket present: YES ID: Inonotus dryadeus

This tree is in good condition structurally but does have signs of root crown decay fungi. The upper branches of the tree do not show decline that would indicate considerable root loss. It is my assessment that the decay is slight at the current time, however there are no accurate means to determine the amount of decay below ground. The site would allow for the replacement of another large species of tree.

Remove tree If replaced, a similar sized tree species would be appropriate in same location
