DATE: June 14, 2023

SUBJECT:
Certificate of Appropriateness Request: H-06-23
Applicant: Chad VanKeuren
Location of Subject Property: 120 Union St N
PINs: 5620-79-1486
Staff Report Prepared by: Jeff Ellis, Planner

TREE RISK ASSESSMENT FORM

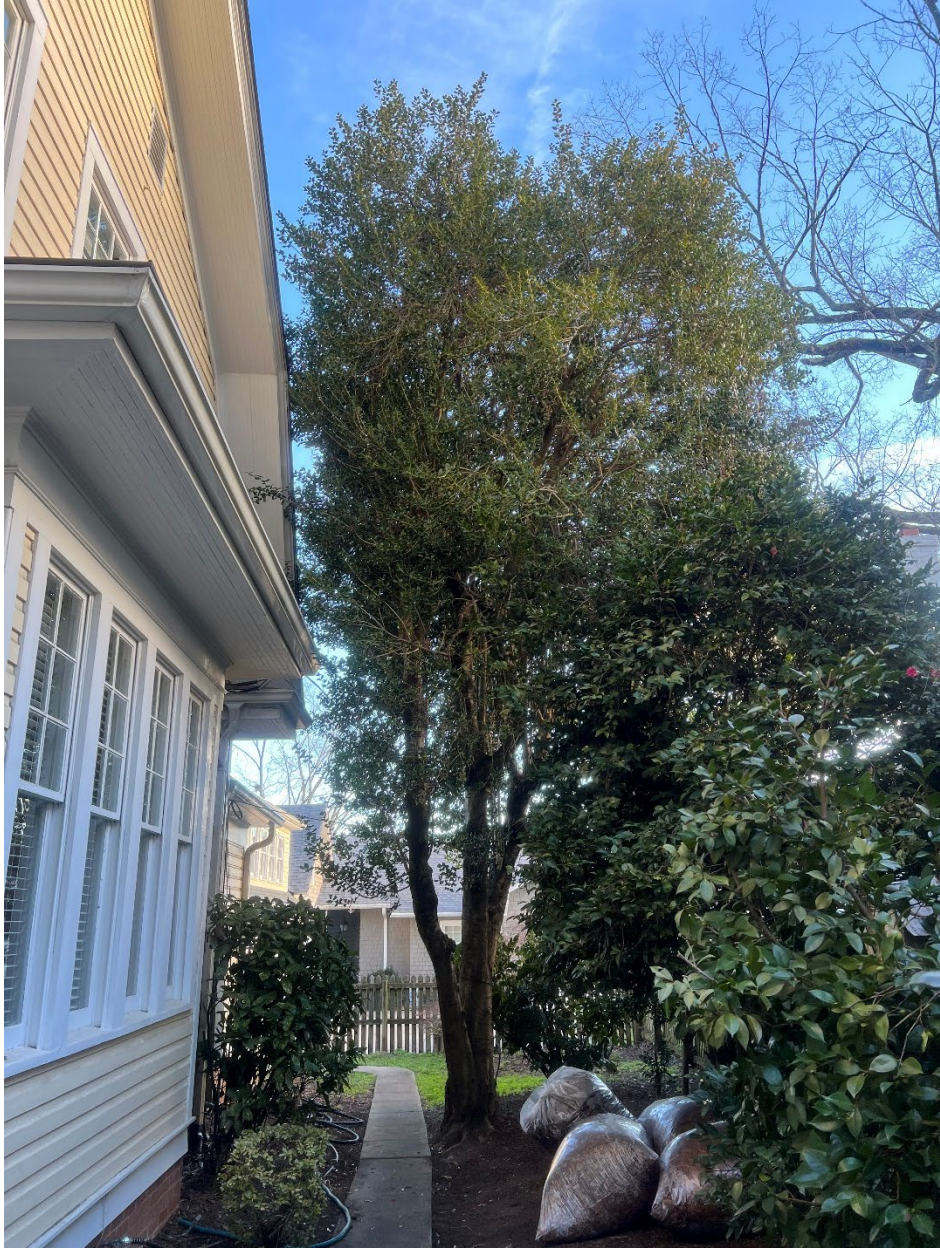
According to the Tree Risk Assessment Form (Exhibit D), the subject tree was inspected and evaluated by Bill Leake, City Arborist, on November 22, 2022. Bill notes the subject tree has no structural defects, and that it is in close proximity to the applicant’s home.

This tree has no structural defects. It is in close proximity to the home.

Remove tree When replaced, a similar sized tree species would be appropriate in same general location
