DATE: April 10, 2024

Certificate of Appropriateness Request: H-07-24
Applicants: Jim Potter, Old Towne Development Corp.
Location of Subject Property: 68 Cabarrus Ave. W
PINs: 5620-87-0595
Staff Report Prepared by: Autumn C. James, AICP - Planning & Development Manager

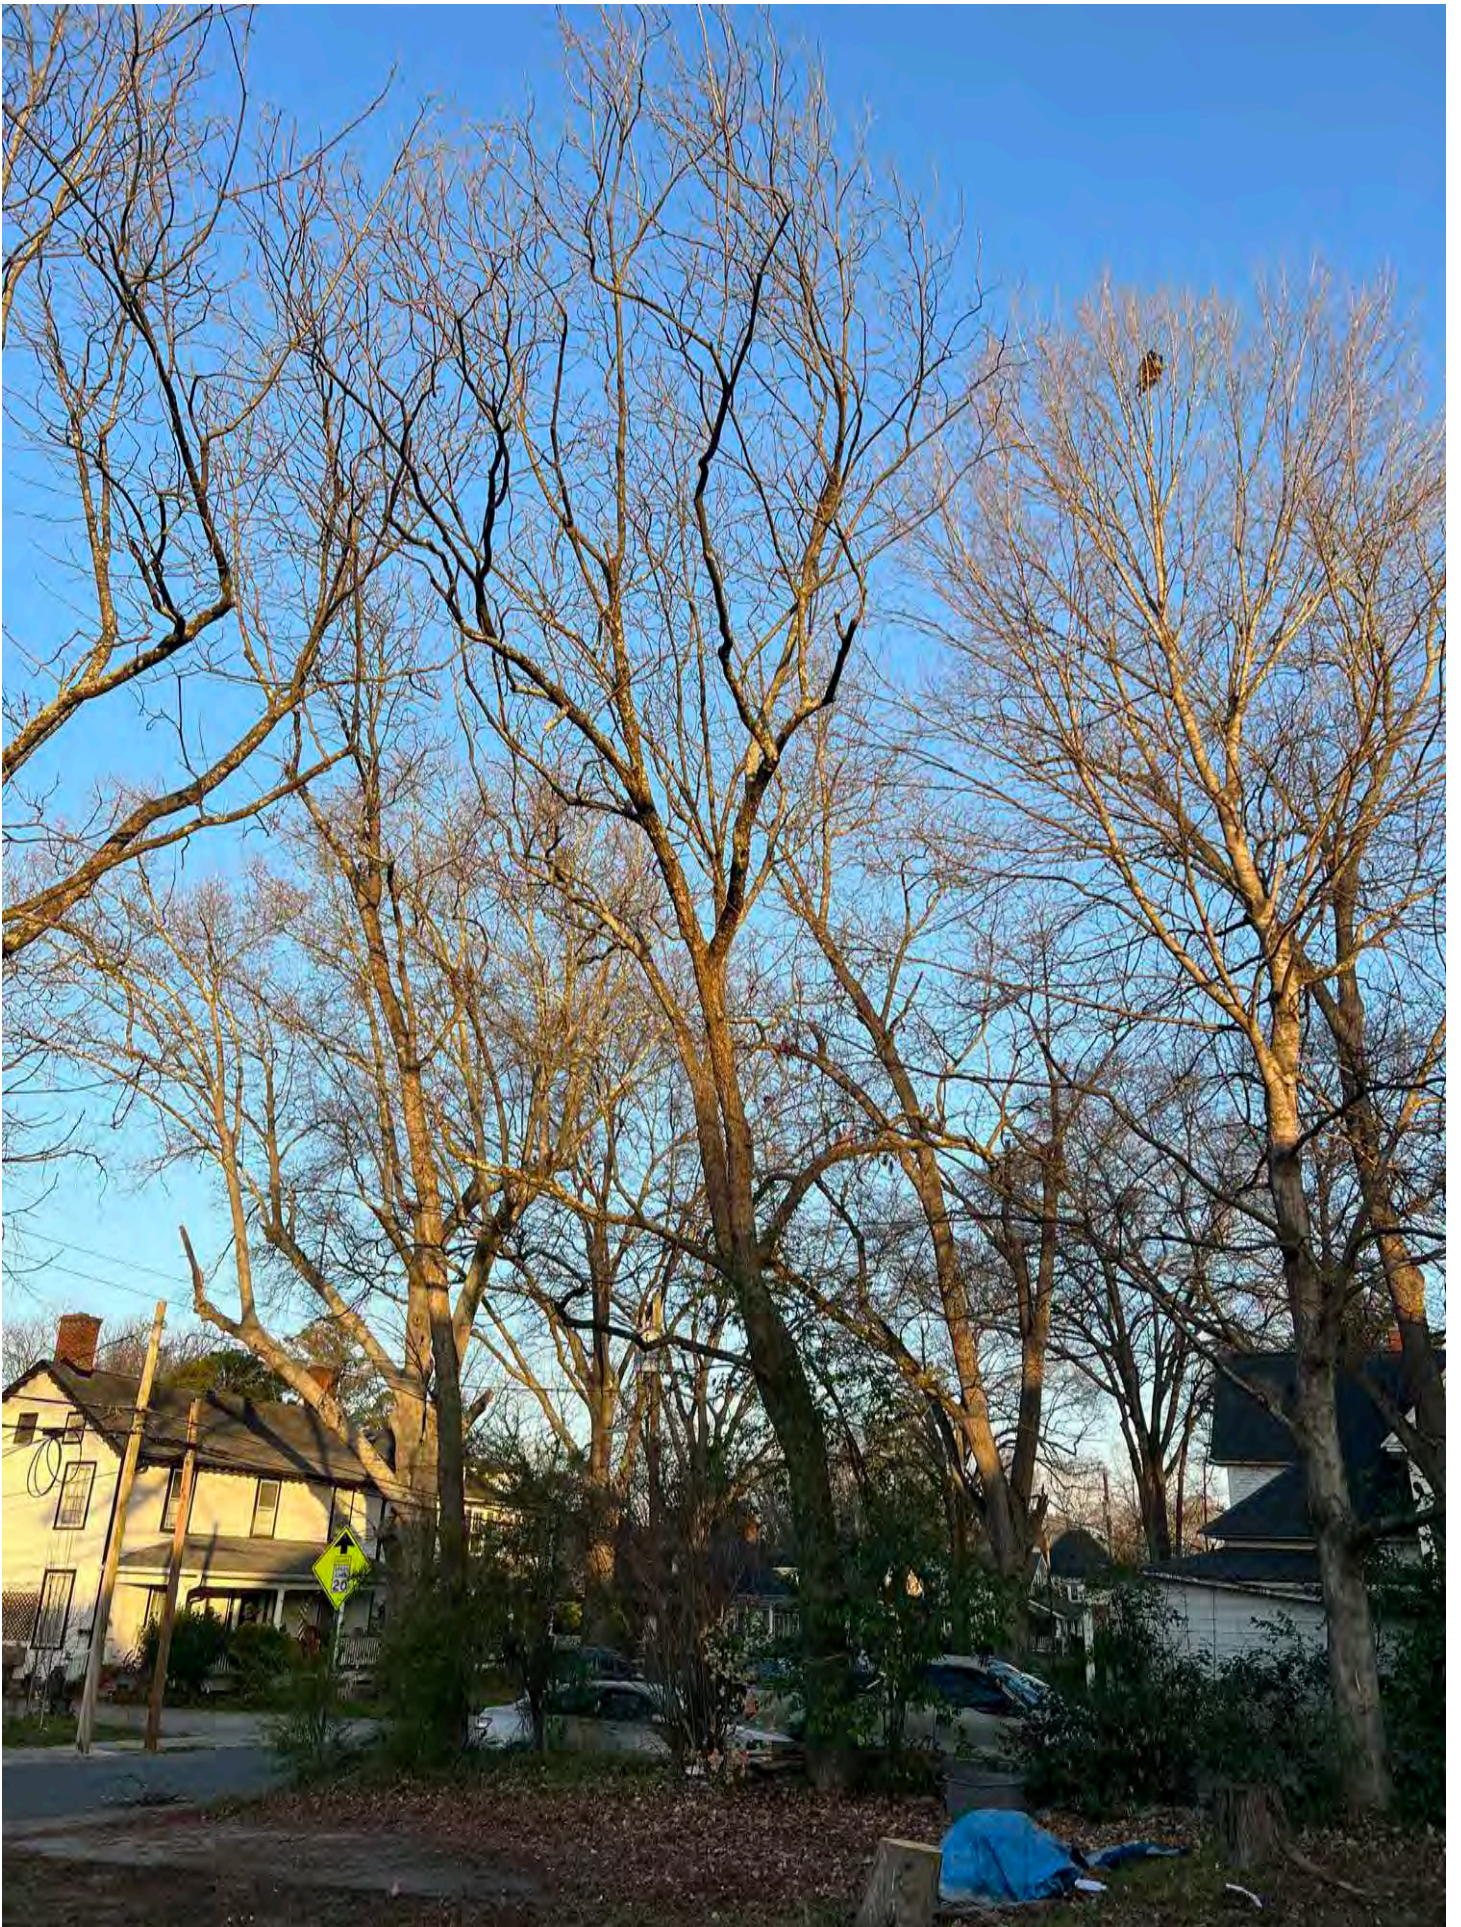
Tree part most likely to fail in the next six months: Branches

This tree has no structural defects or disease concerns.

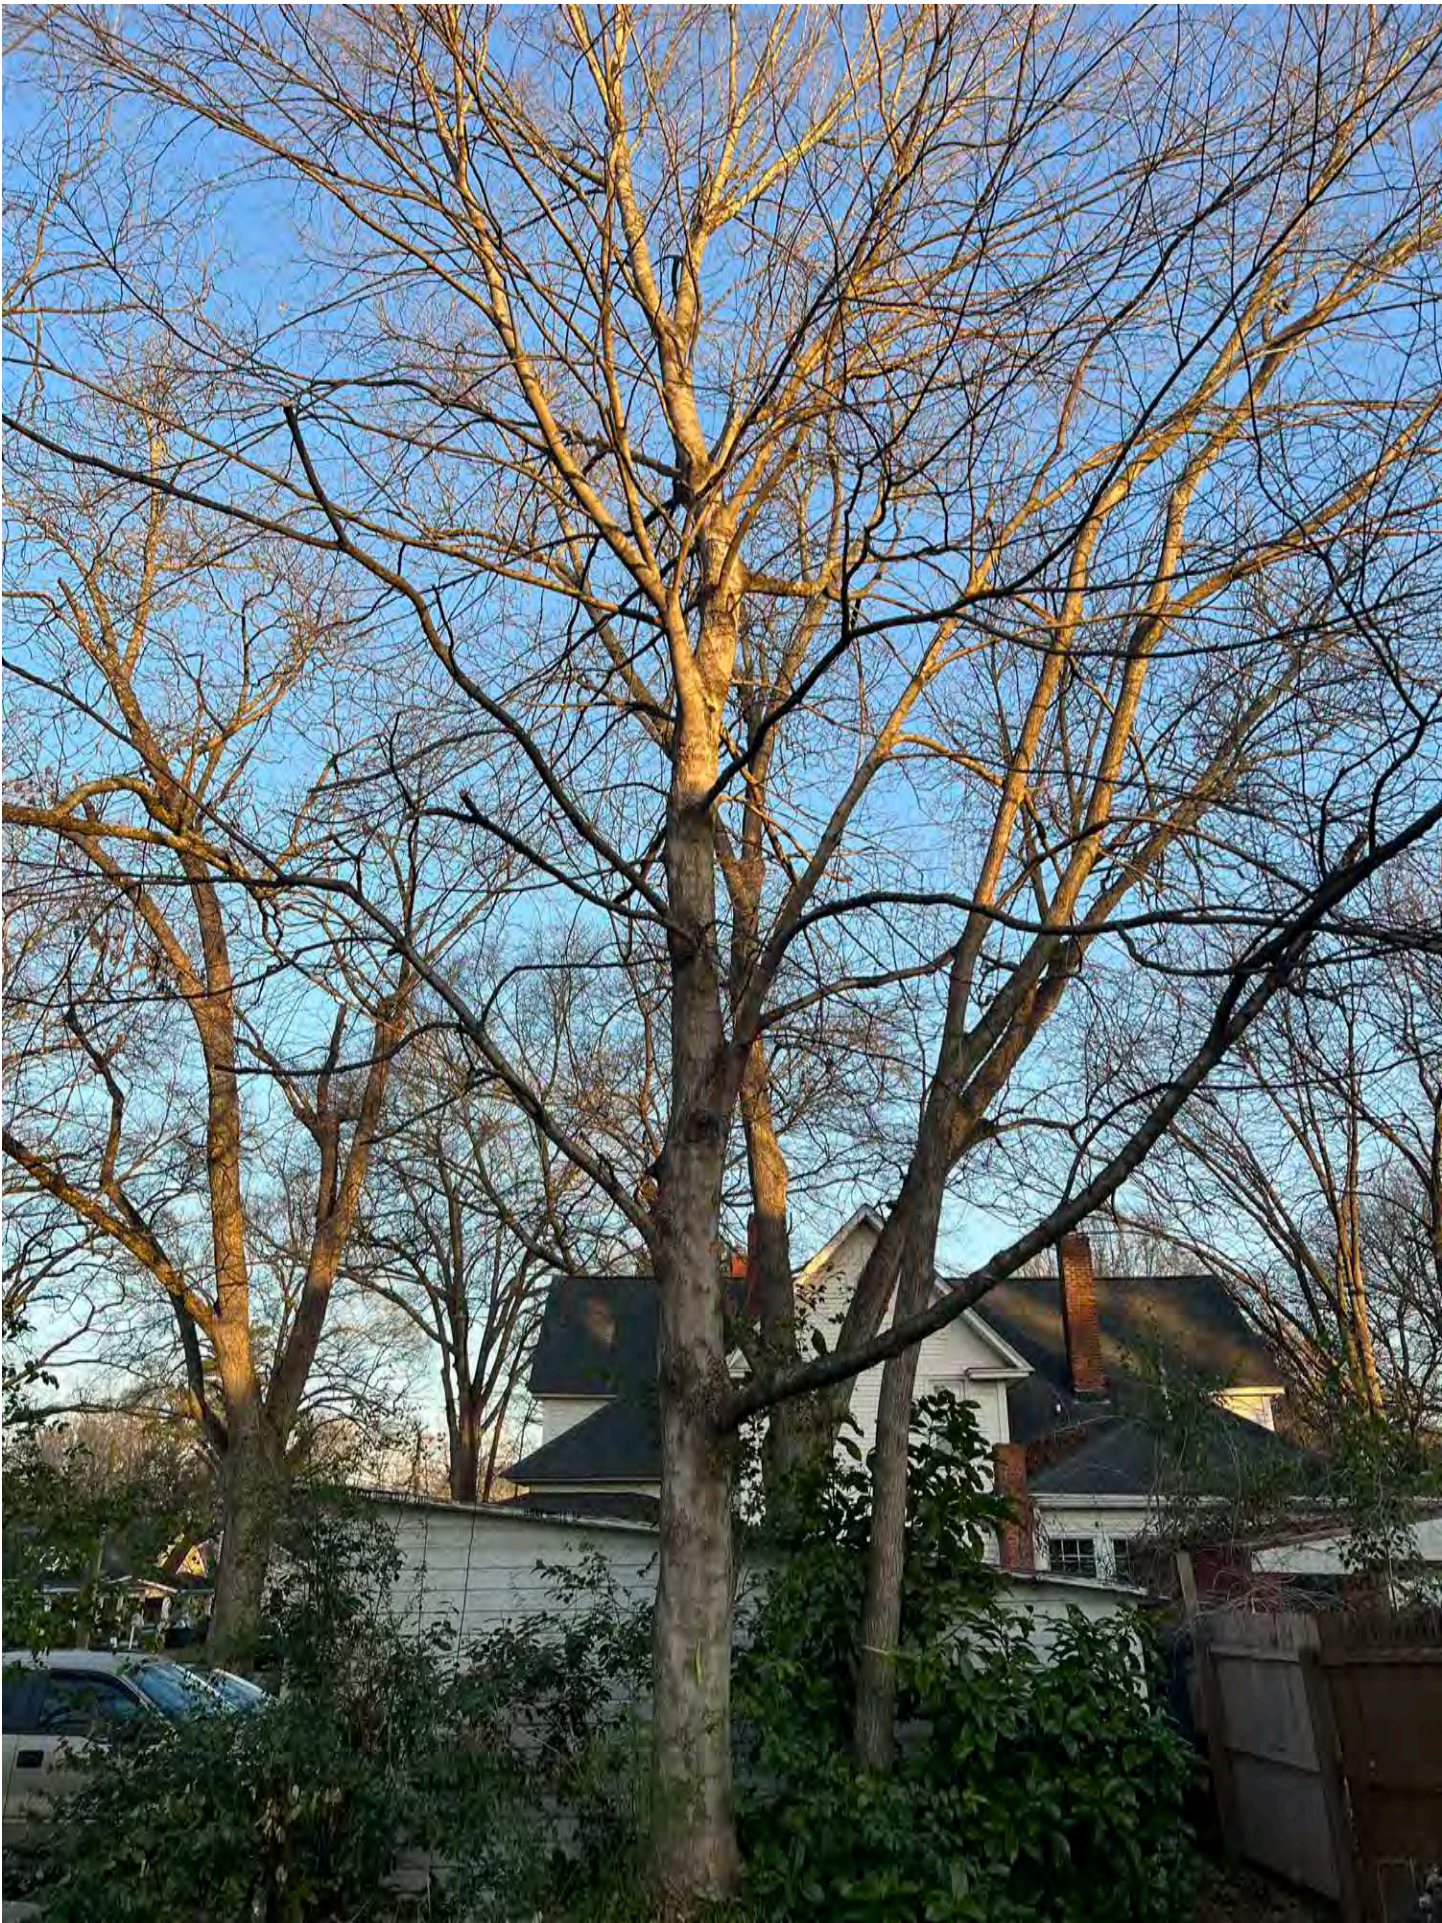
Tree part most likely to fail in the next six months: Branches

This tree has no structural defects or disease concerns.

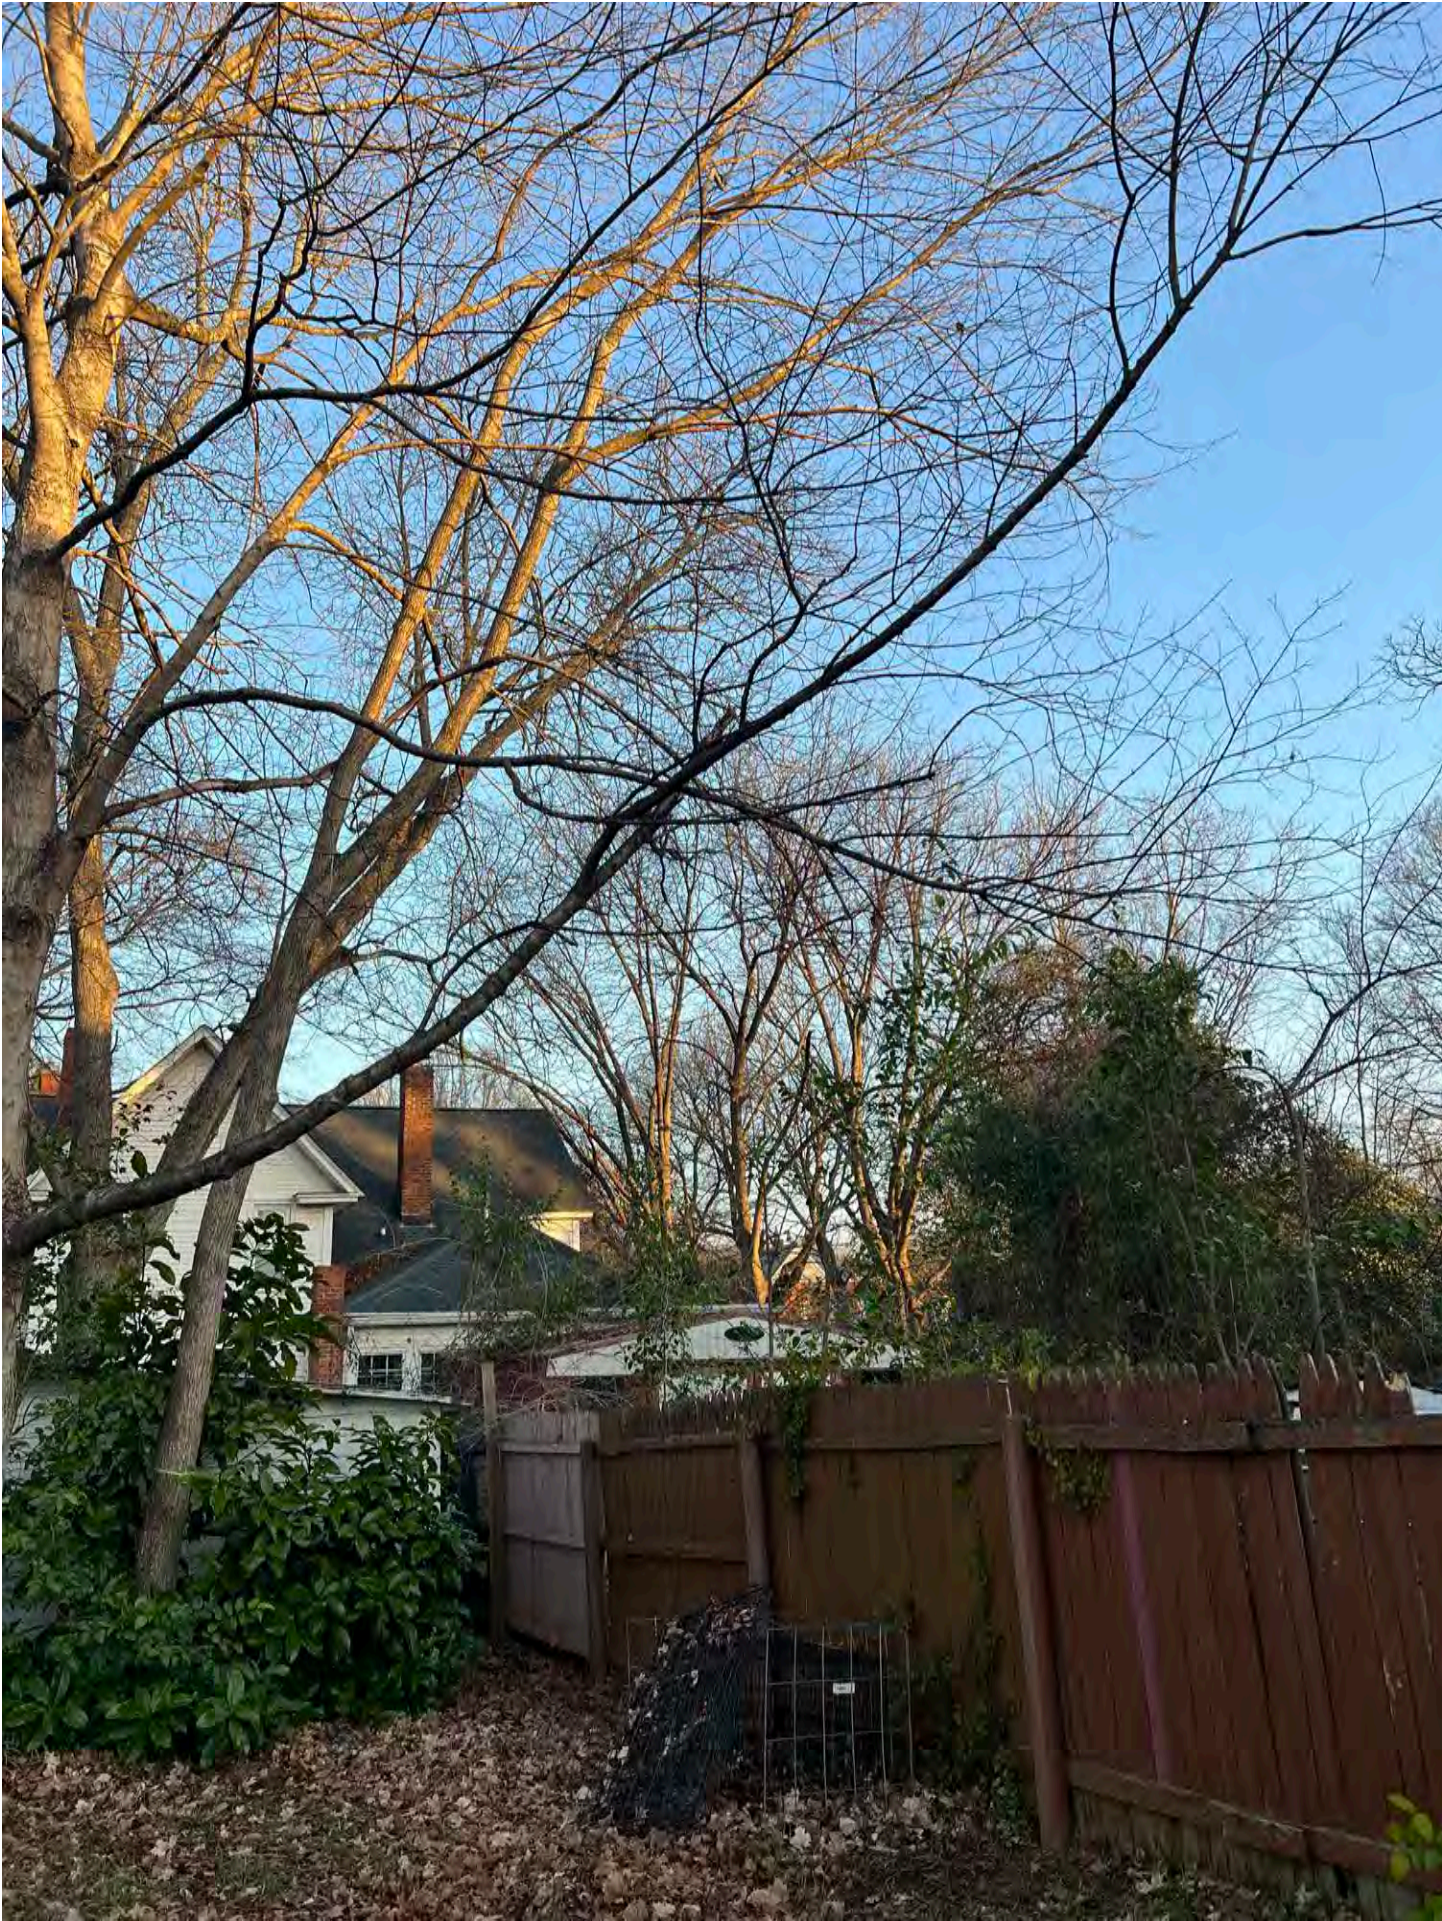
Tree #: 3 Elm (*Ulmus americana*)

Tree part most likely to fail in the next six months: Branches

This tree has no structural defects or disease concerns.
