**DATE:** March 11, 2020

<u>Certificate of Appropriateness Request:</u>	H-08-20
<u>Applicant:</u>	Mac Swaringen
<u>Location of subject property:</u>	246 Union St. N.
<u>Staff Report prepared by:</u>	Starla Rogers, Planning & Development Mgr.

# TREE RISK ASSESSMENT FORM

Site/Address: 246 Union St N

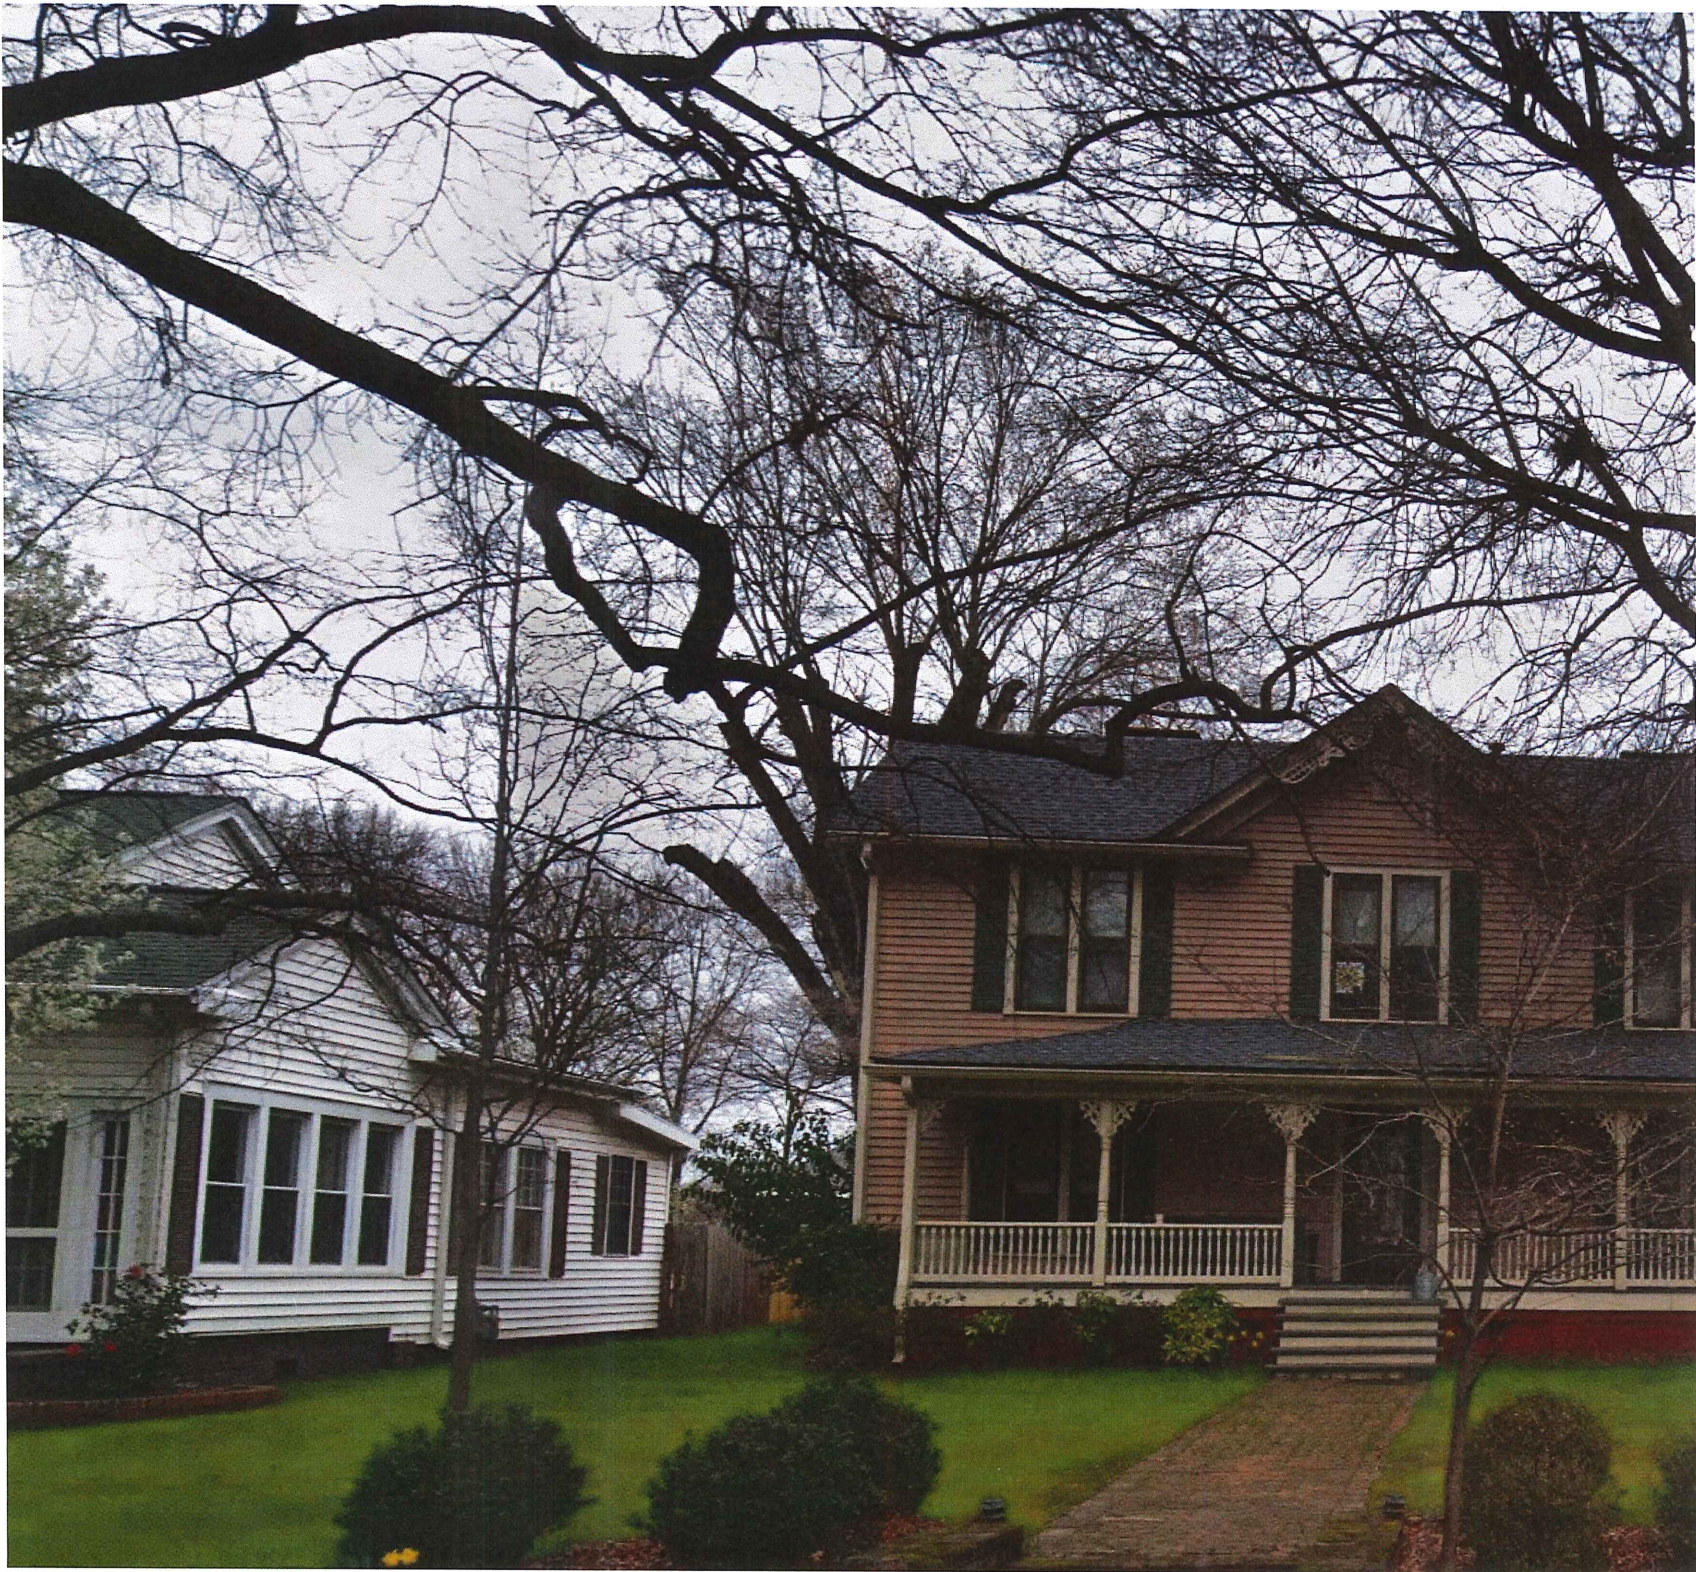
P. 3

Tree part most likely to fail in the next six months: Branches above previous topping cuts.

This assessment is made using google street view, knowledge of the history of this tree and existing pieces of wood still on the site. The assessment is an estimate of the condition of the tree before removal was started.
