DATE: May 9, 2018

<u>Certificate of Appropriateness Request:</u>	H-10-18
<u>Applicant:</u>	John Turner
<u>Location of subject property:</u>	43 Marsh Ave NW
<u>Staff Report prepared by:</u>	Scott Sherrill, Sr. Planner

TREE RISK ASSESSMENT FORM

Site/Address: 43 Marsh Avenue

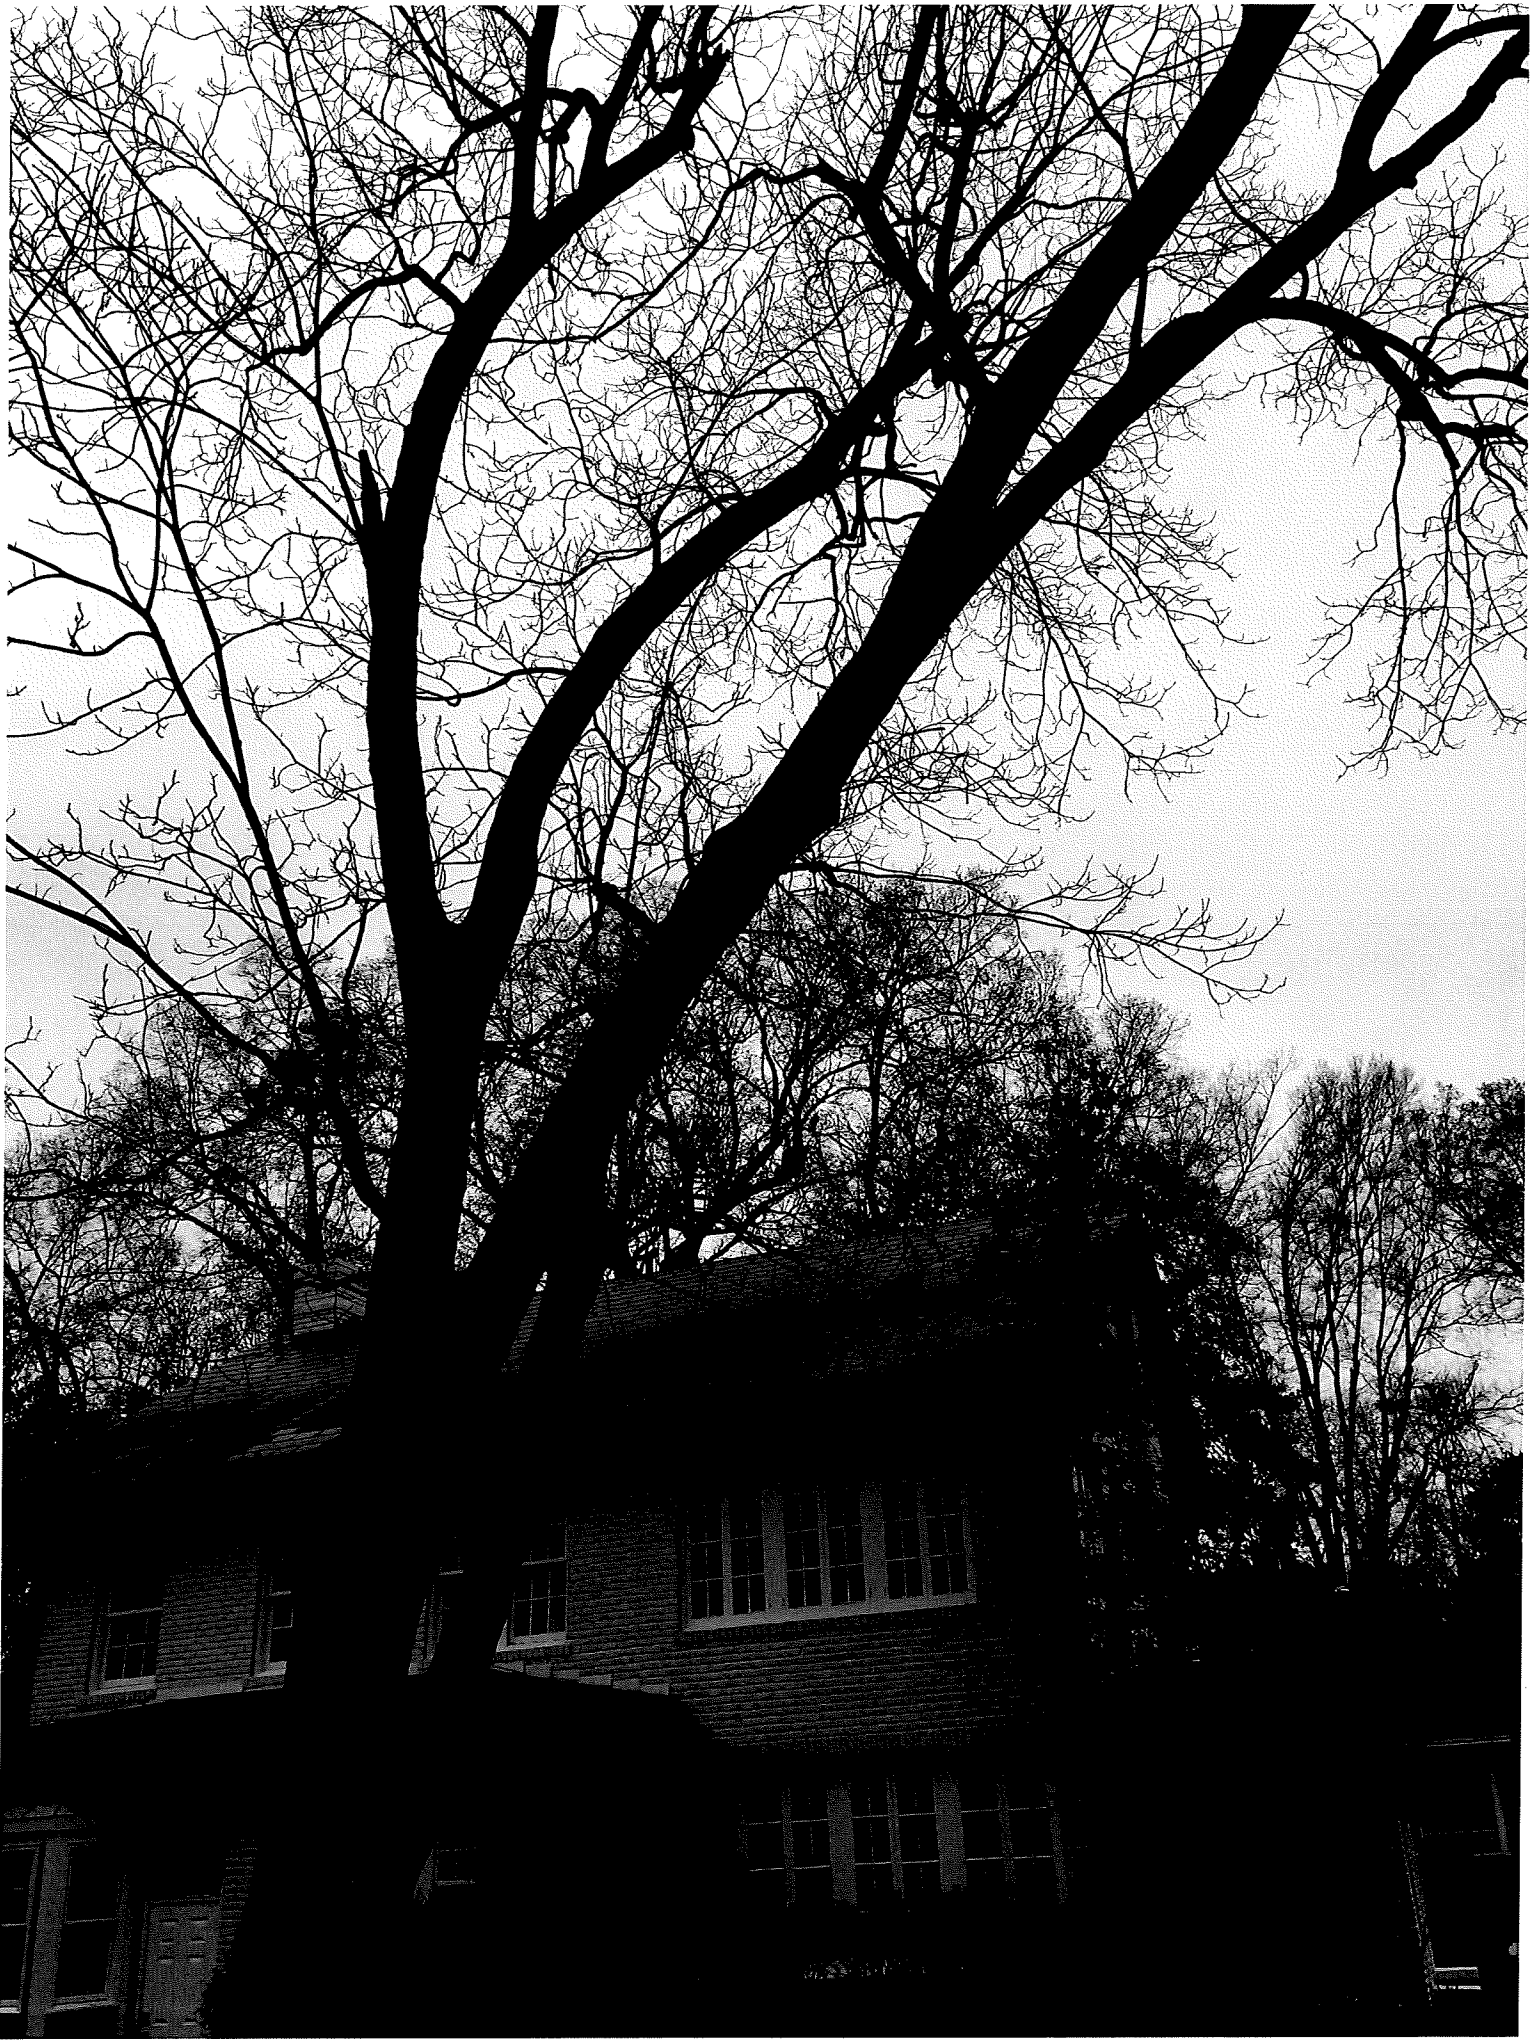
Tree #: 1 Species: Pecan (Carya illinoensis)

This tree is in good overall condition and has been well maintained. There have been multiple pruning events to reduce the size of the upper crown of this tree and correct the bowed, elongated limbs typical of pecan trees. The proposed landscape improvements will have significant impact on the root system of this tree.

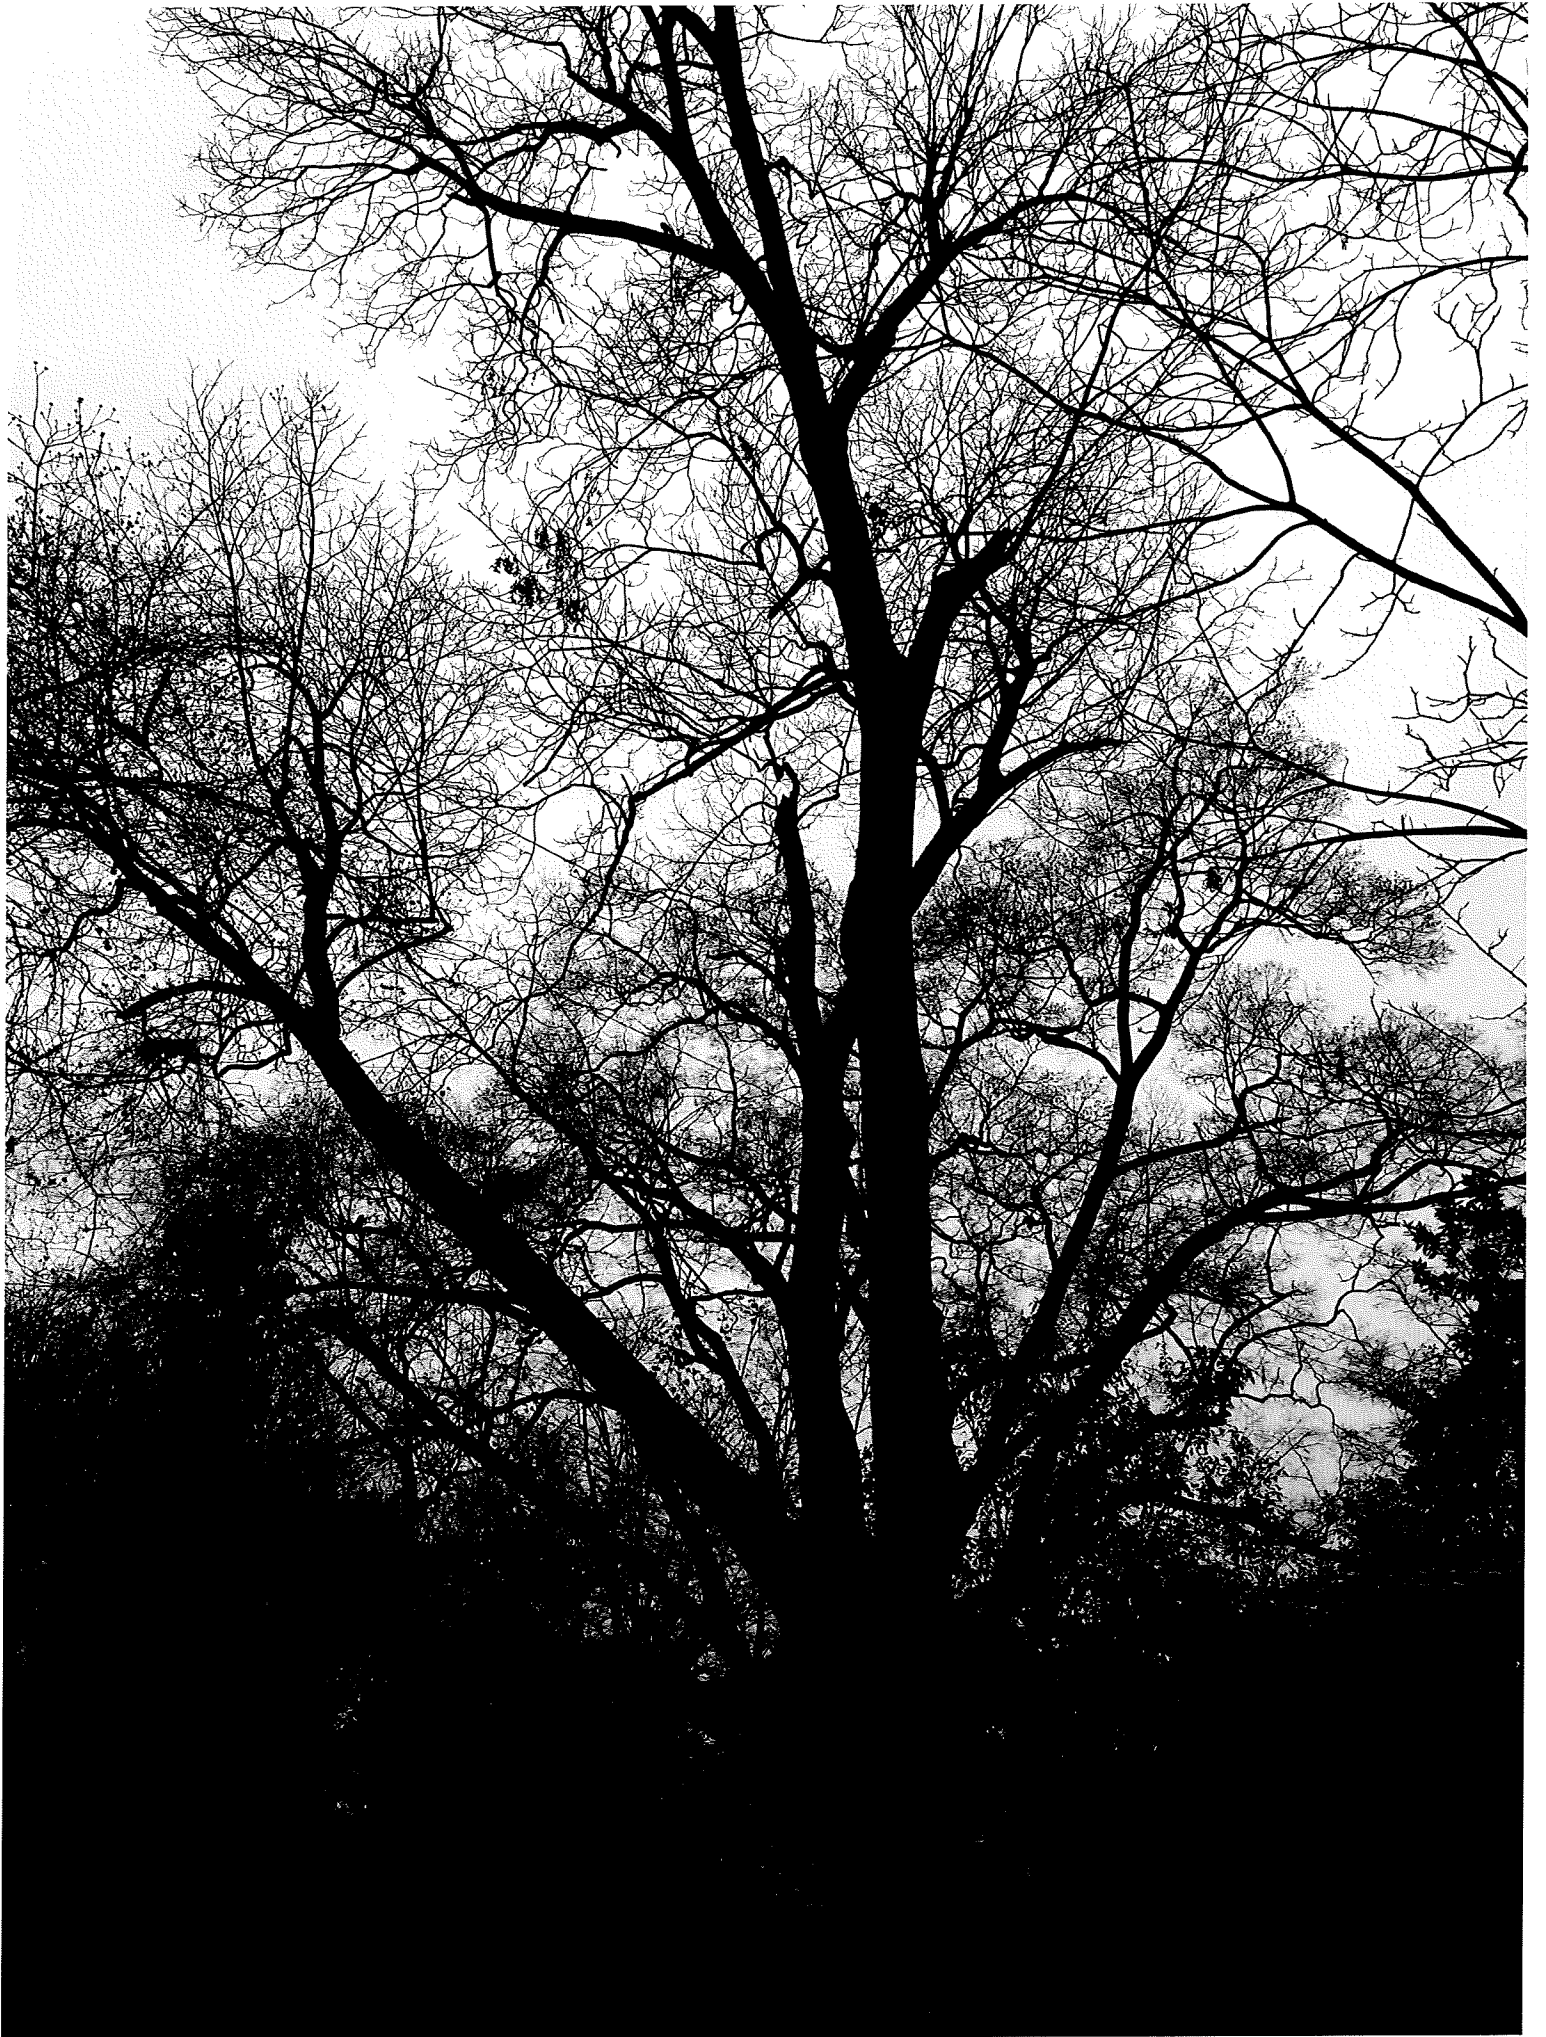
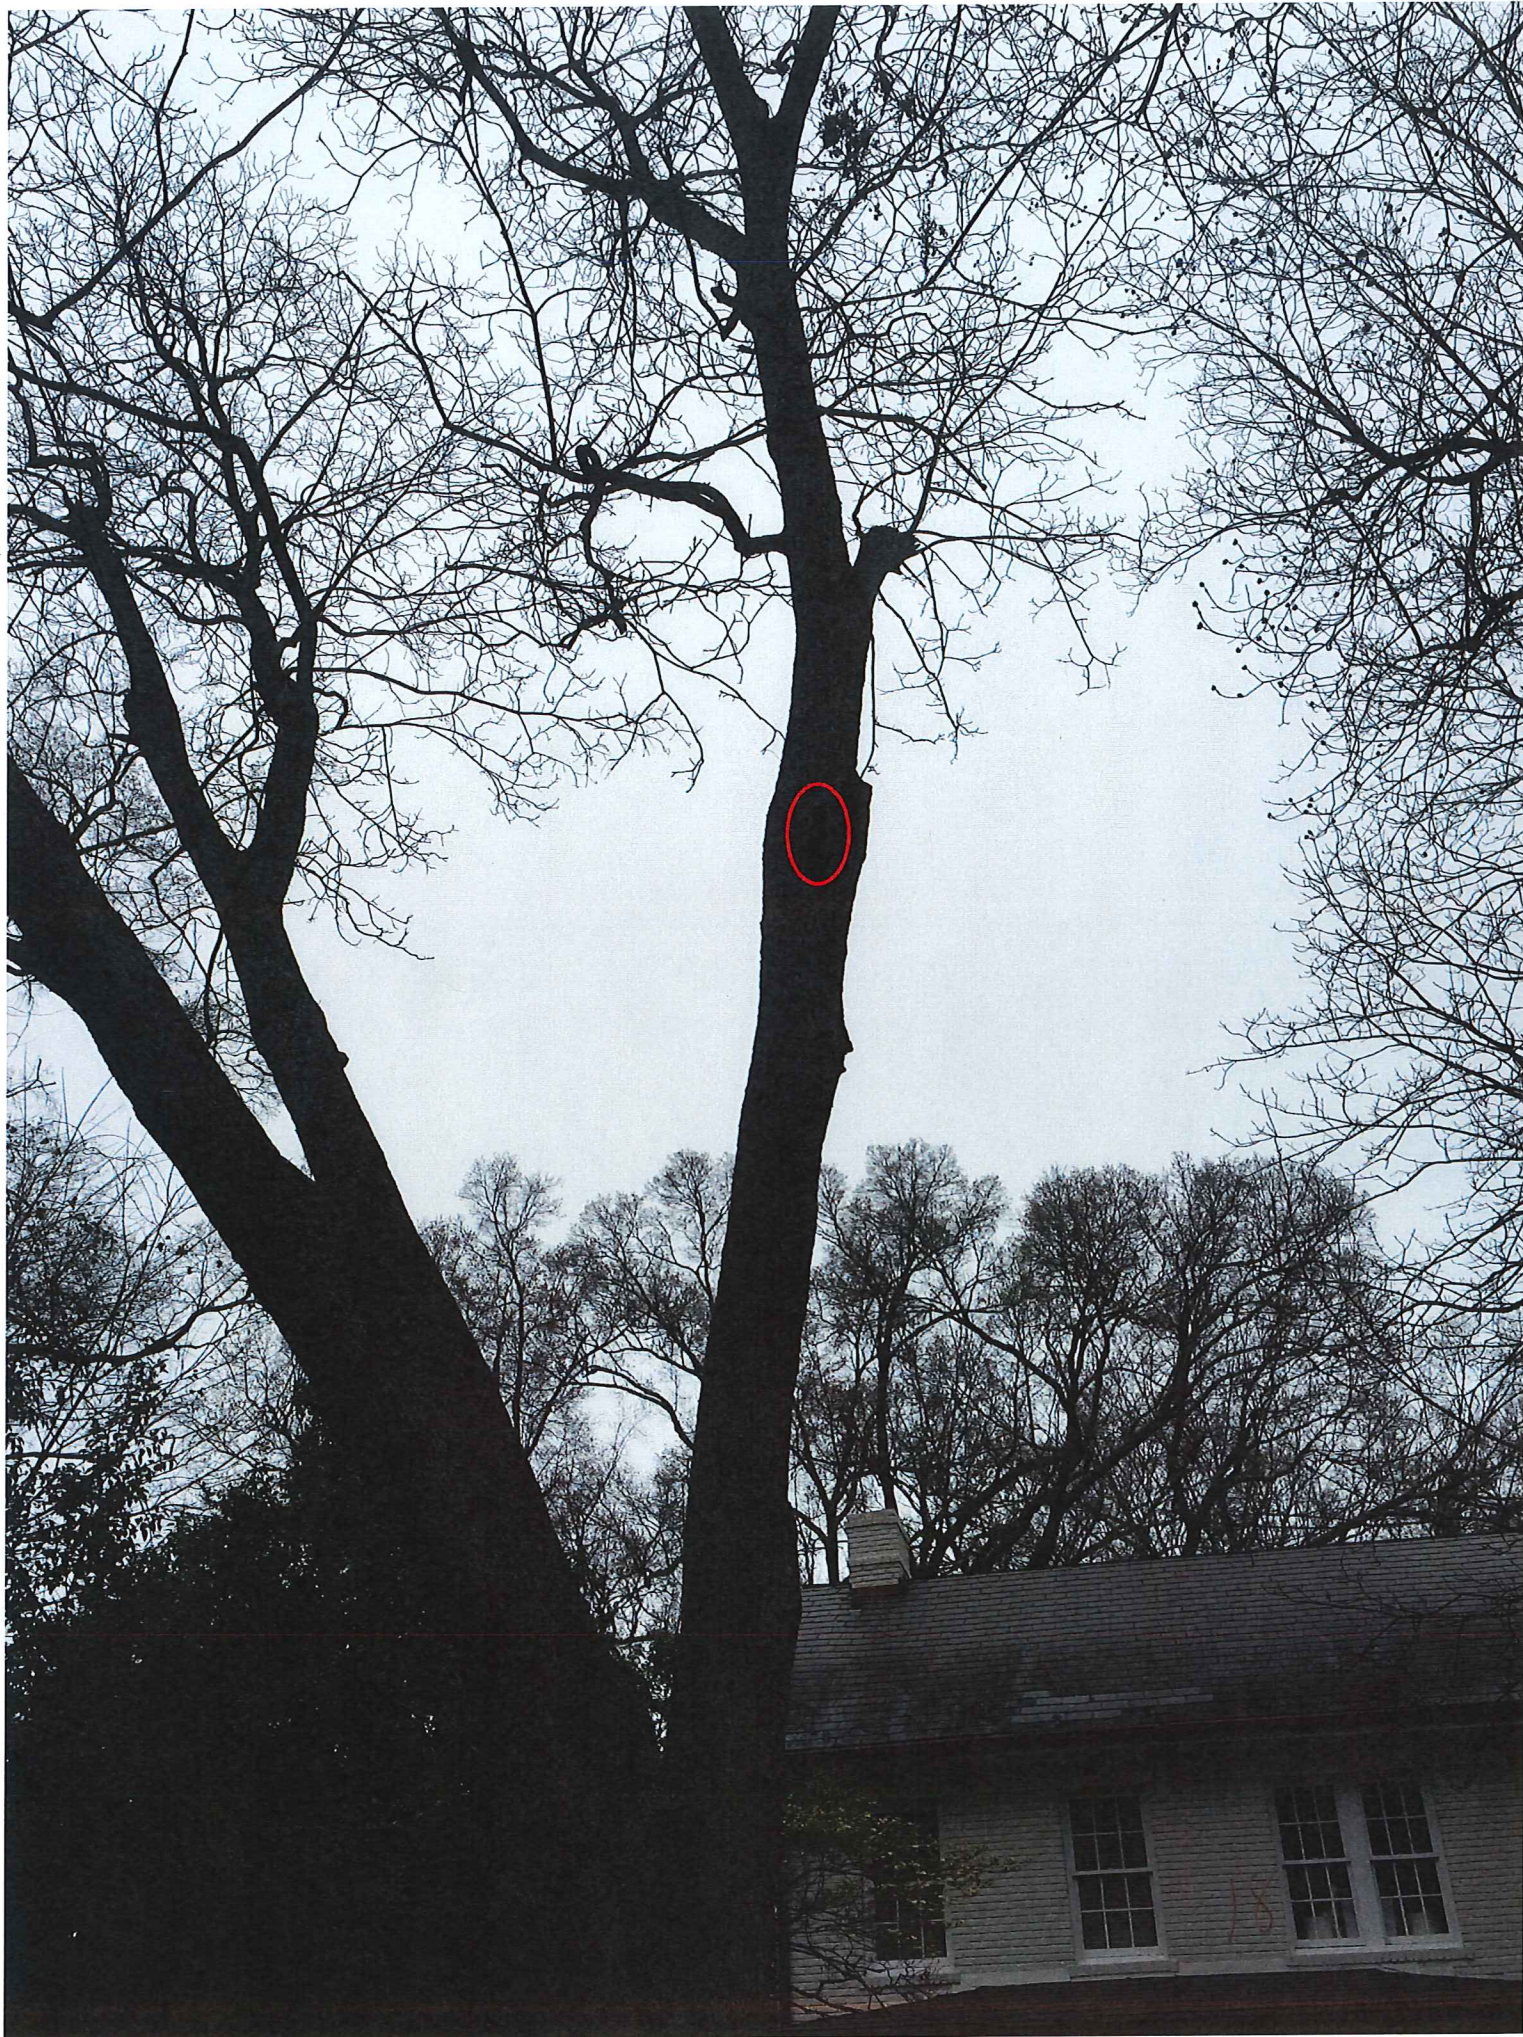
This tree is in good overall condition and has been well maintained. On the upright scaffold trunk there is an area of decay with adaptive tissue growth forming around the wound. There is also a wound, on the lower main trunk, from a very large section of scaffold trunk previously removed. This will be an area of considerable decay in the future. The proposed landscape improvements will have significant impact on the root system of this tree. *Bill Leake*

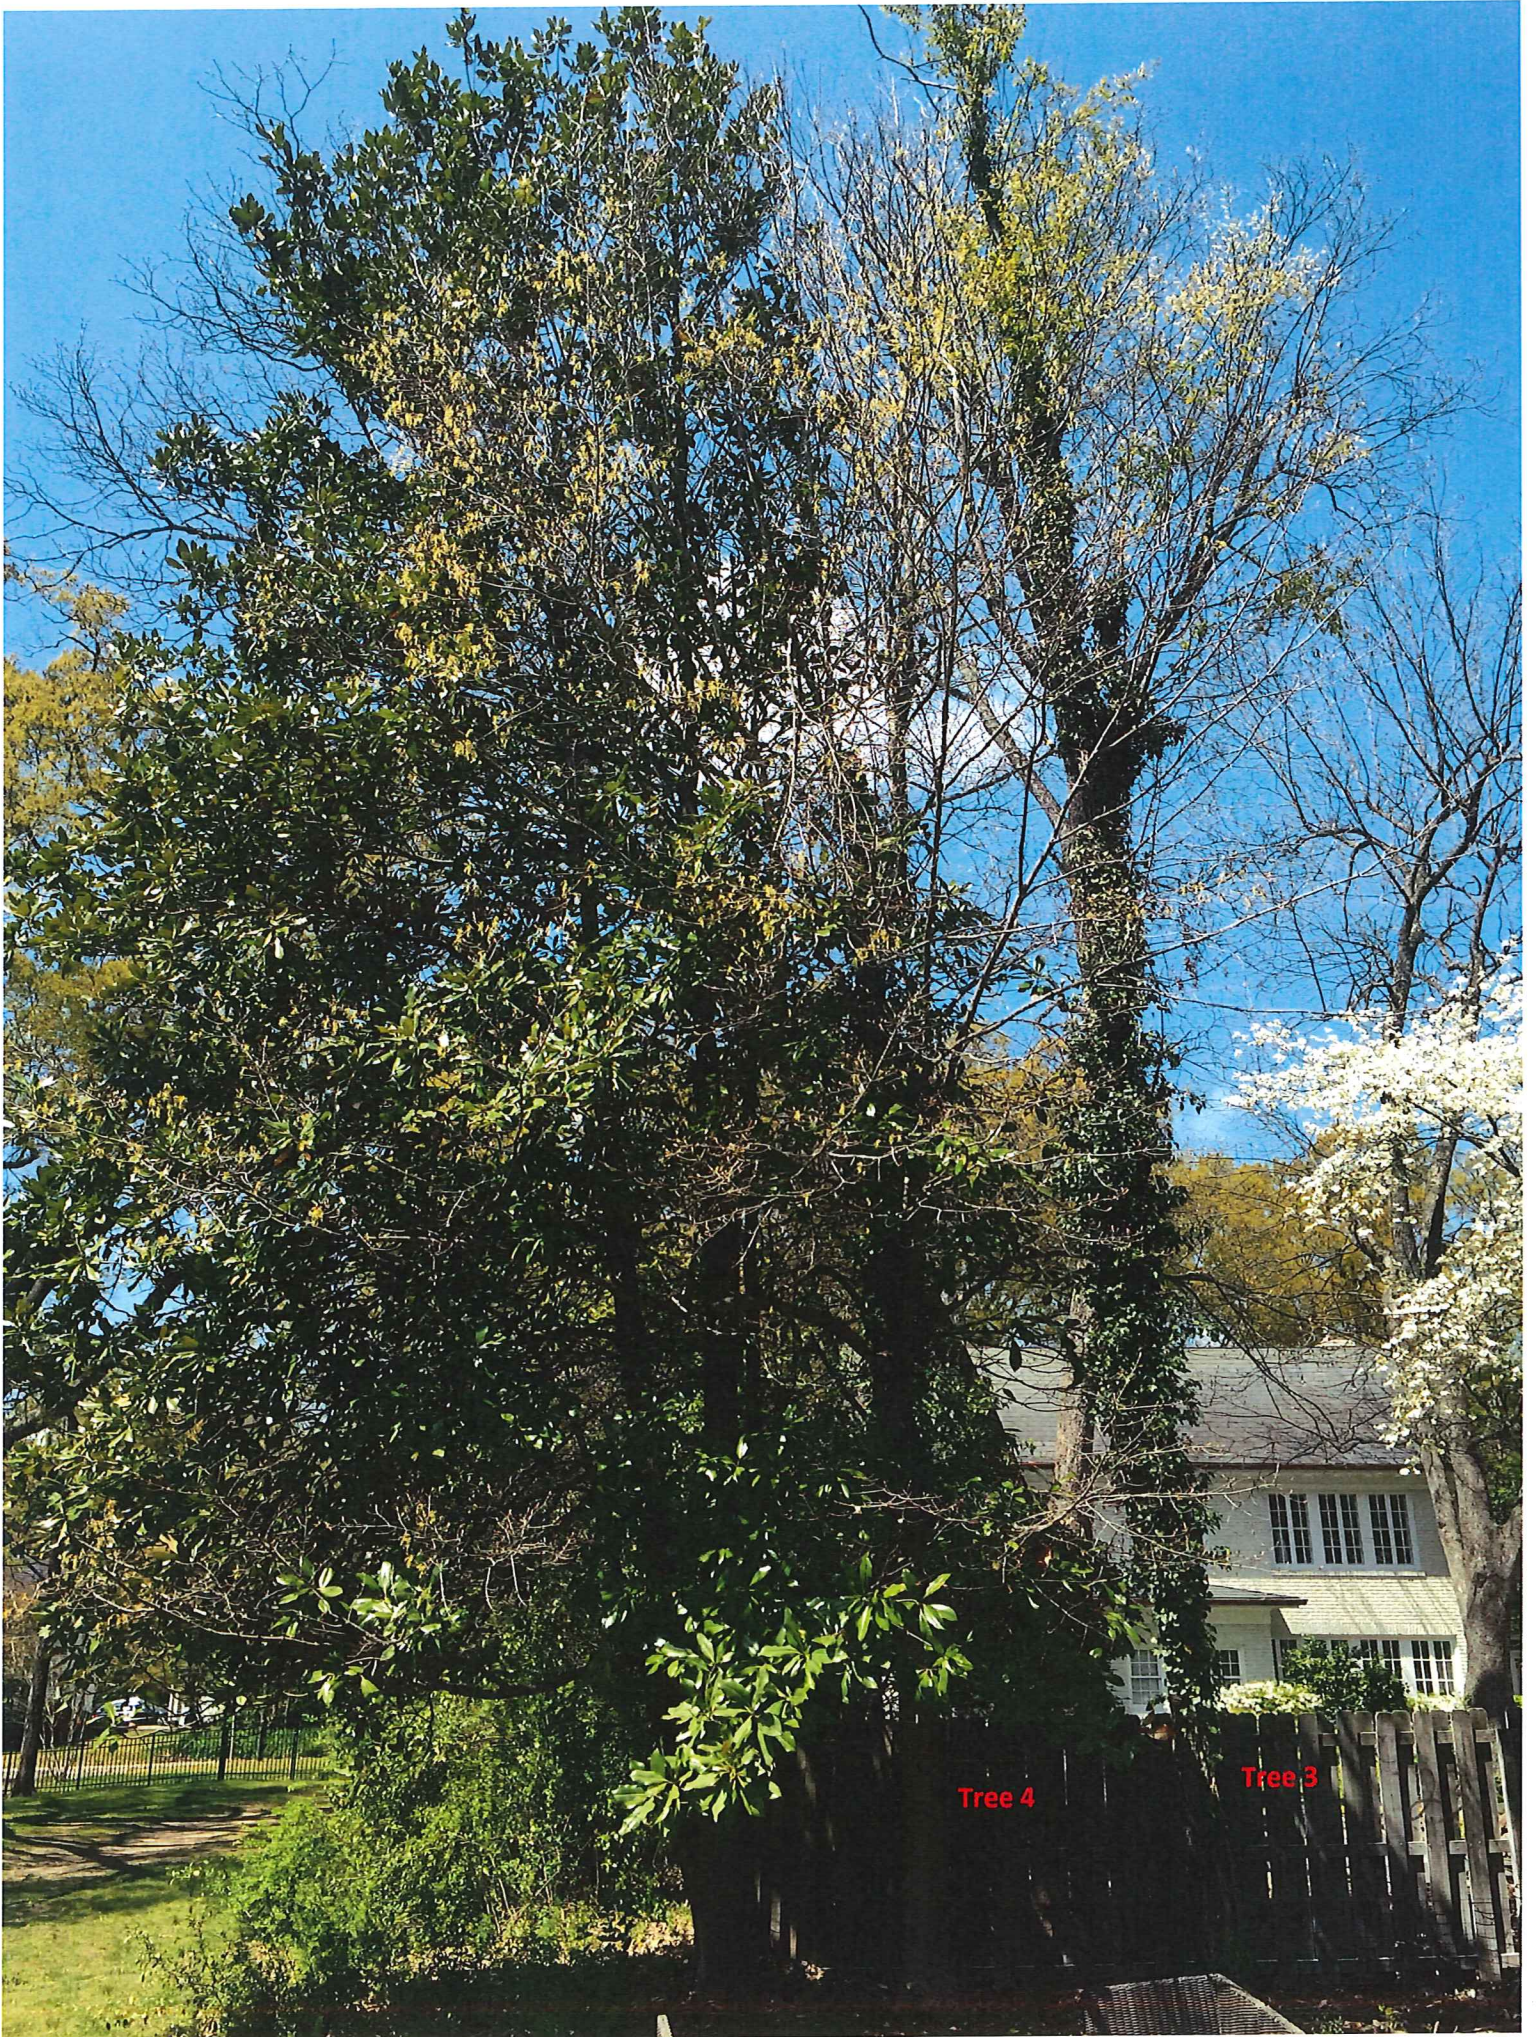
Tree #: 3 Species: Wild Cherry (Prunus serotina)

This tree is in poor overall condition. The upper portions of this tree have died and new branches sprouts have formed. This response growth will be poorly attached may cause issues as the tree continues to grow. I recommend the tree be removed and replaced. The proposed landscape improvements will impact the root system of this tree.

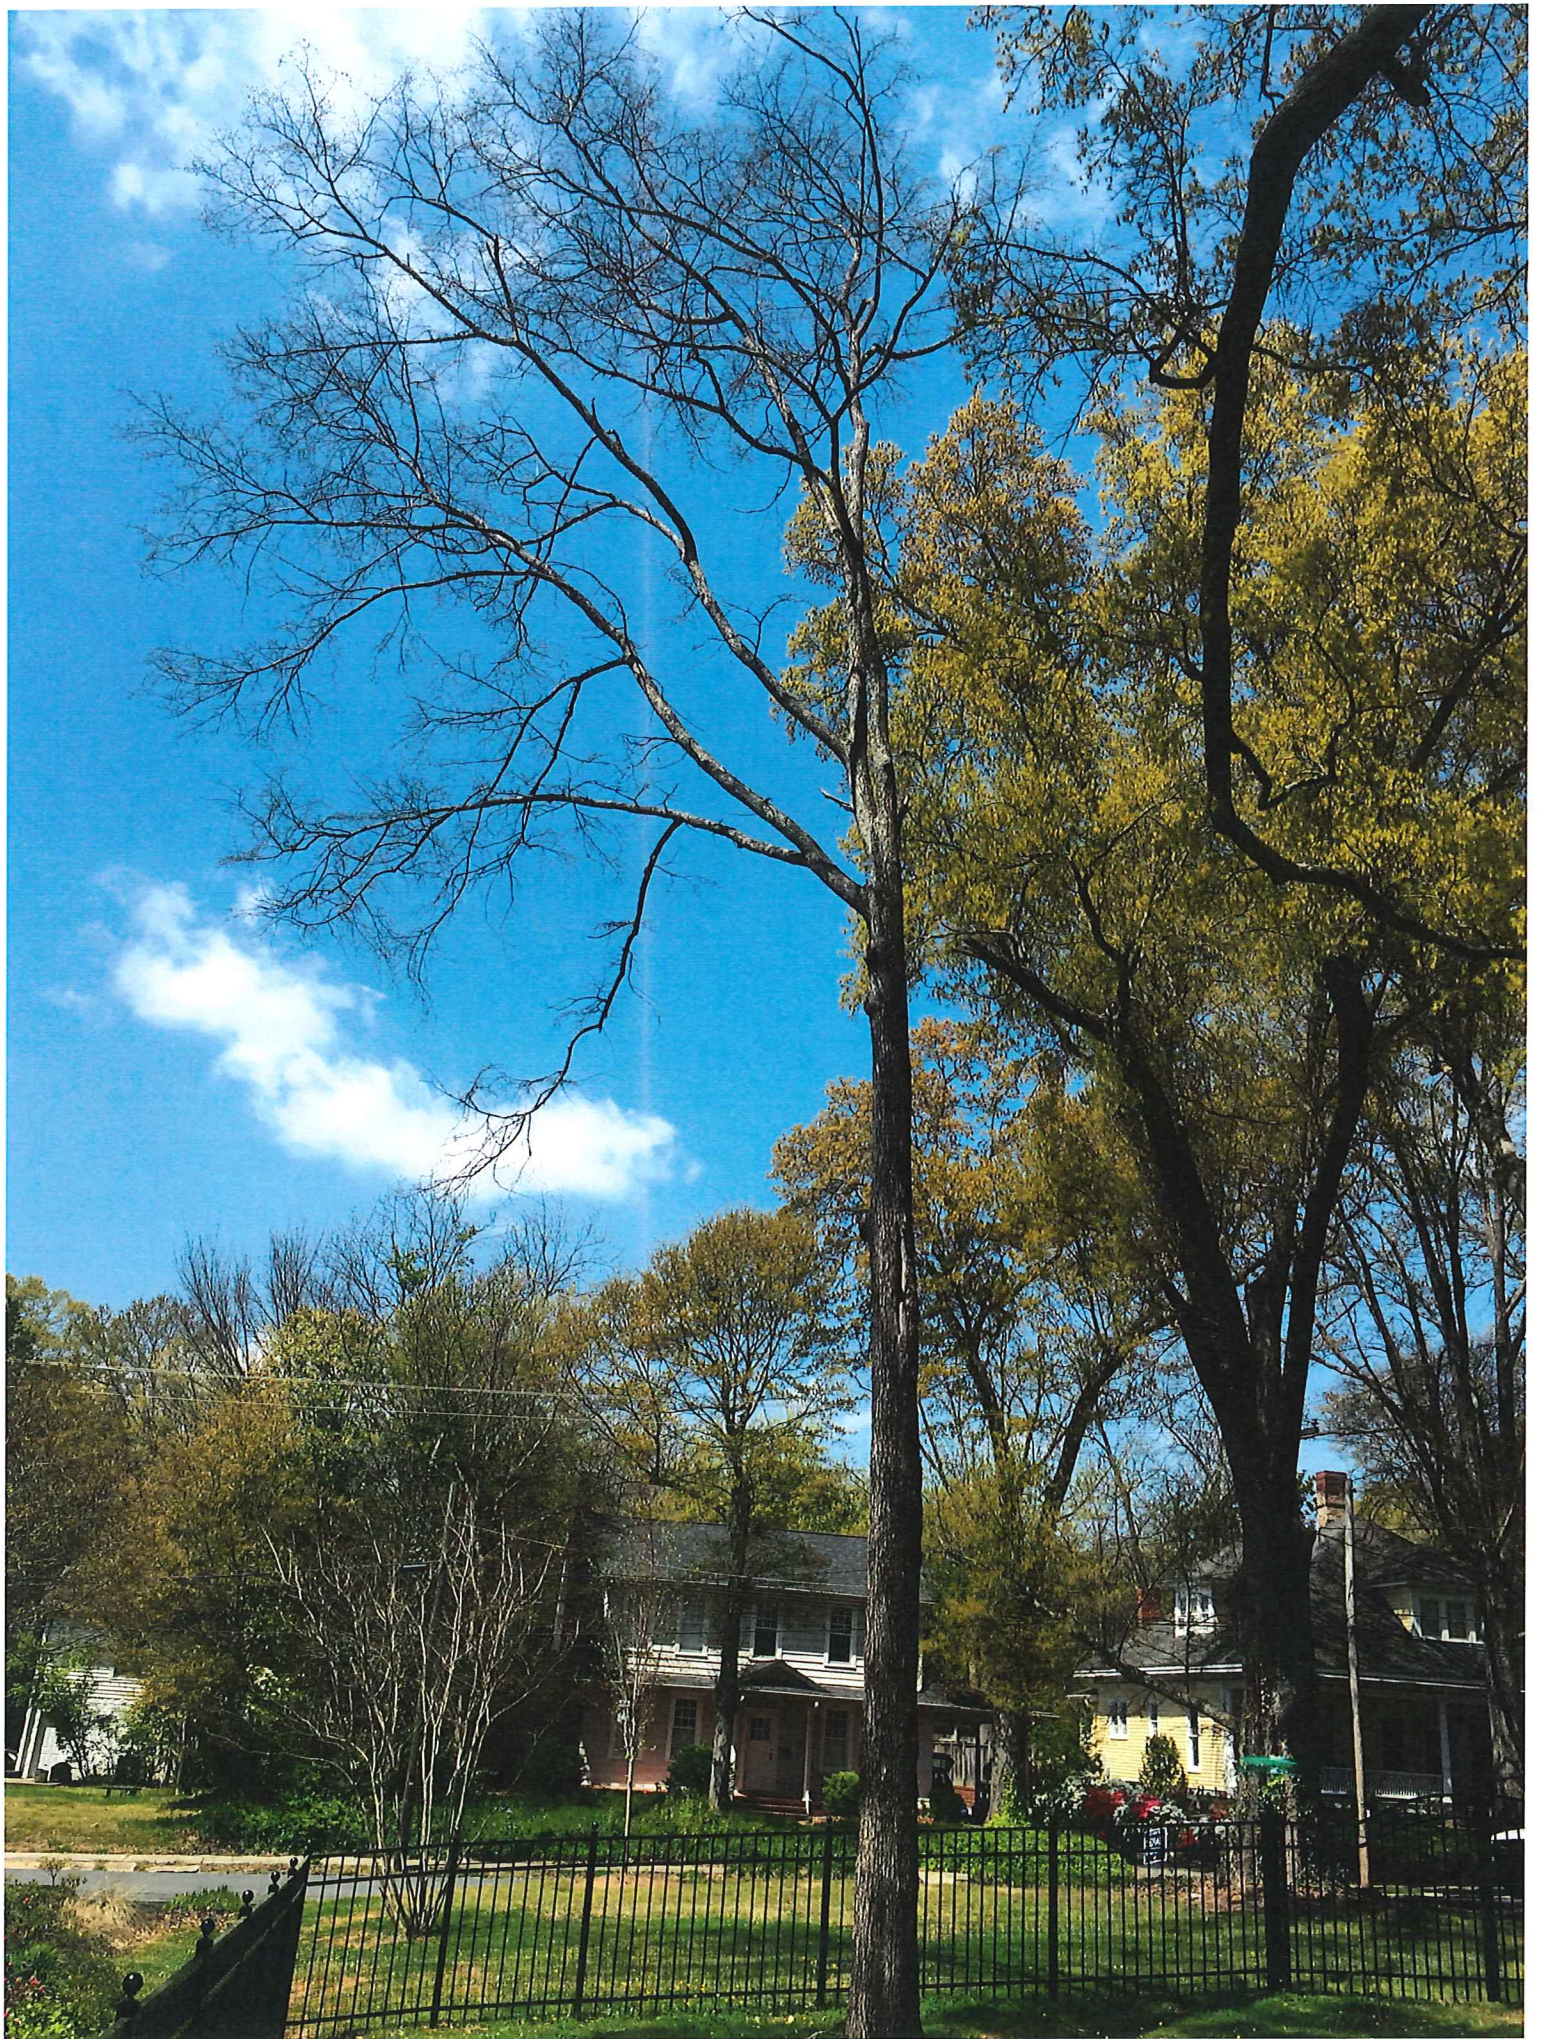
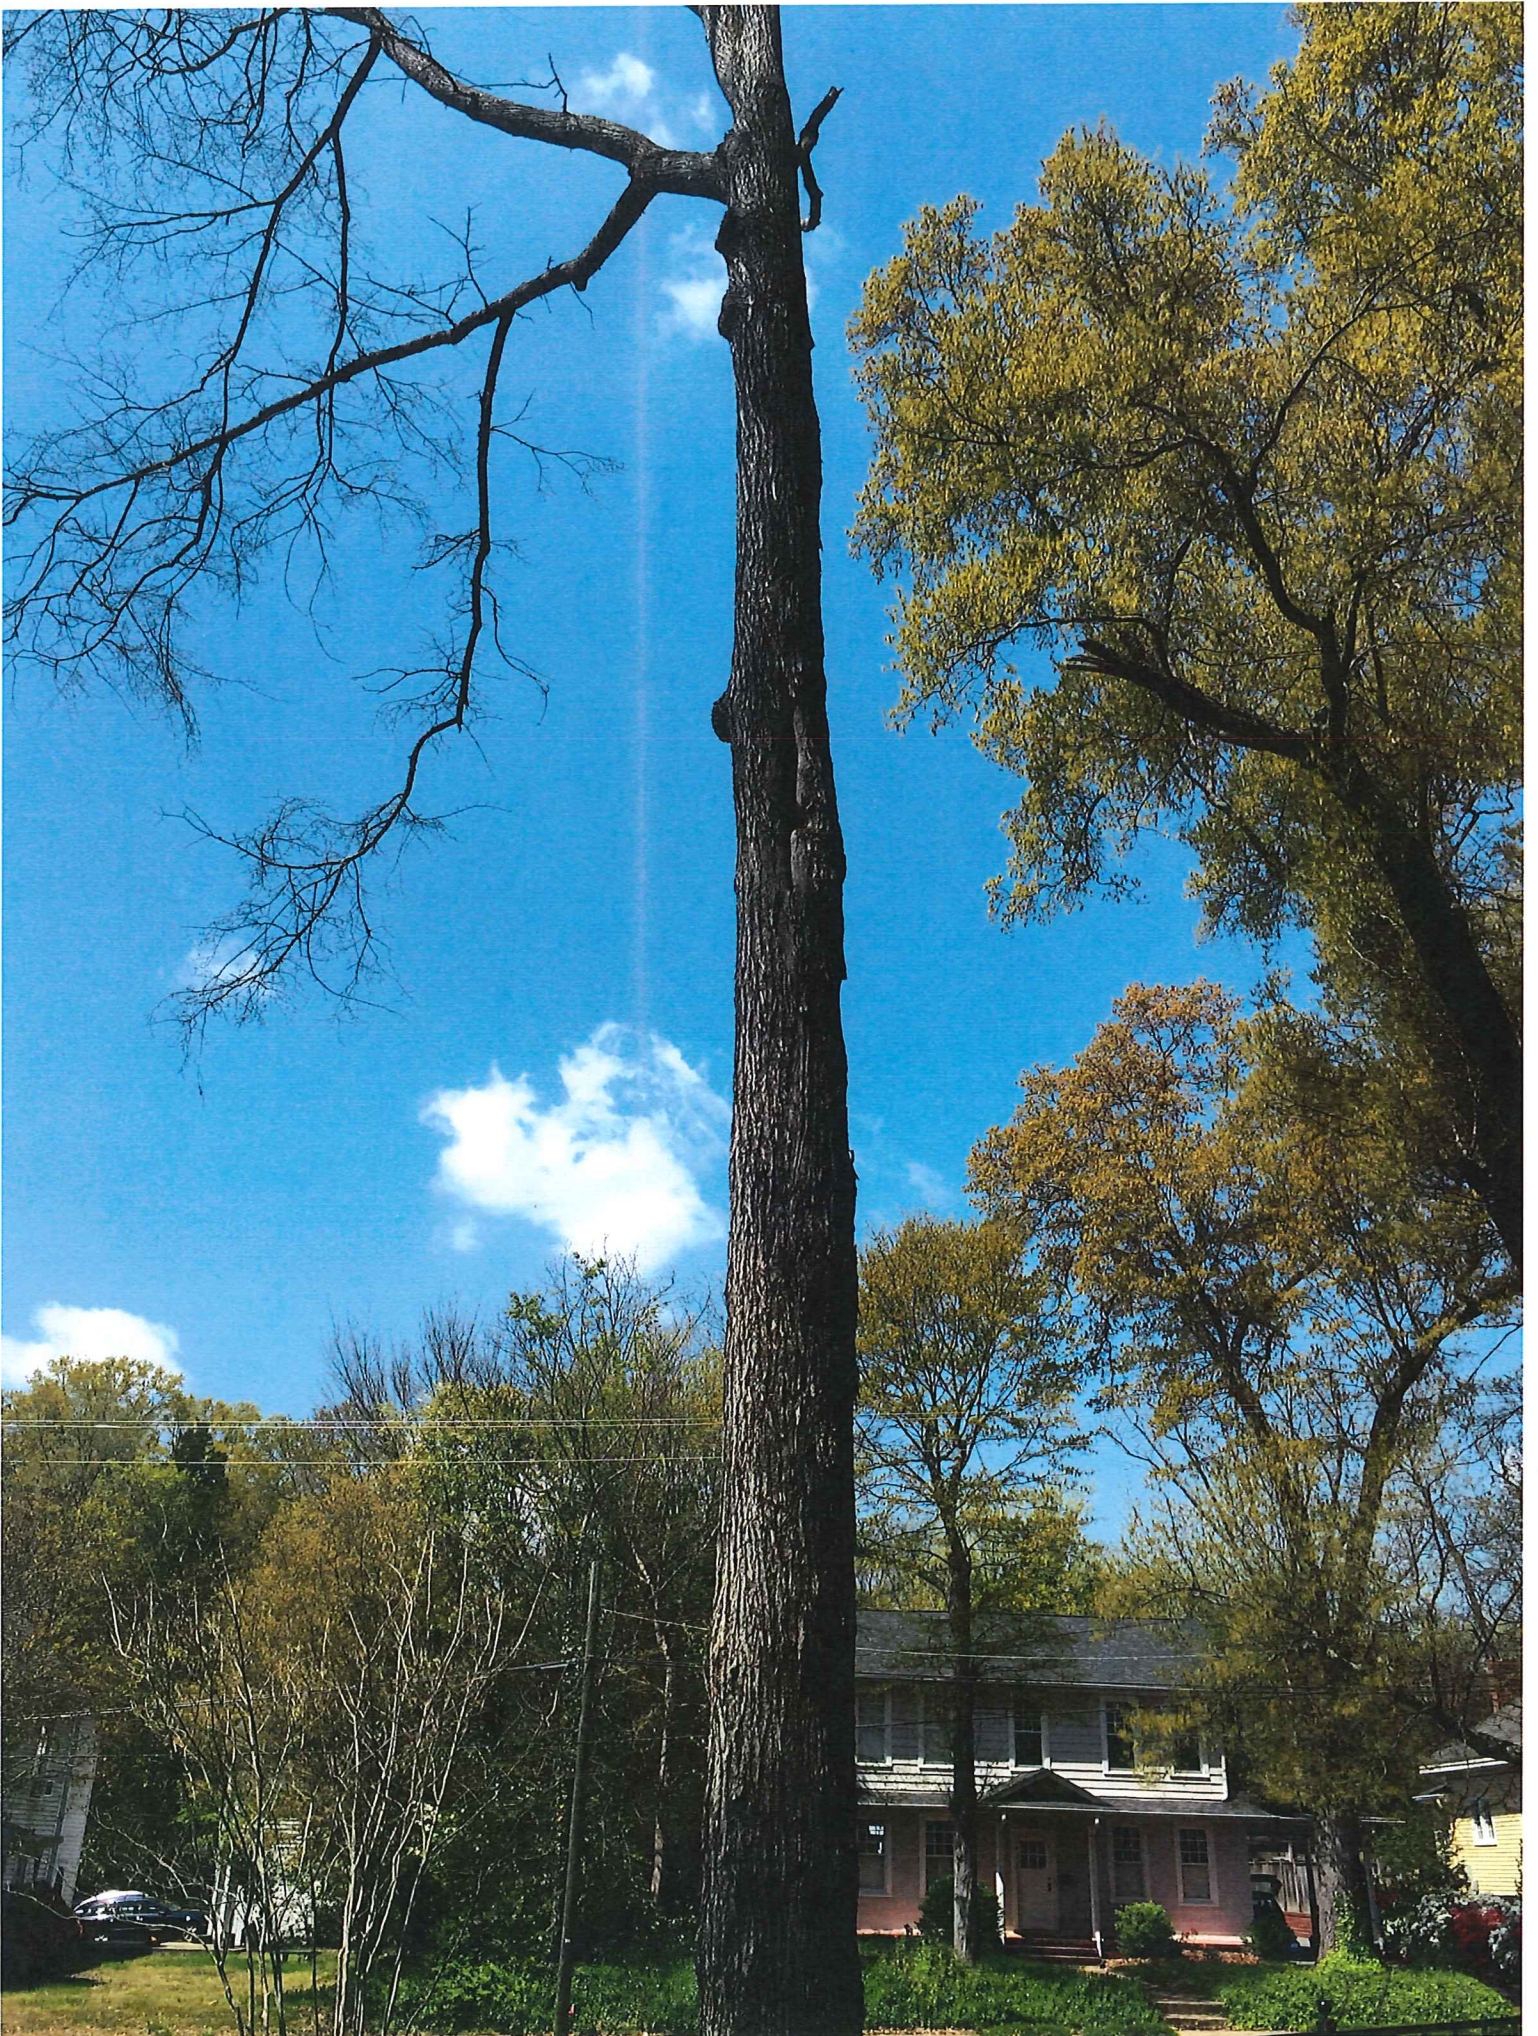
This tree is in fair overall condition. There is a wound with a small amount of decay on the trunk. The wound does show adaptive growth. The proposed landscape improvements impact the root system of this tree. Due to wind loads at the tree location and the trunk injury, I feel removal should be considered even without factoring the landscape improvements.
