**DATE:** June 10, 2020

Certificate of Appropriateness Request: H-11-20  
Applicant: Mark and Marcia Lewis  
Location of subject property: 356 Union St. S  
Staff Report prepared by: Kristen Boyd-Sullivan, Sr. Planner

## PHOTOS OF TREE

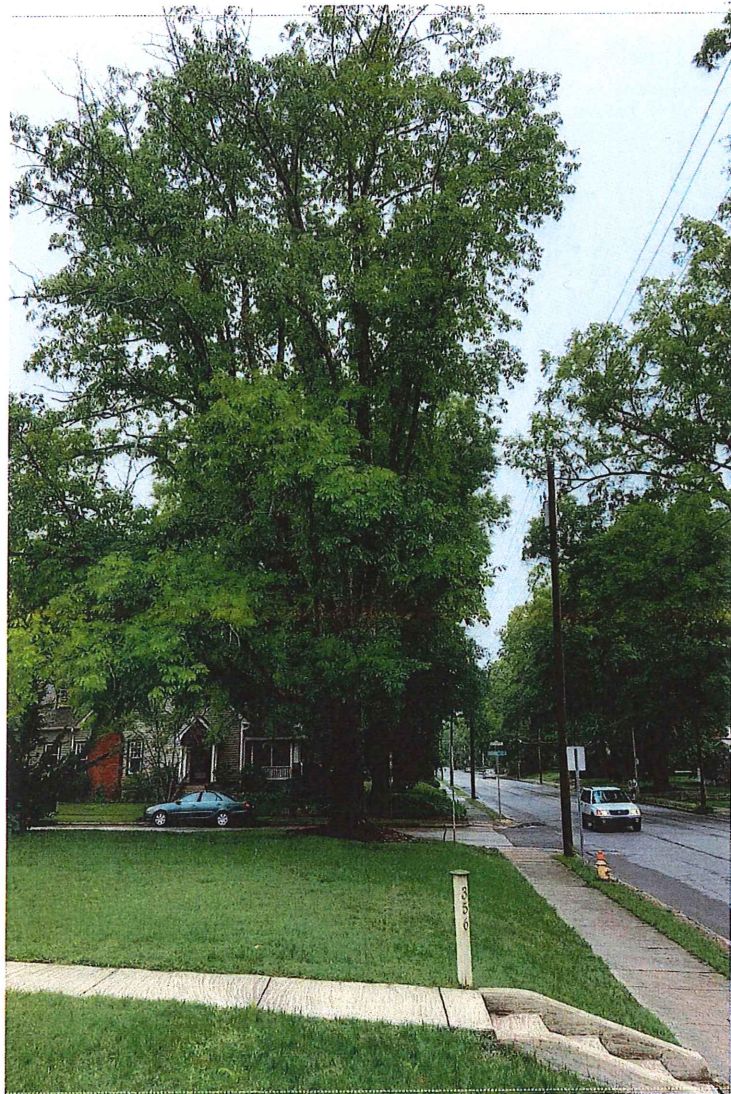
This tree has been pruned for many years to keep the branches from the utility lines that run overhead along Union Street. After all this time, the tree has shifted its growth and now leans heavily over our home. Due to the weight distribution and the lean, there is only one place that tree will land - on our home. The house is a ranch, we have no protection of an upper level to shield us.

- 1 - front of house
- 2 - shows how asymmetrical the tree is due to pruning
- 3 - shows heavy growth over the house
- 4 - more of the growth over the house
- 5 - shows dead branches
- 6 - more of the lean over the house
