DATE: June 12, 2019

| <u>Certificate of Appropriateness Request:</u> | H-15-19 |
| <u>Applicant:</u> | St. James Lutheran Church |
| <u>Location of subject property:</u> | 104 Union St S |

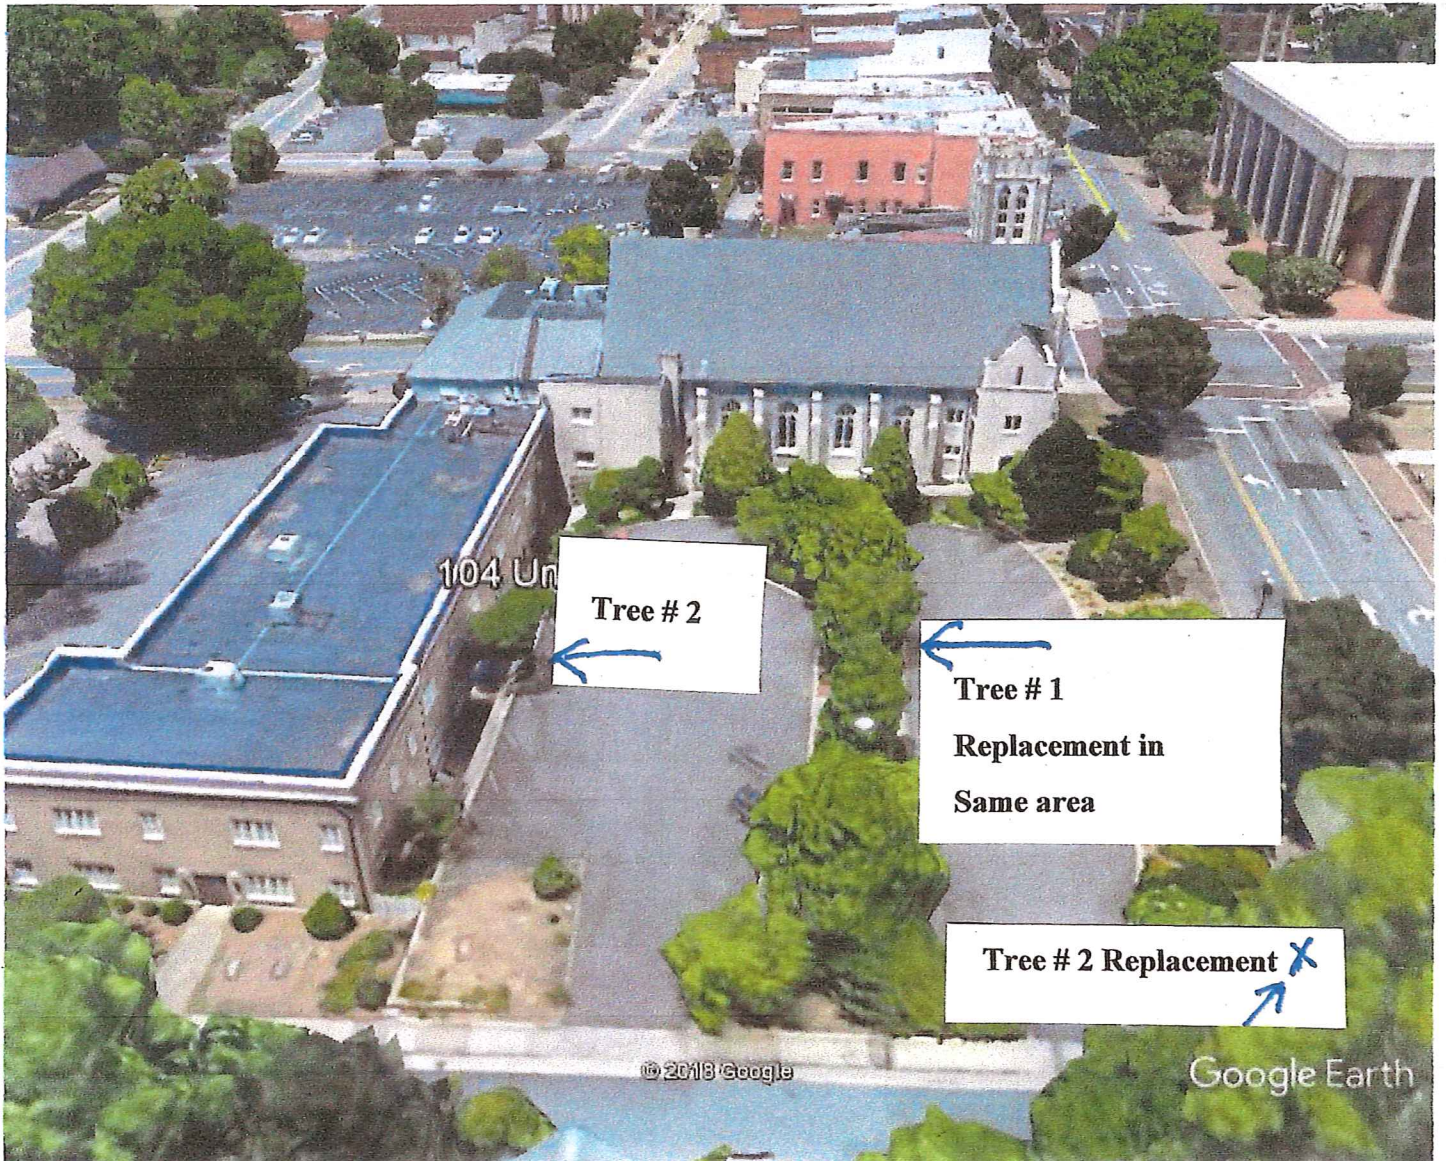
Saint James Lutheran Church submitted and was approved COA for construction of Columbarium in 2018. There are 2 trees that were not on the approved plan.

Tree # 1 was damaged during construction and will need to be replaced. Replacement should be a Dogwood* located in same area of new median .

Tree #2 is growing in the retaining wall next to the Education Wing of Saint James. Replacement should be a Dogwood* located on vacant knoll at corner of Union Street South and Foard Avenue SW on church property

*** Numerous Dogwoods were removed from the construction site, and request was made by church members to add more if possible to our property. Cherokee Princess Dogwood will be a good replacement for the Historic Dogwoods.**
