Application for  
Certificate of Appropriateness

1. Project or Type of Work to be Done: Removal and Replacement of two trees from the Columbarium site at Saint James Lutheran Church. not included in the COA approved in 2018
2. Detailed specifications of the project( type of siding, windows, doors, height/style of fence, color, etc.):  
Tree # 1 - Removal of American Holly that was damaged during construction of columbarium. Roots were Damaged, and tree will not recover. Replace with Cherokee Princess Dogwood Tree in same area.  
Tree # 2 Removal of Cherry Laurel Tree that is growing into the retaining wall next to the building. Damage is recurring and needs replacement. Replace with Cherokee Princess Dogwood tree on vacant Knoll in planting bed at the corner of Union Street South and Foard Avenue S.W.

# TREE RISK ASSESSMENT FORM

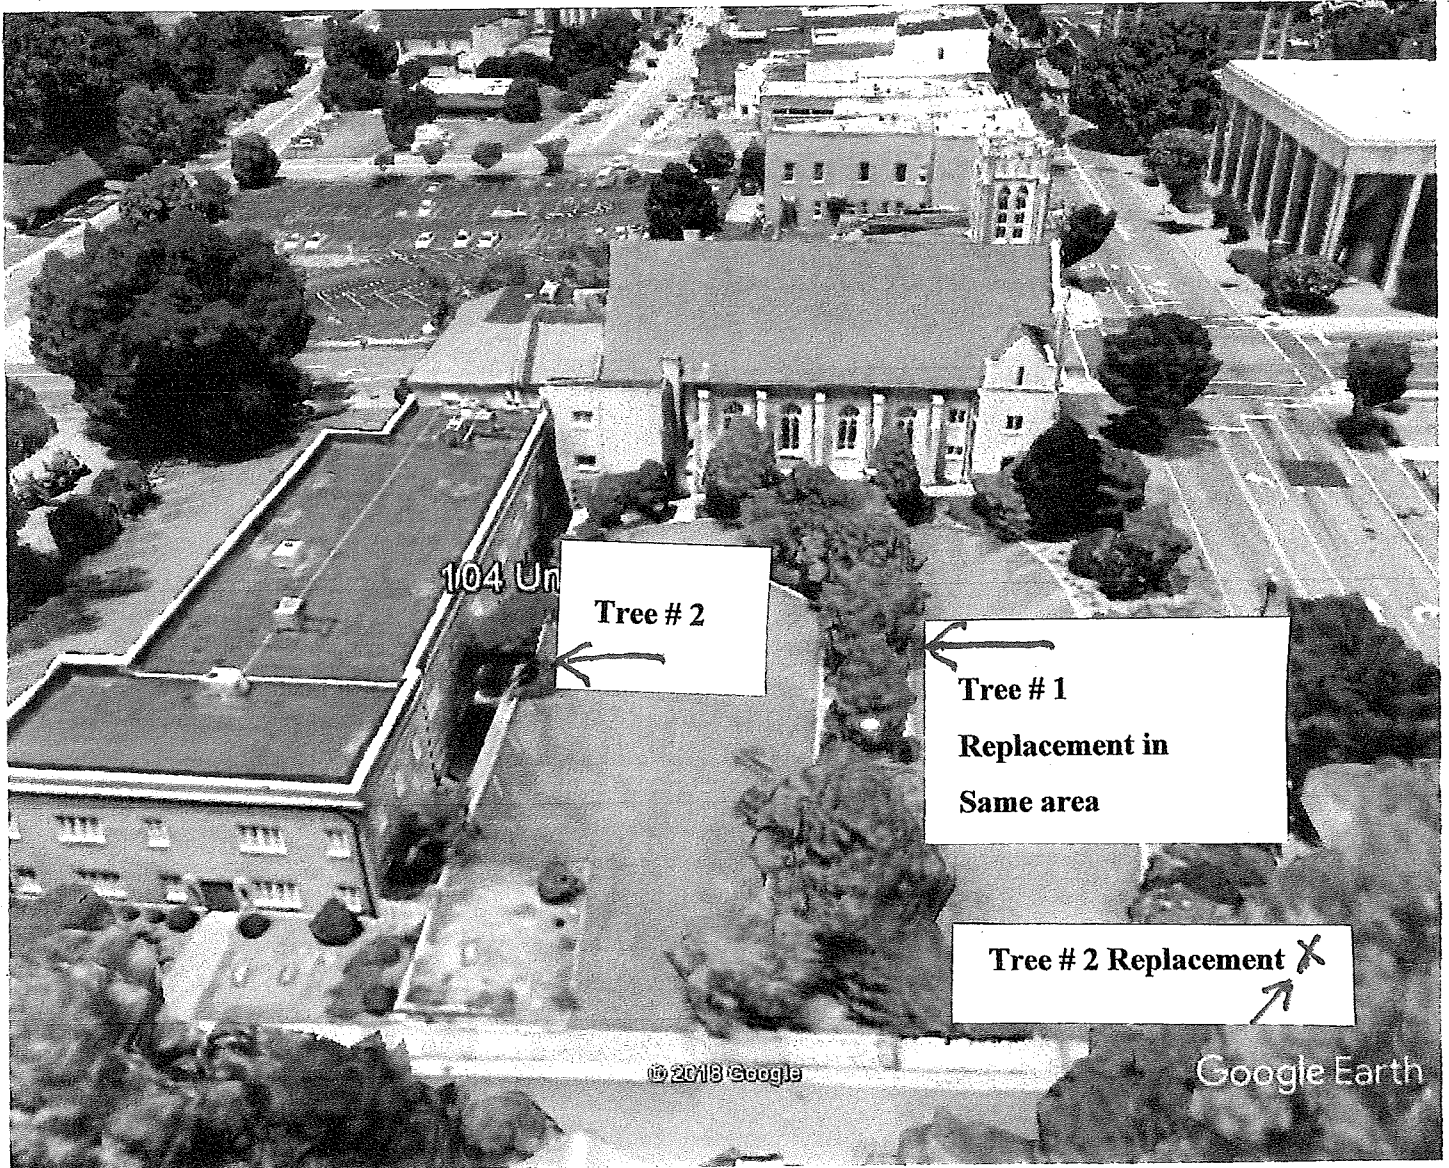
**Saint James Lutheran Church submitted and was approved COA for construction of Columbarium in 2018. There are 2 trees that were not on the approved plan.**

**Tree # 1 was damaged during construction and will need to be replaced. Replacement should be a Dogwood\* located in same area of new median .**

**Tree #2 is growing in the retaining wall next to the Education Wing of Saint James. Replacement should be a Dogwood\* located on vacant knoll at corner of Union Street South and Foard Avenue SW on church property**

**\* Numerous Dogwoods were removed from the construction site, and request was made by church members to add more if possible to our property. Cherokee Princess Dogwood will be a good replacement for the Historic Dogwoods.**

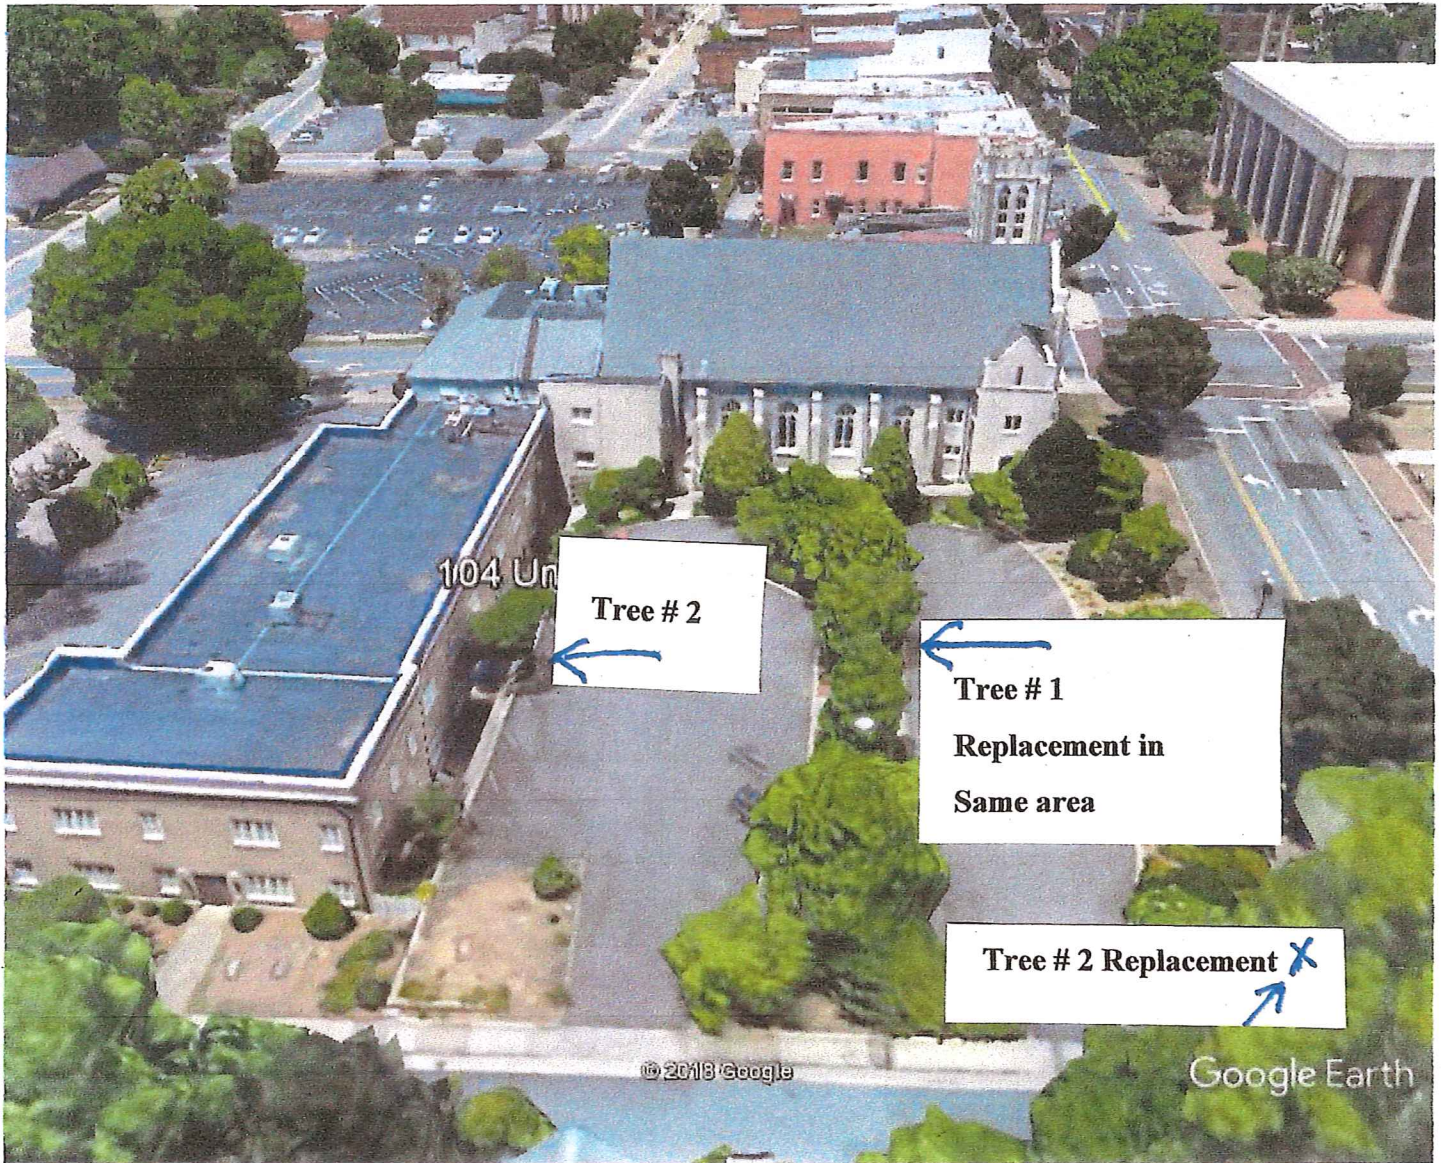
**Saint James Lutheran Church submitted and was approved COA for construction of Columbarium in 2018. There are 2 trees that were not on the approved plan.**

**Tree # 1 was damaged during construction and will need to be replaced. Replacement should be a Dogwood\* located in same area of new median .**

**Tree #2 is growing in the retaining wall next to the Education Wing of Saint James. Replacement should be a Dogwood\* located on vacant knoll at corner of Union Street South and Foard Avenue SW on church property**

**\* Numerous Dogwoods were removed from the construction site, and request was made by church members to add more if possible to our property. Cherokee Princess Dogwood will be a good replacement for the Historic Dogwoods.**
