**DATE:** July 13, 2022

Certificate of Appropriateness Request: H-17-22  
Applicant: Sandra West  
Location of Subject Property: 410 Union St S  
PIN: 5630-24-0324  
Staff Report Prepared by: Brad Lagano, Senior Planner

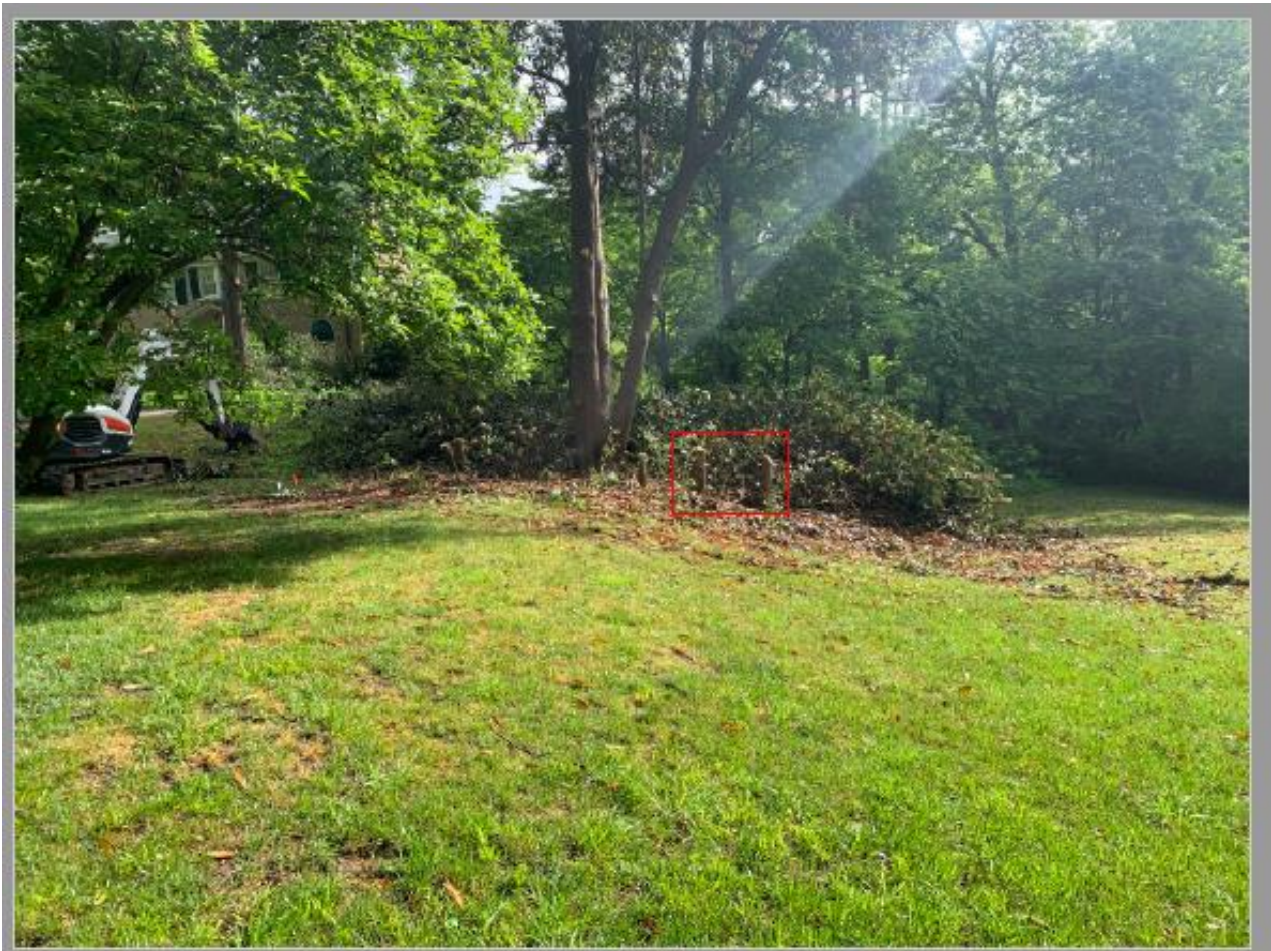
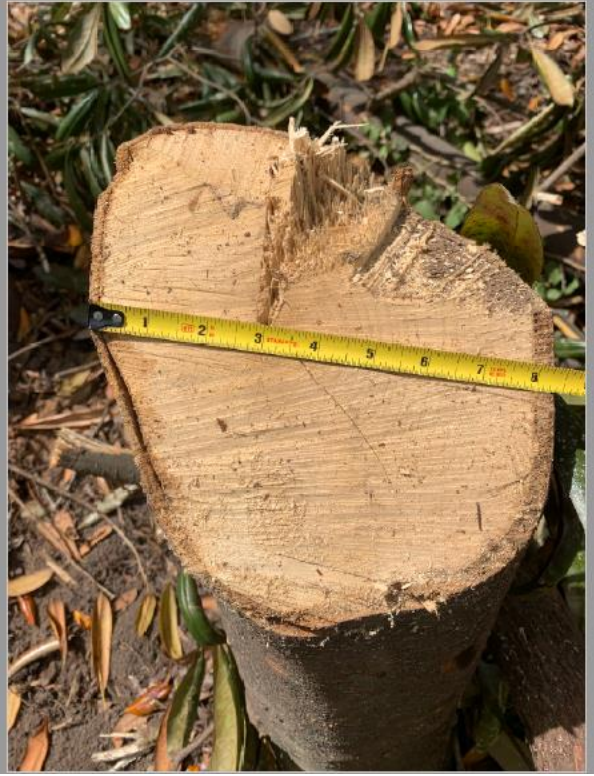
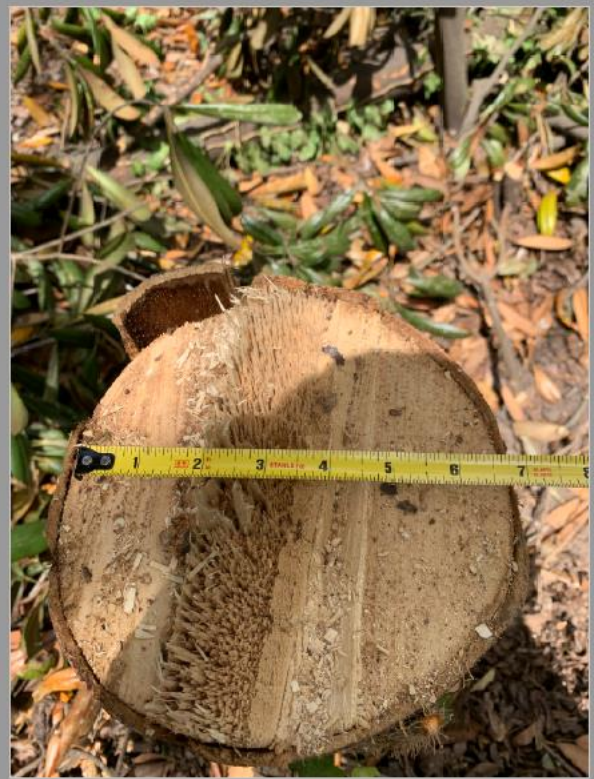
Trees #1 & 2 - Southern Magnolias

- Trees #1 & 2 – Southern Magnolias – Risk Rating 2  
Bill’s comment: “The debris from these two removed trees showed no signs or symptoms of above normal risk” (Exhibit D).
- Tree #3 – Shortleaf Pine – Risk Rating 4

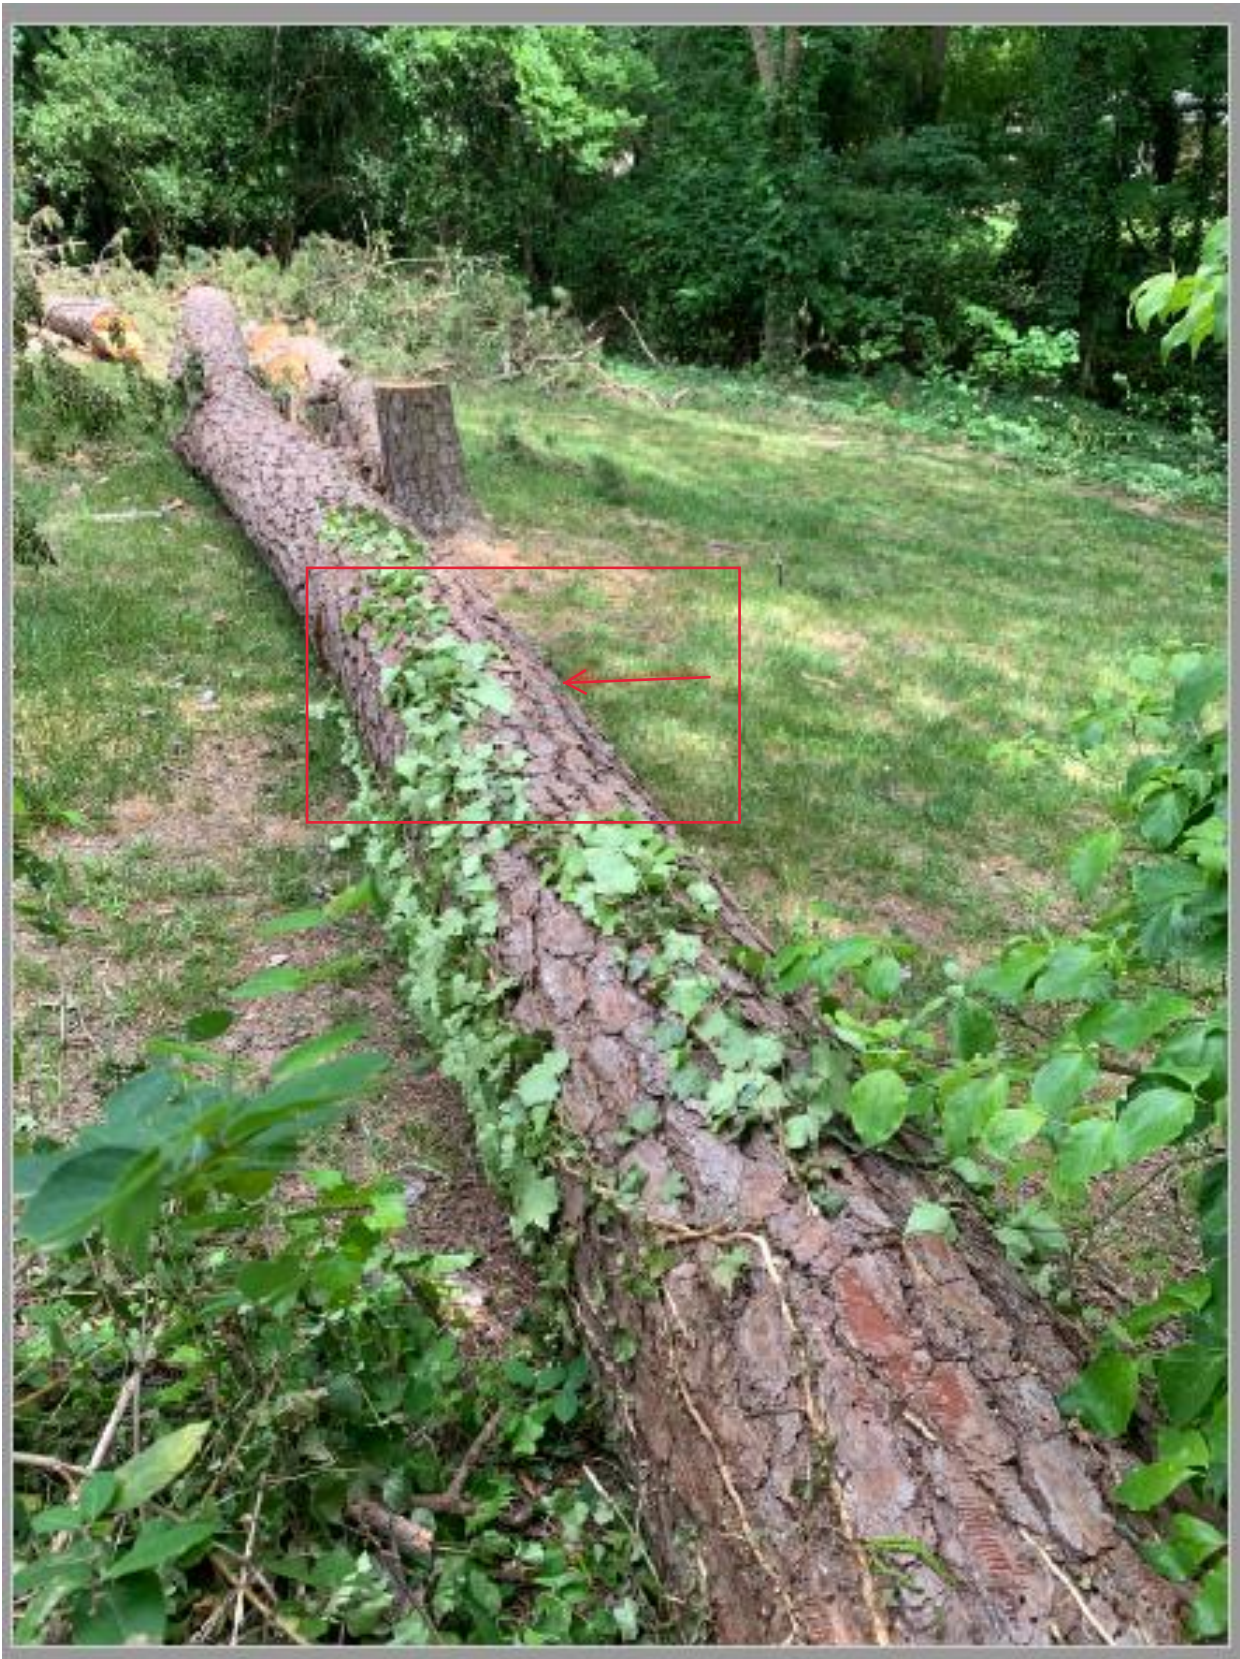
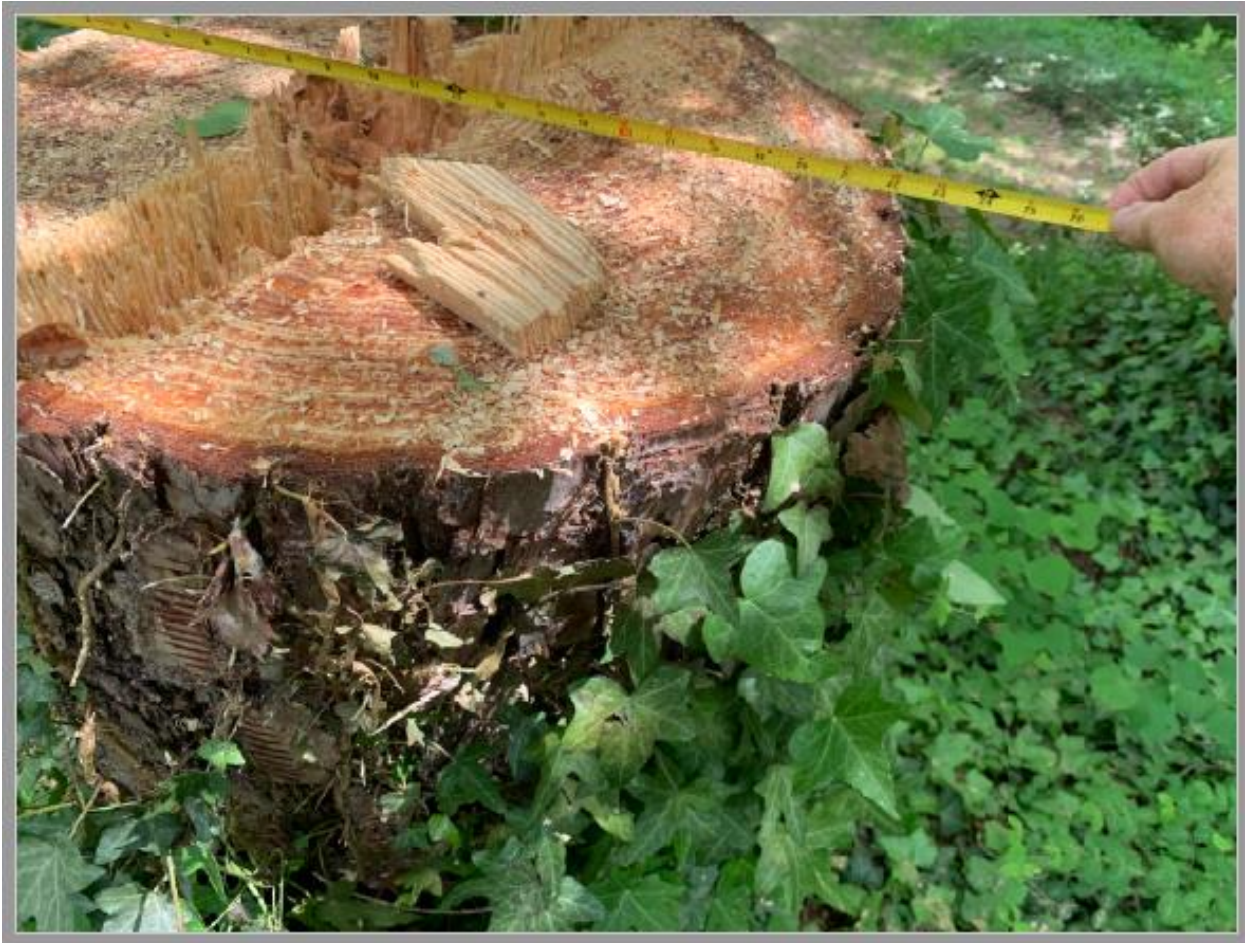
Tree #3 - Shortleaf Pine

Bill's comment: "The debris from this removed tree showed no signs or symptoms of above normal risk" (Exhibit E).

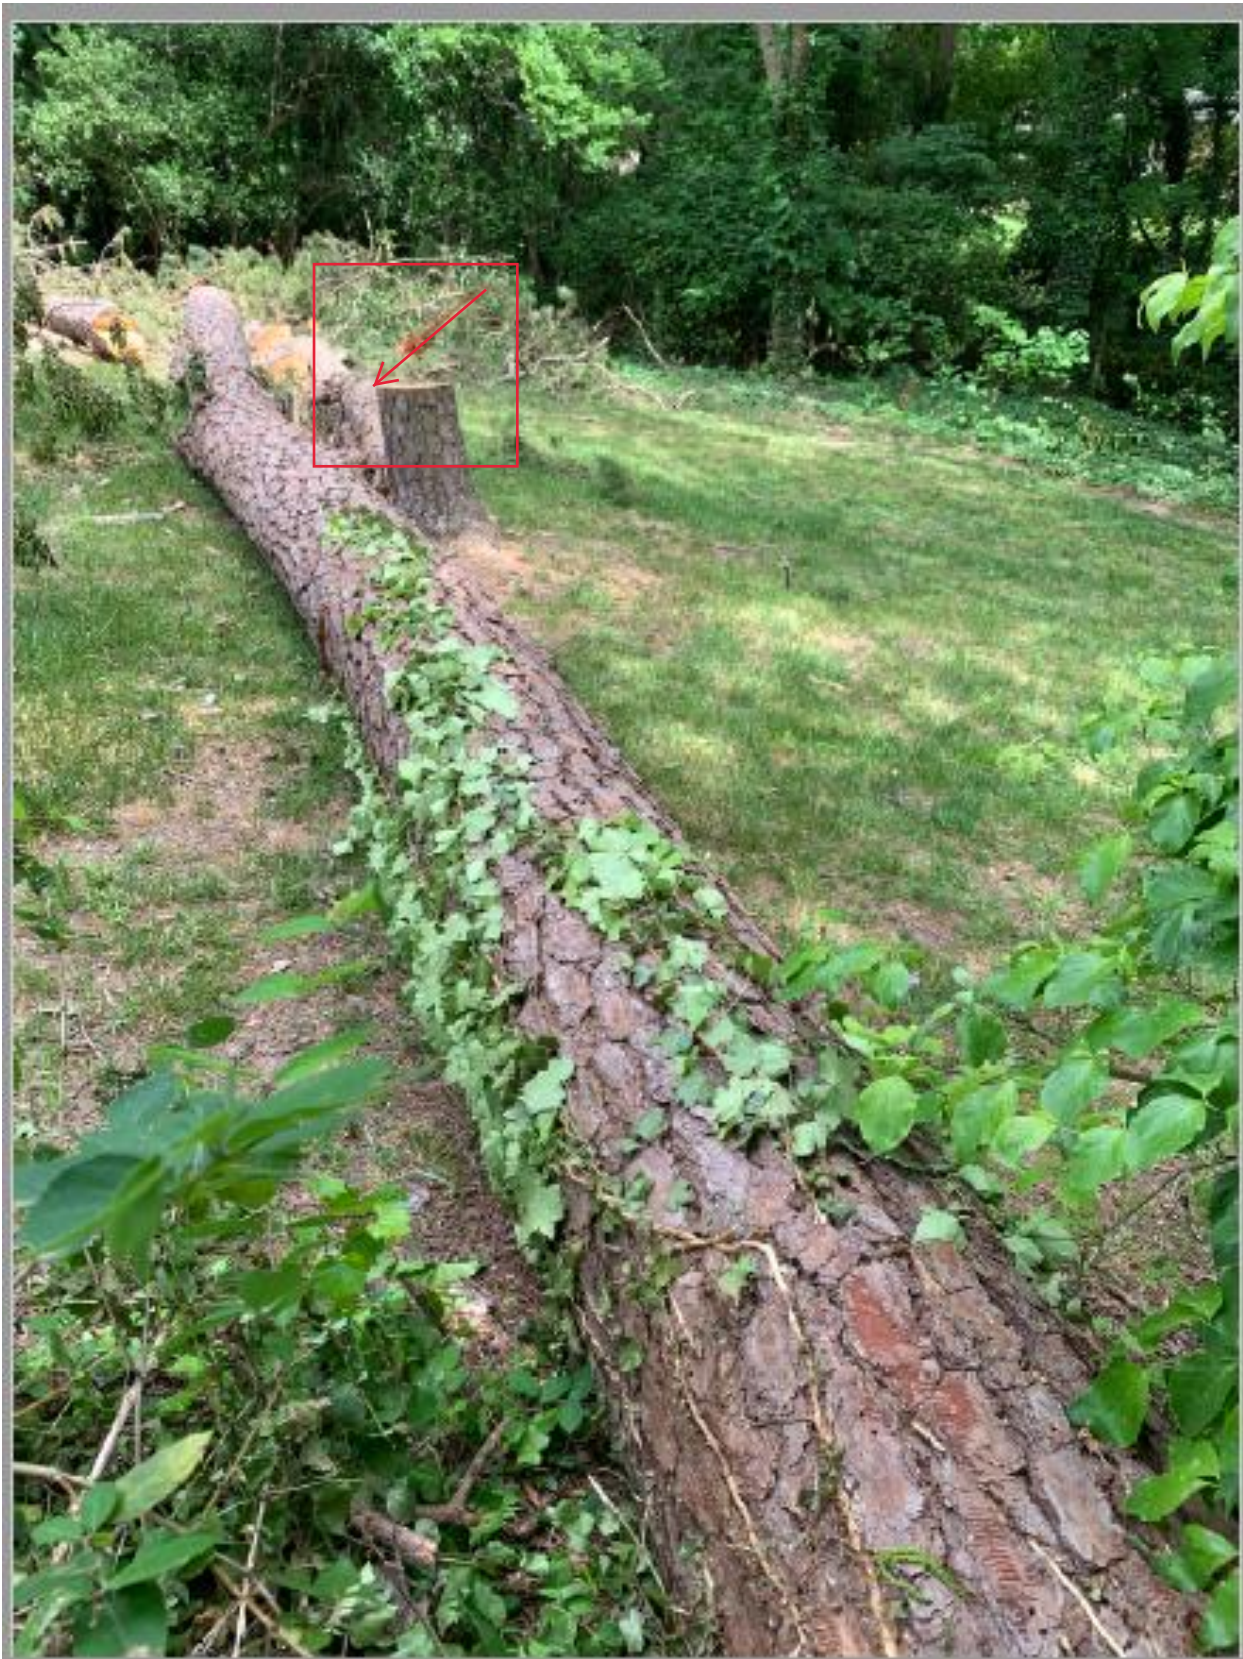
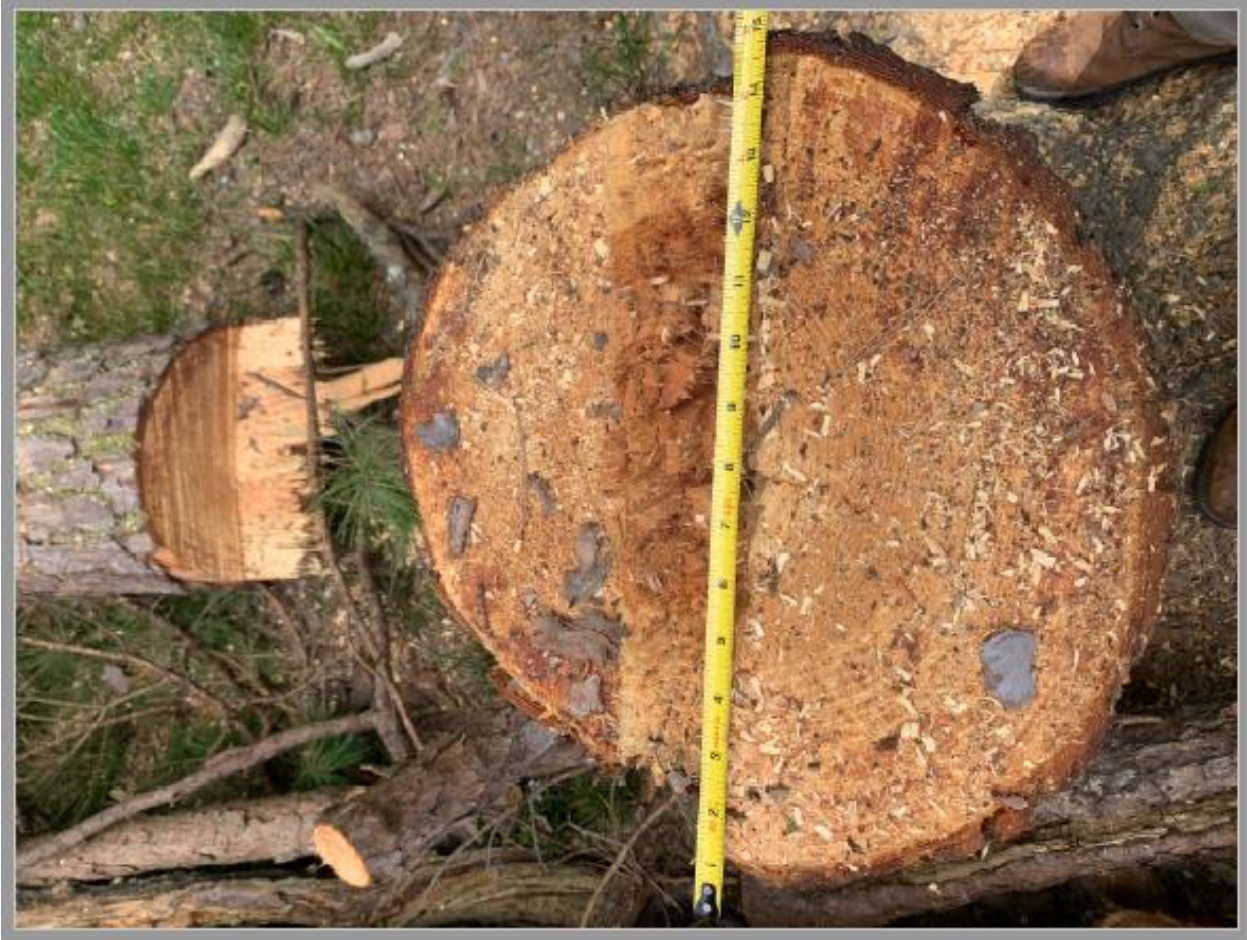
Tree #4 - Shortleaf Pine

- Tree #4 – Shortleaf Pine – Risk Rating 3

Bill's comment: "The debris from this removed tree showed no signs or symptoms of above normal risk" (Exhibit F).

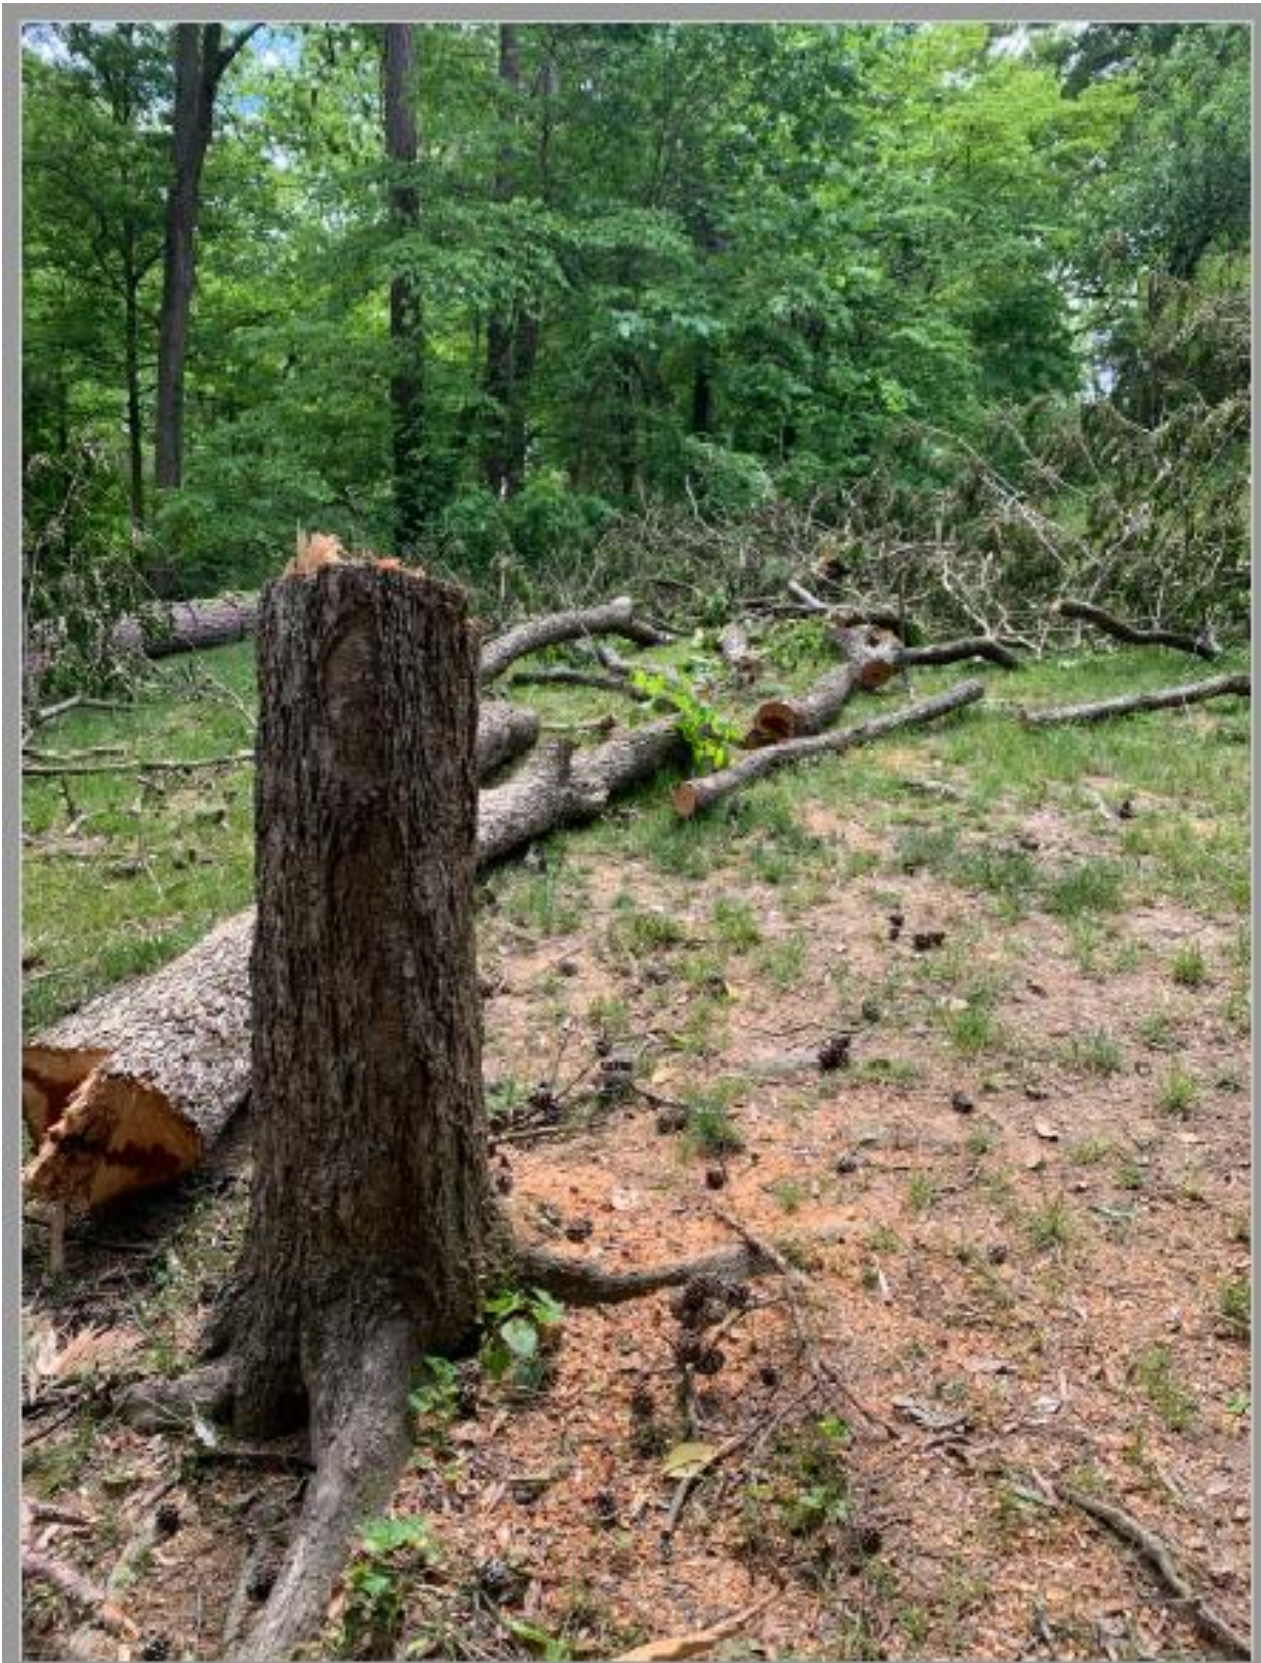
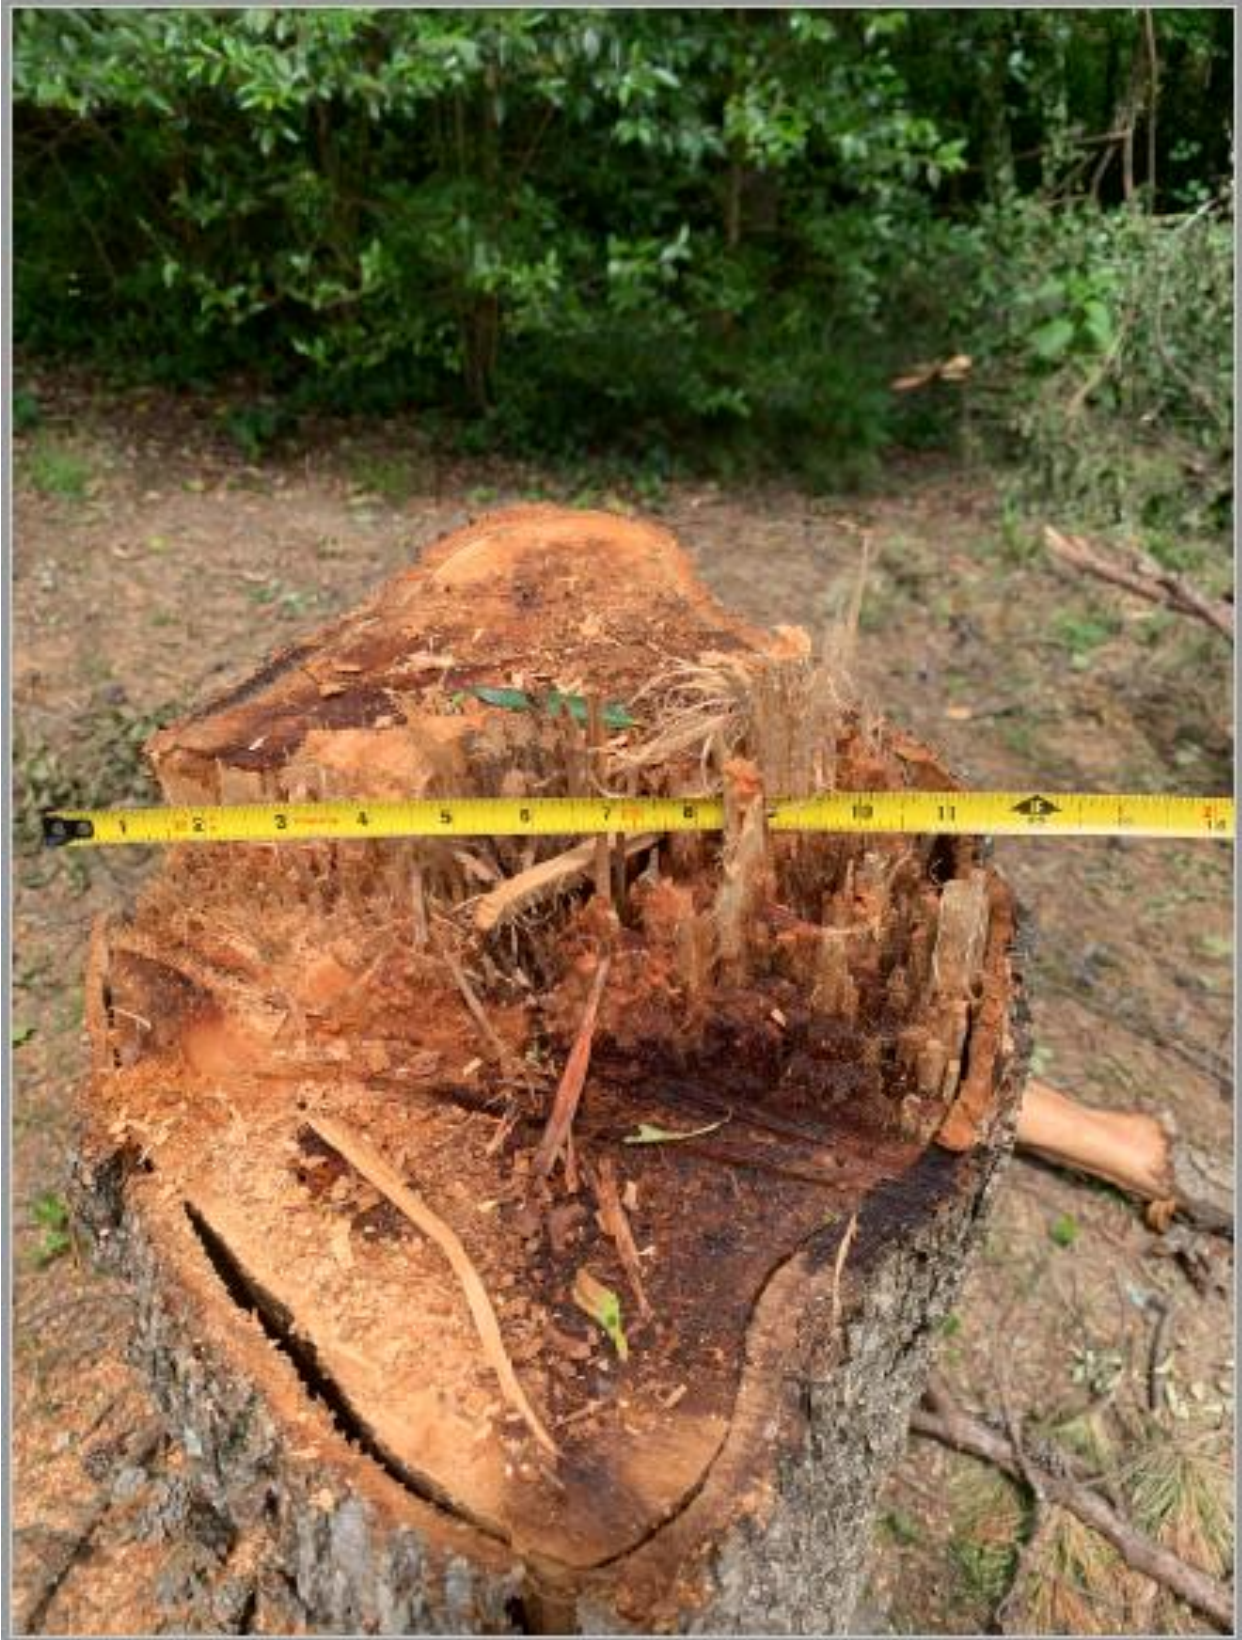
Tree #5 - Pecan

- Tree #5 – Pecan – Risk Rating 2

Bill's comment: "The debris from this removed tree showed no signs or symptoms of above normal risk" (Exhibit G).

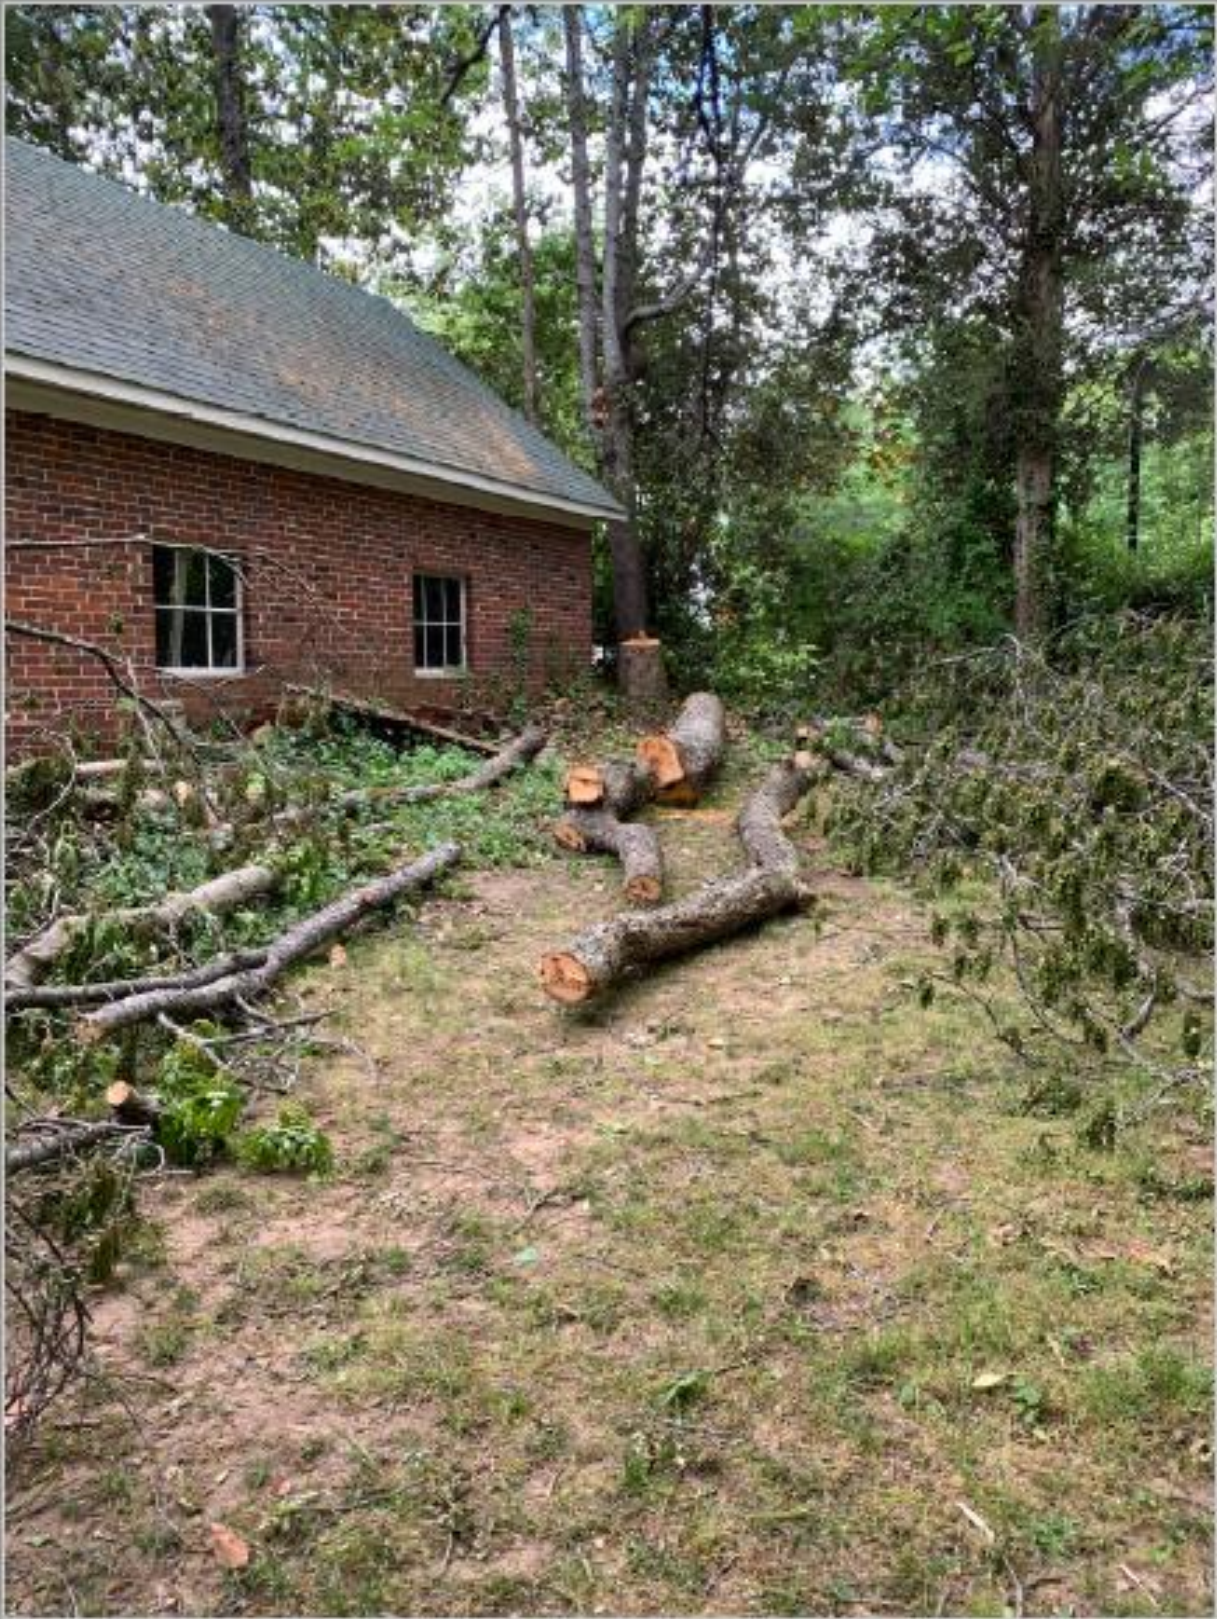
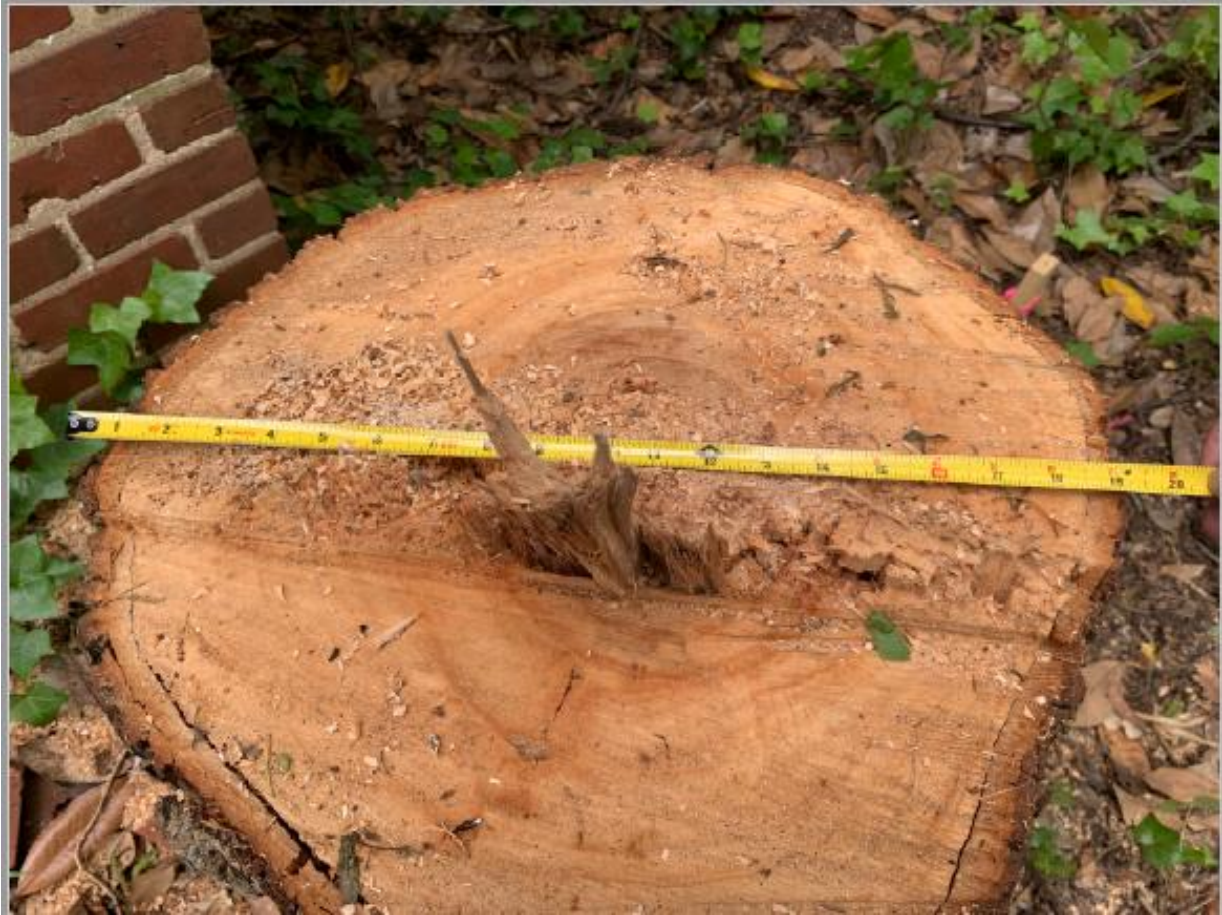
Tree #6 - Pecan

- Tree #6 – Pecan – Risk Rating 4

Bill's comment: "The debris from this removed tree showed no signs or symptoms of above normal risk" (Exhibit H).

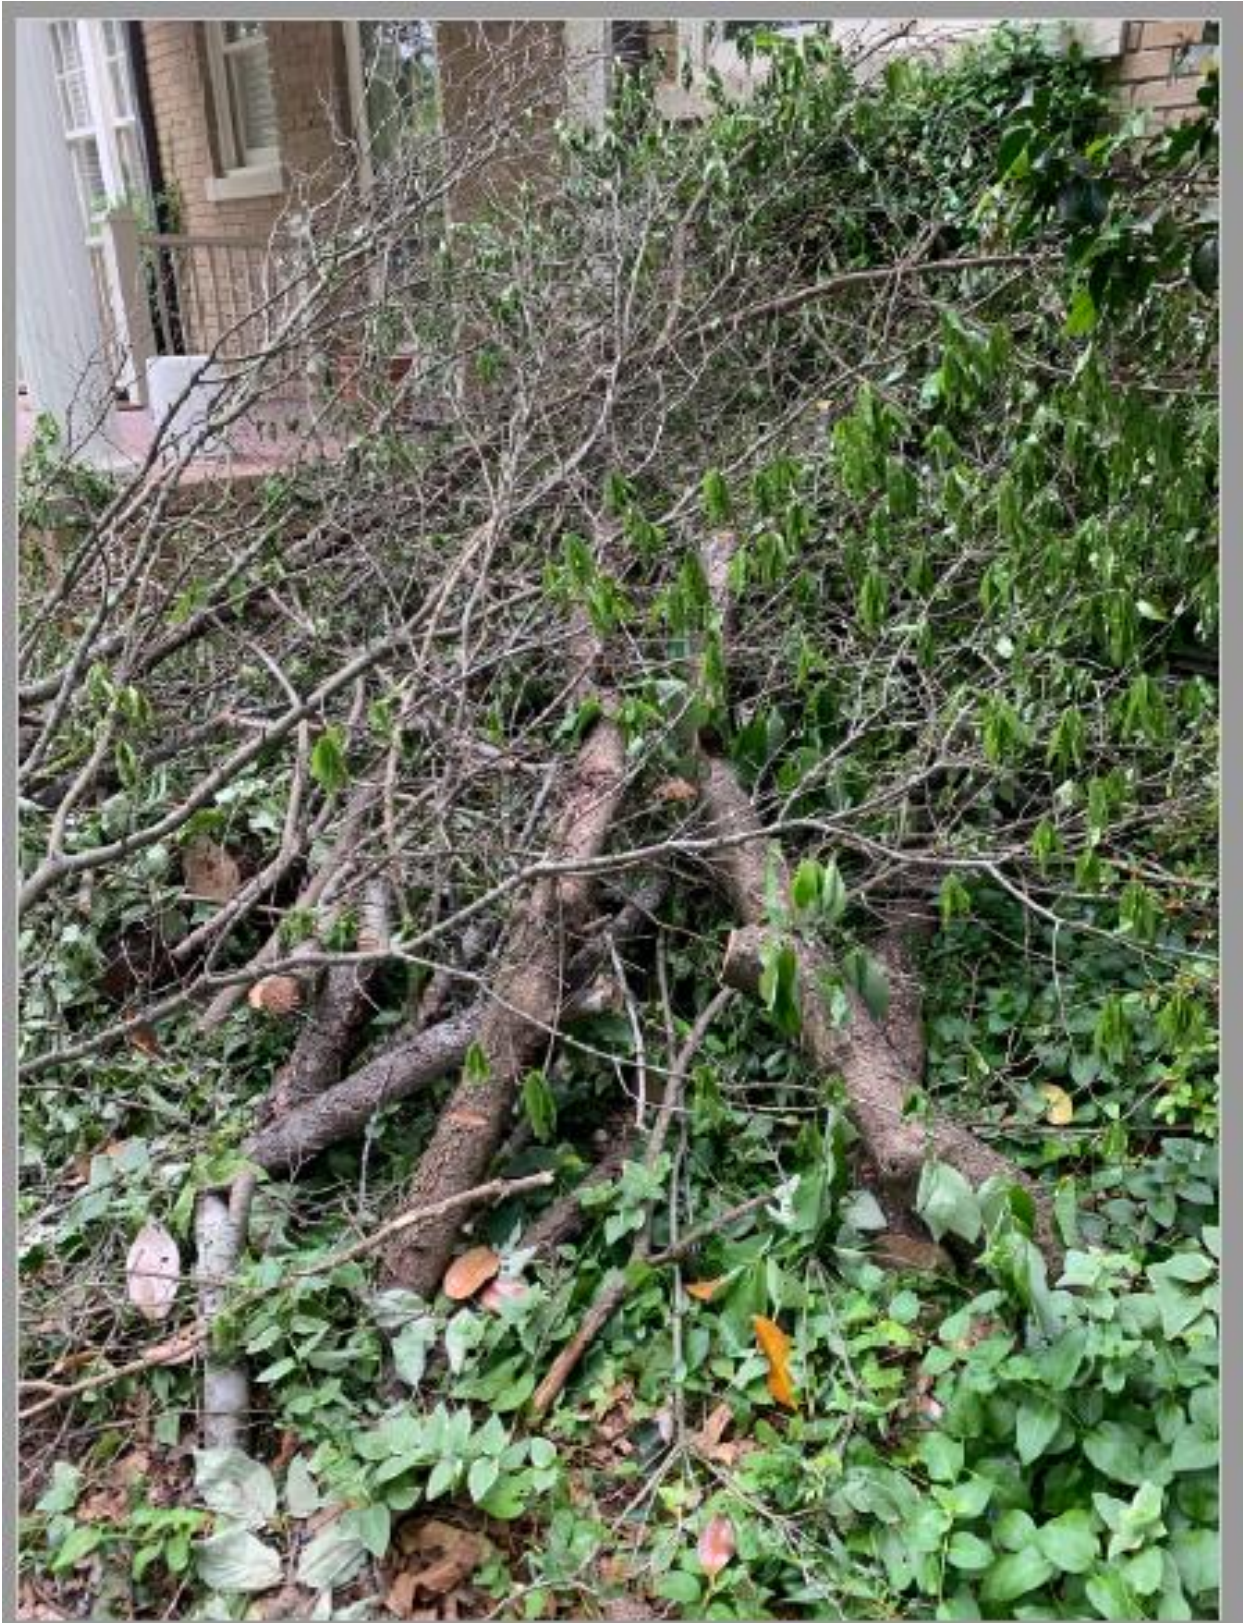
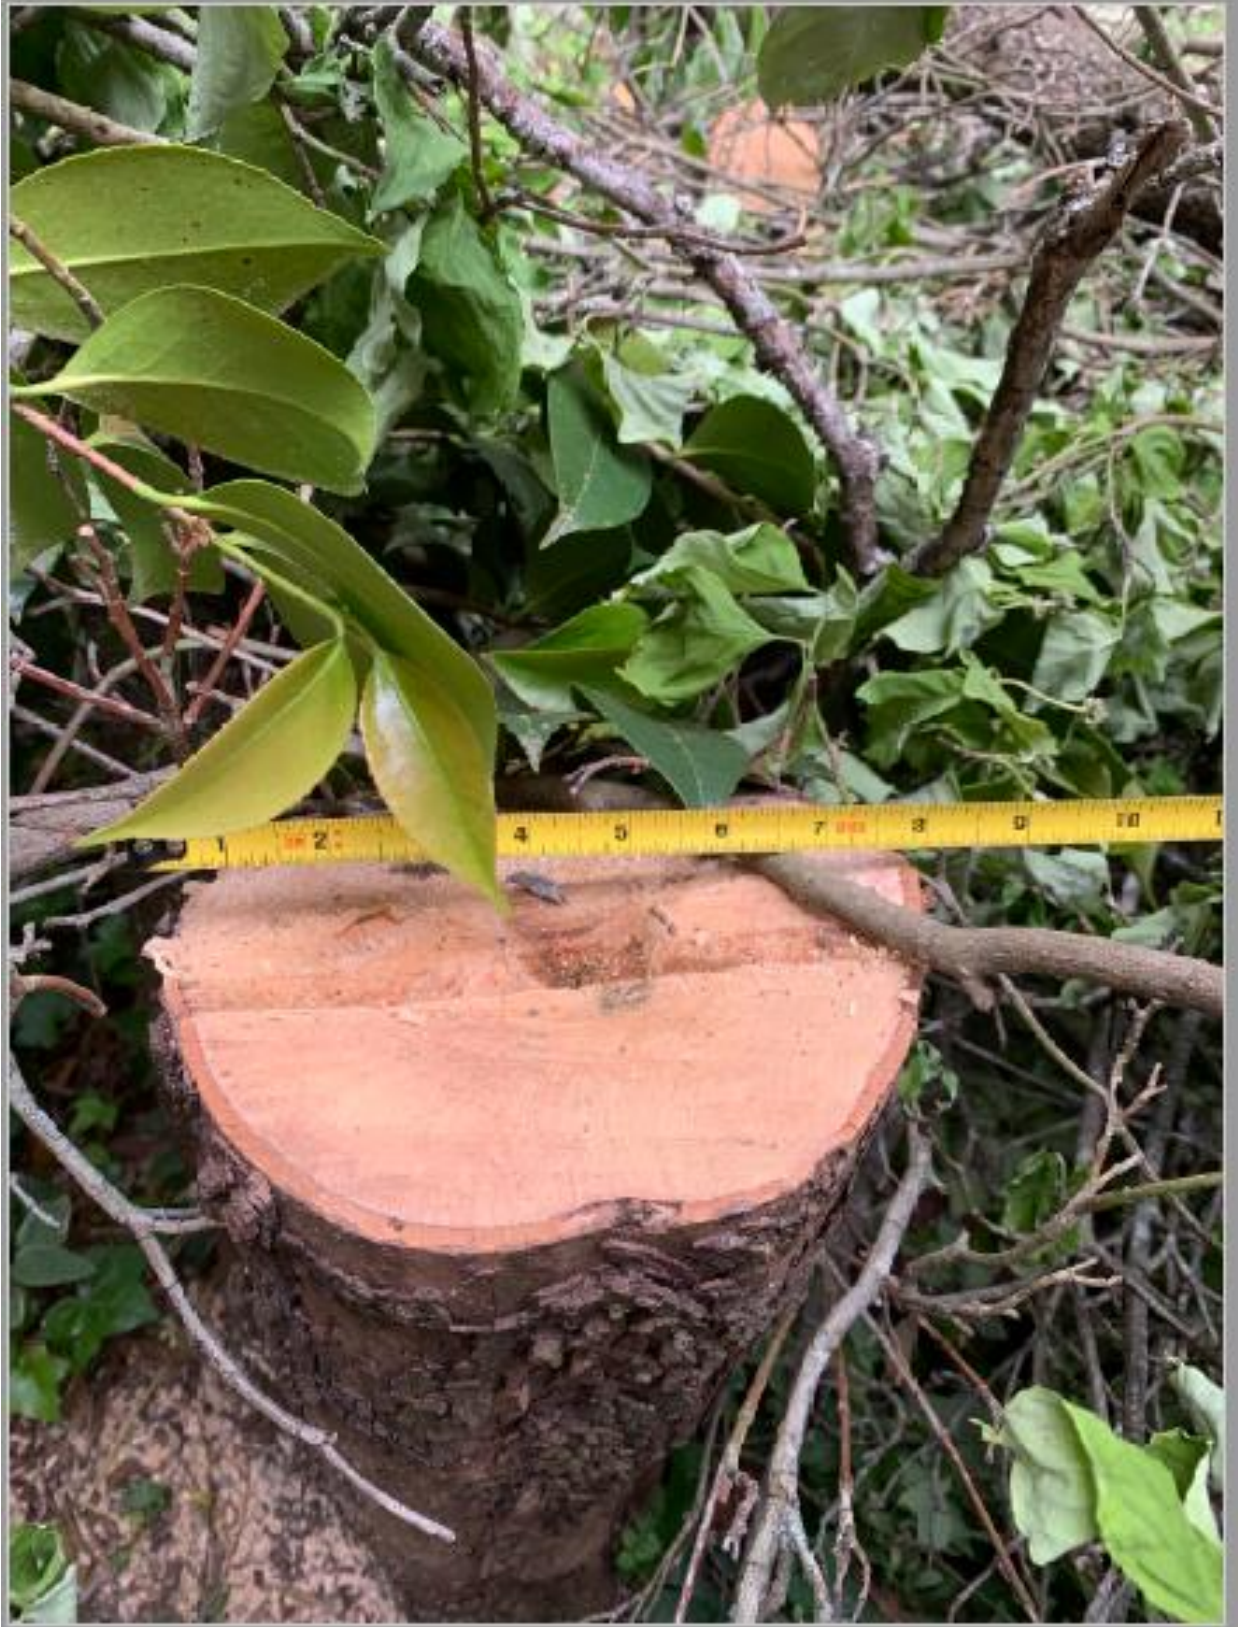
Tree #7 - Dogwood

- Tree #7 – Dogwood – Risk Rating 3

Bill's comment: "The debris from this removed tree did show some dead branches, but the trunk still retained sap" (Exhibit I).
