DATE: September 13, 2023

<u>Certificate of Appropriateness Request:</u>	H-21-23
<u>Applicant:</u>	Chad Celetti
<u>Location of Subject Property:</u>	27 Yorktown Street NW
<u>PINs:</u>	5620-77-8612
<u>Staff Report Prepared by:</u>	Kim Wallis, Senior Planner

TREE RISK ASSESSMENT FORM

EXHIBIT E

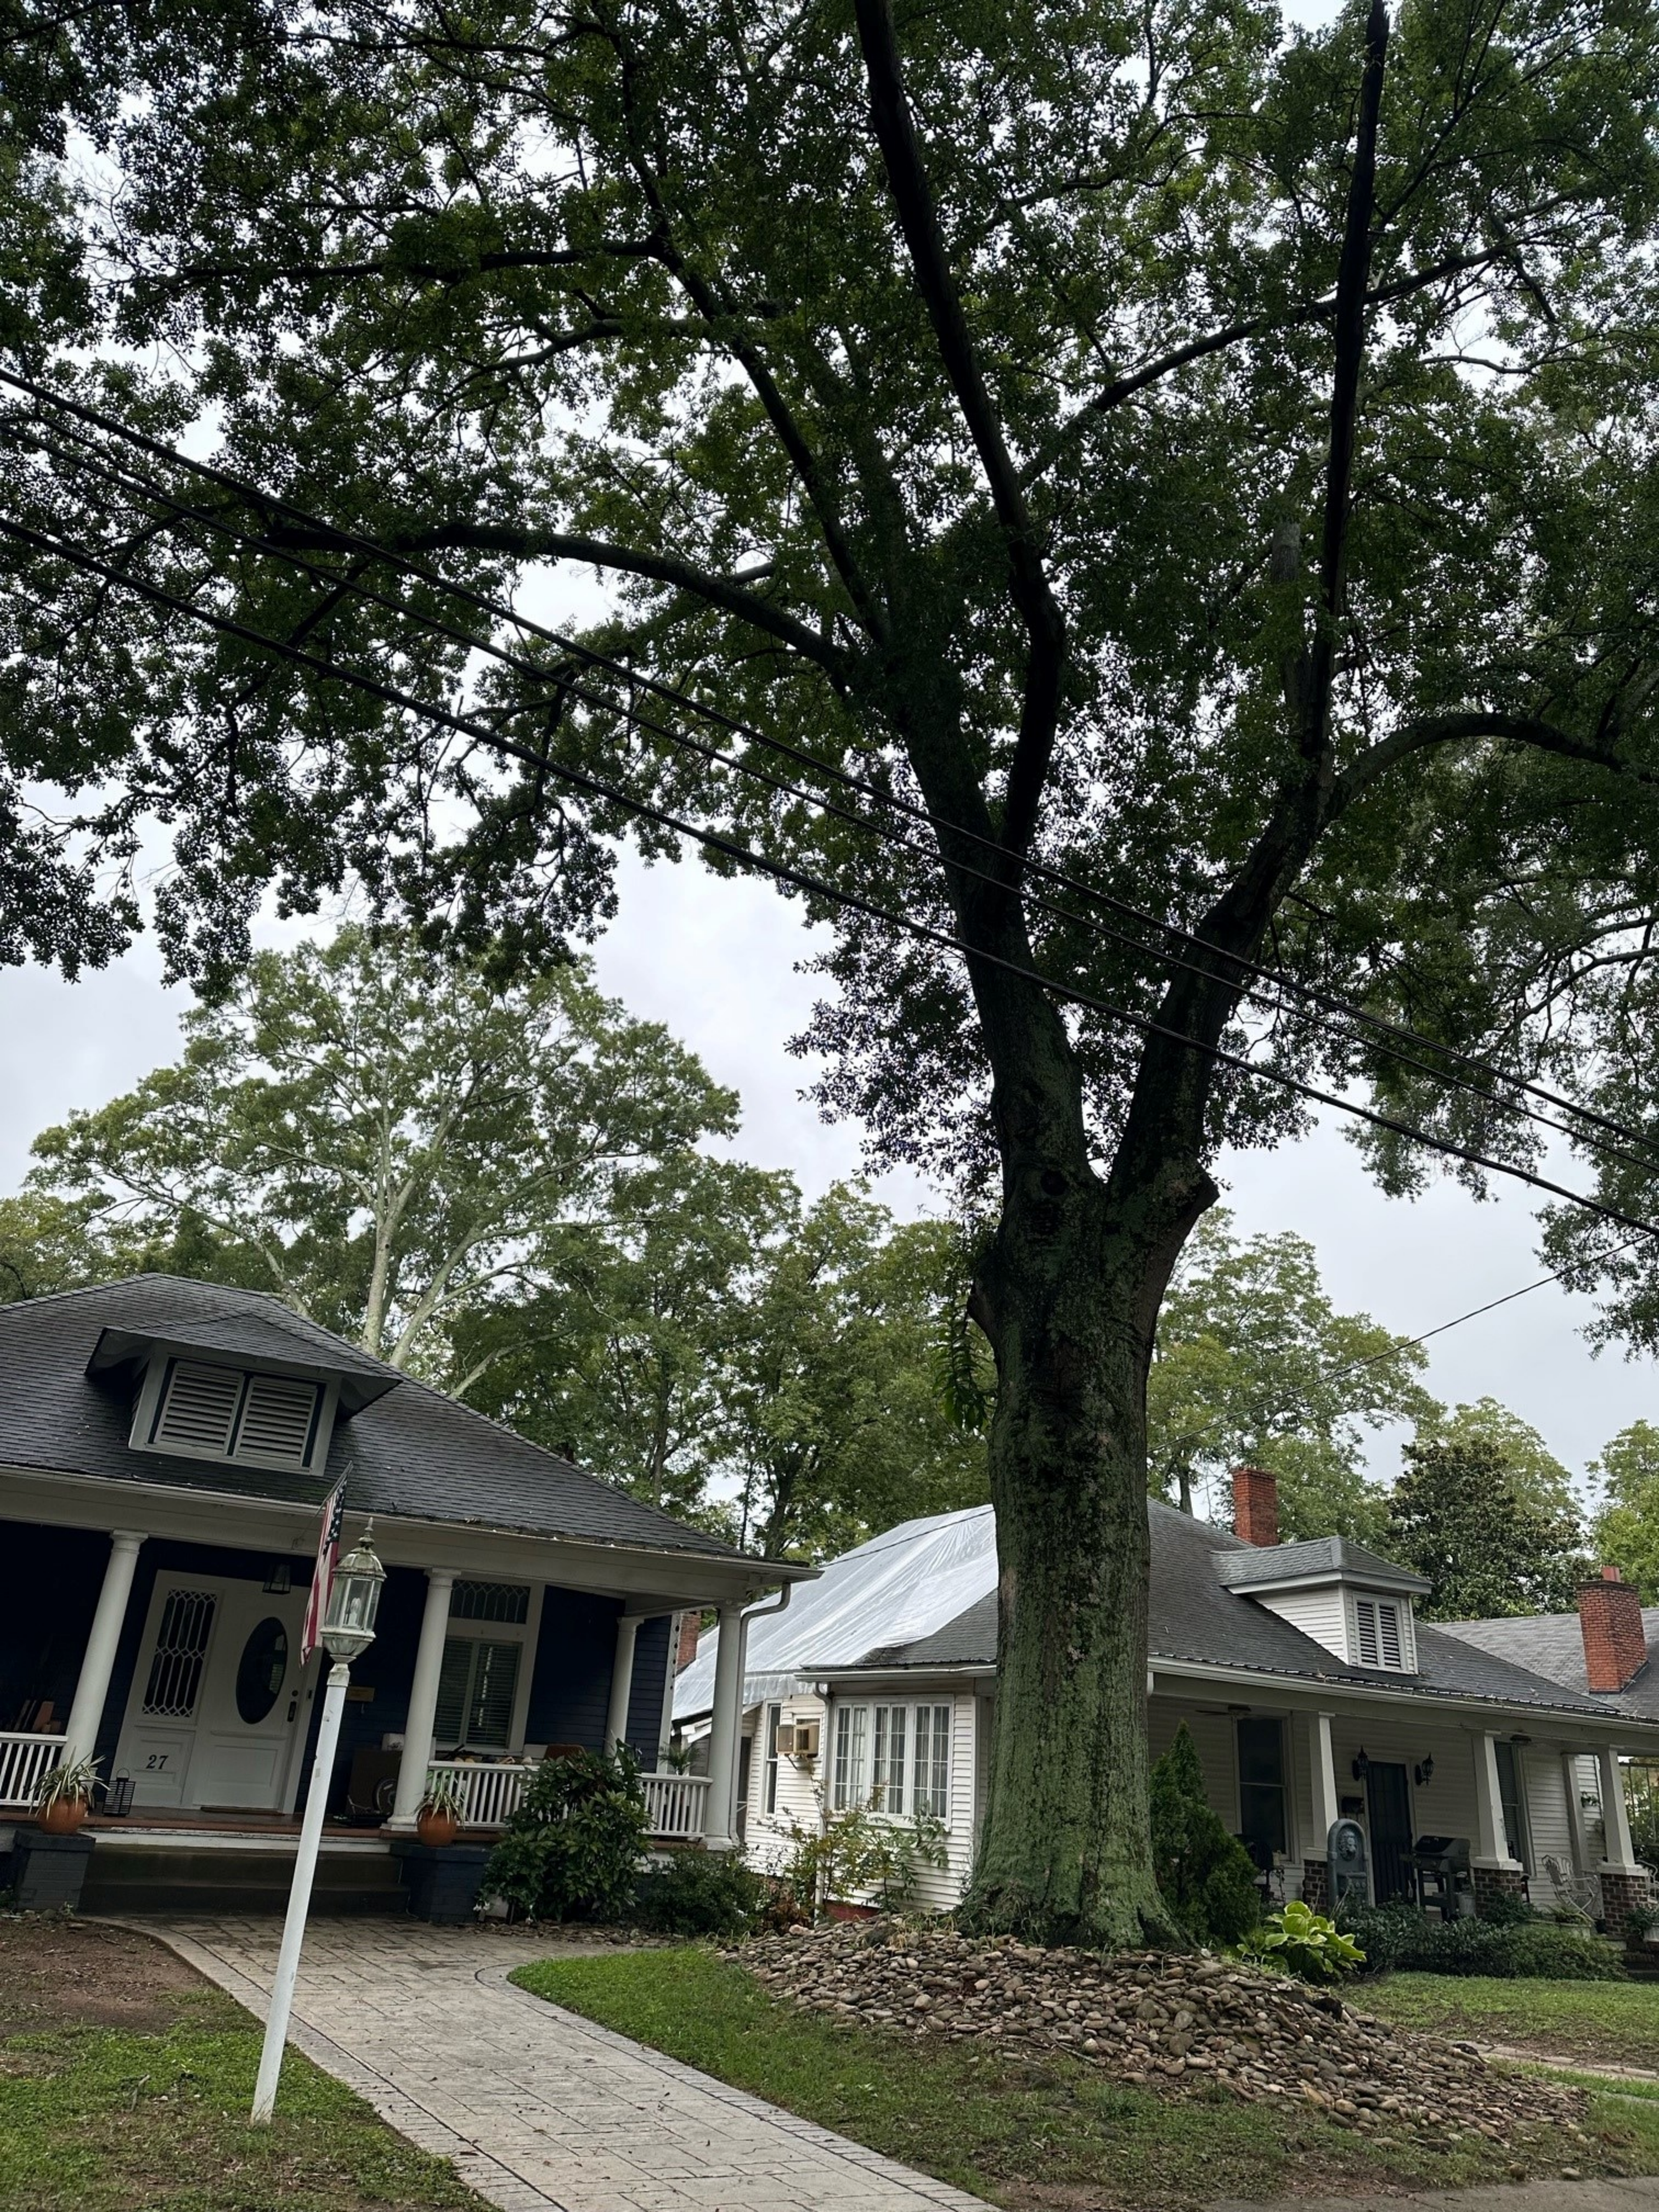
27

Major pests/diseases: Root decay on driveway side.

Suspect root rot: YES Mushroom/conk/bracket present: YES ID: Inonotus dryadeus

This tree has an area of decay on the North side and considerable bow on several upper branches.

Remove tree When replaced, a similar sized tree species would be appropriate in same general location
