DATE: November 8, 2023

Certificate of Appropriateness Request: H-23-23
Applicants: Forest Hill United Methodist Church
Location of Subject Property: 265 Union Street N
PINs: 5621-60-3553
Staff Report Prepared by: Kim Wallis, AICP, Senior Planner

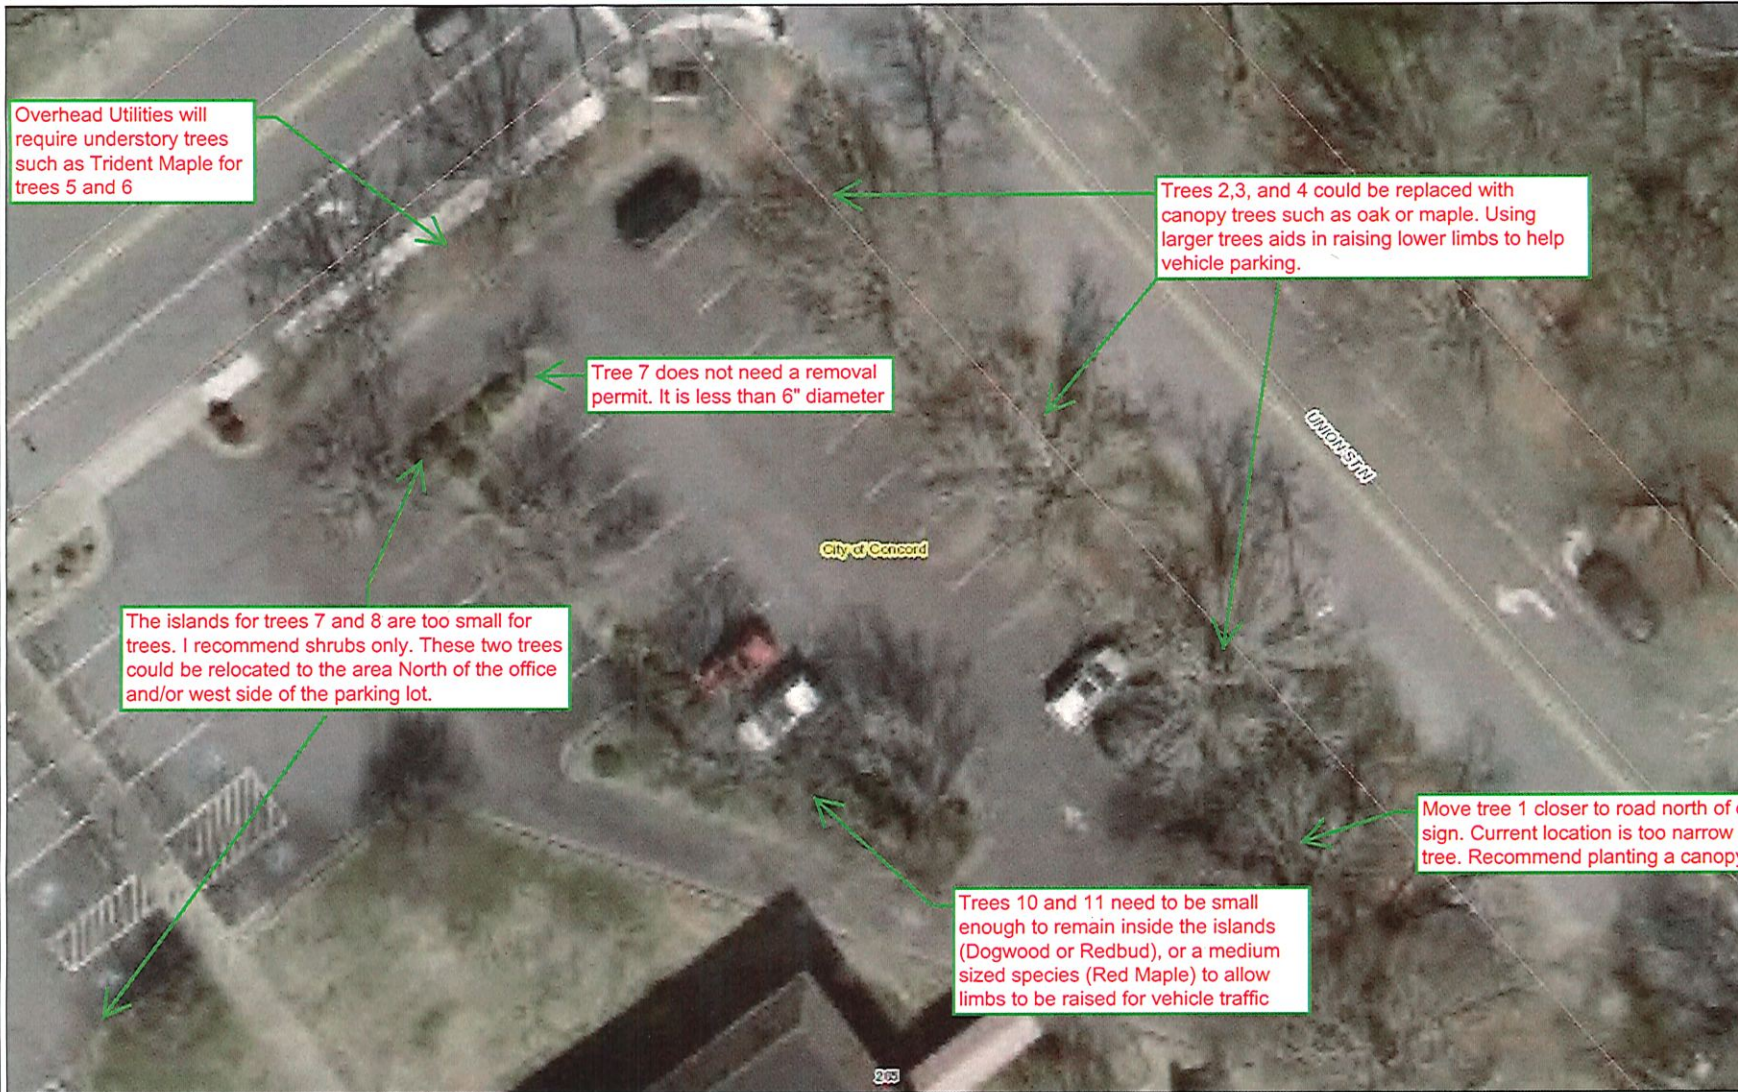
Overhead Utilities will require understory trees such as Trident Maple for trees 5 and 6

The islands for trees 7 and 8 are too small for trees. I recommend shrubs only. These two trees could be relocated to the area North of the office and/or west side of the parking lot.

Move tree 1 closer to road north of office sign. Current location is too narrow for a tree. Recommend planting a canopy tree.

Trees 2,3, and 4 could be replaced with canopy trees such as oak or maple. Using larger trees aids in raising lower limbs to help vehicle parking.

existing shrubs to remain or be replaced with similar sized evergreen shrubs

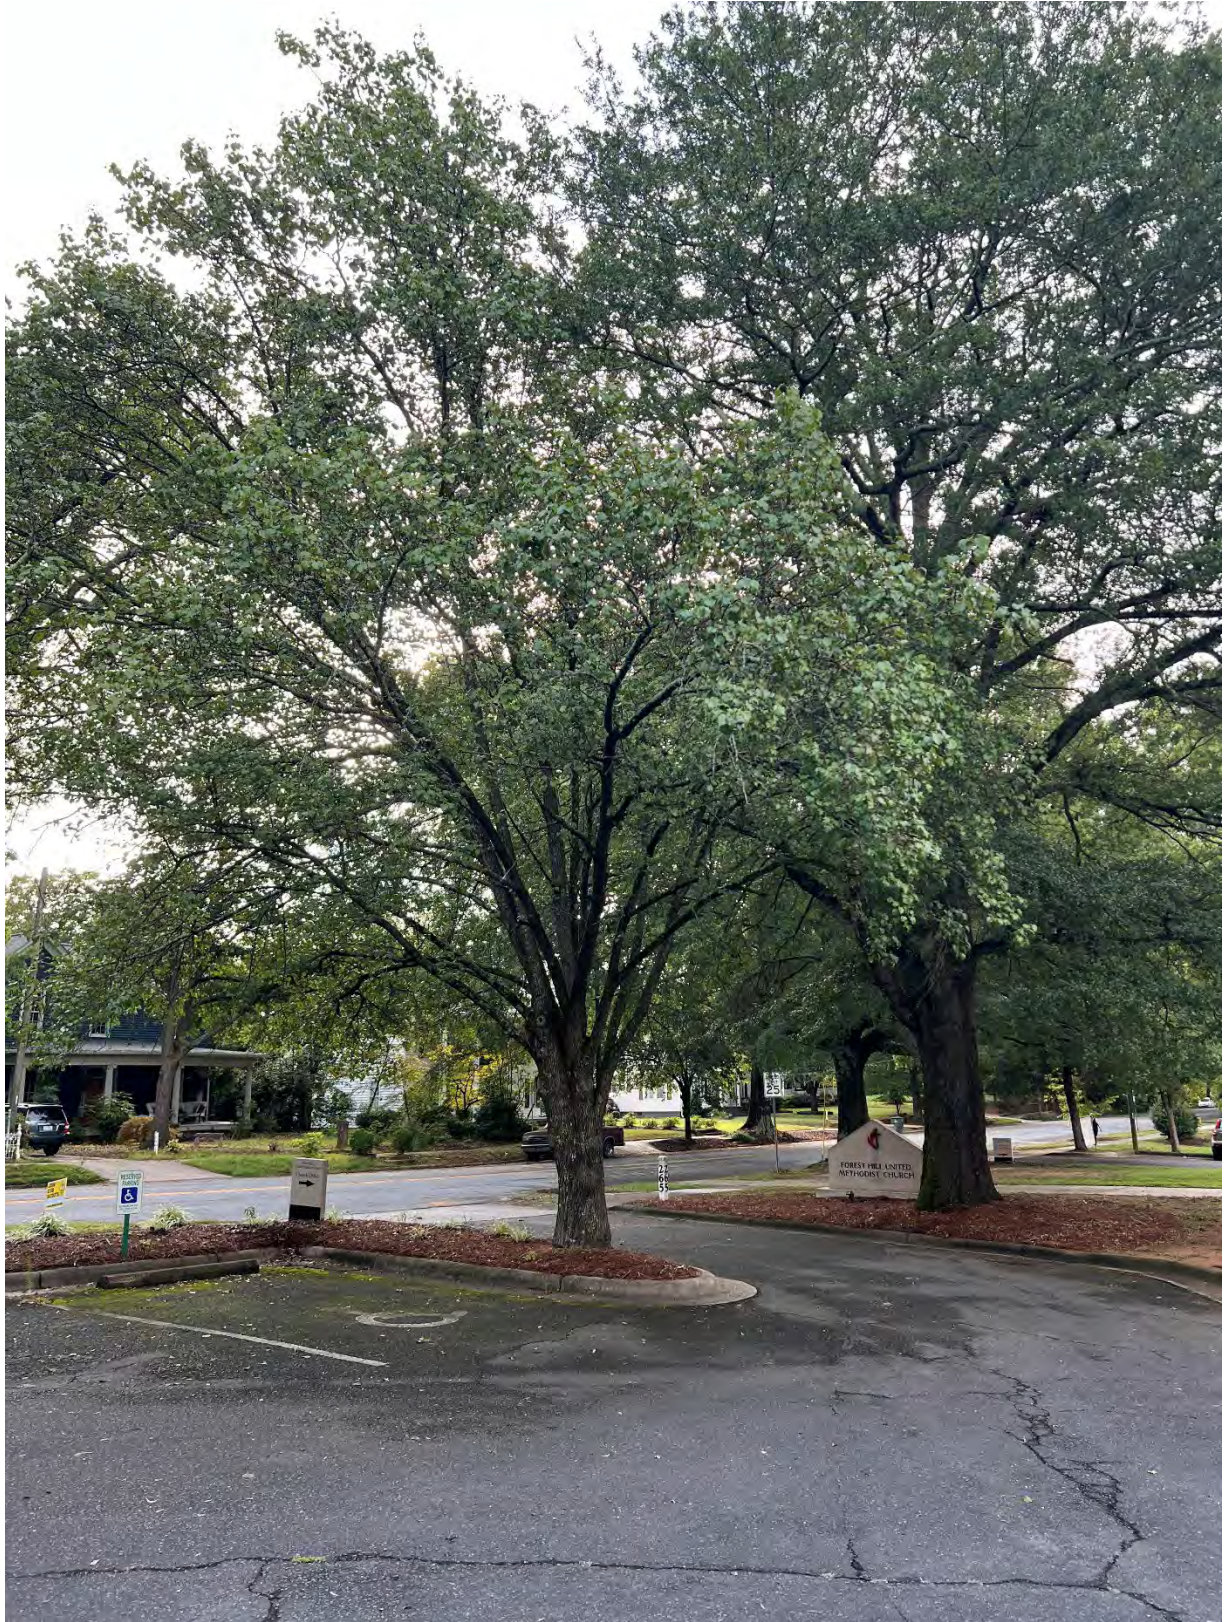
Pear 1

Tree #1: “This mature pear tree has weak branch unions as is typical of the species and a small area of decay at the first branch union.” DBH 21” Height 20’ Spread 35’ (Exhibit E).

This mature pear tree has weak branch unions as is typical of the species and a small area of decay at the first branch union.

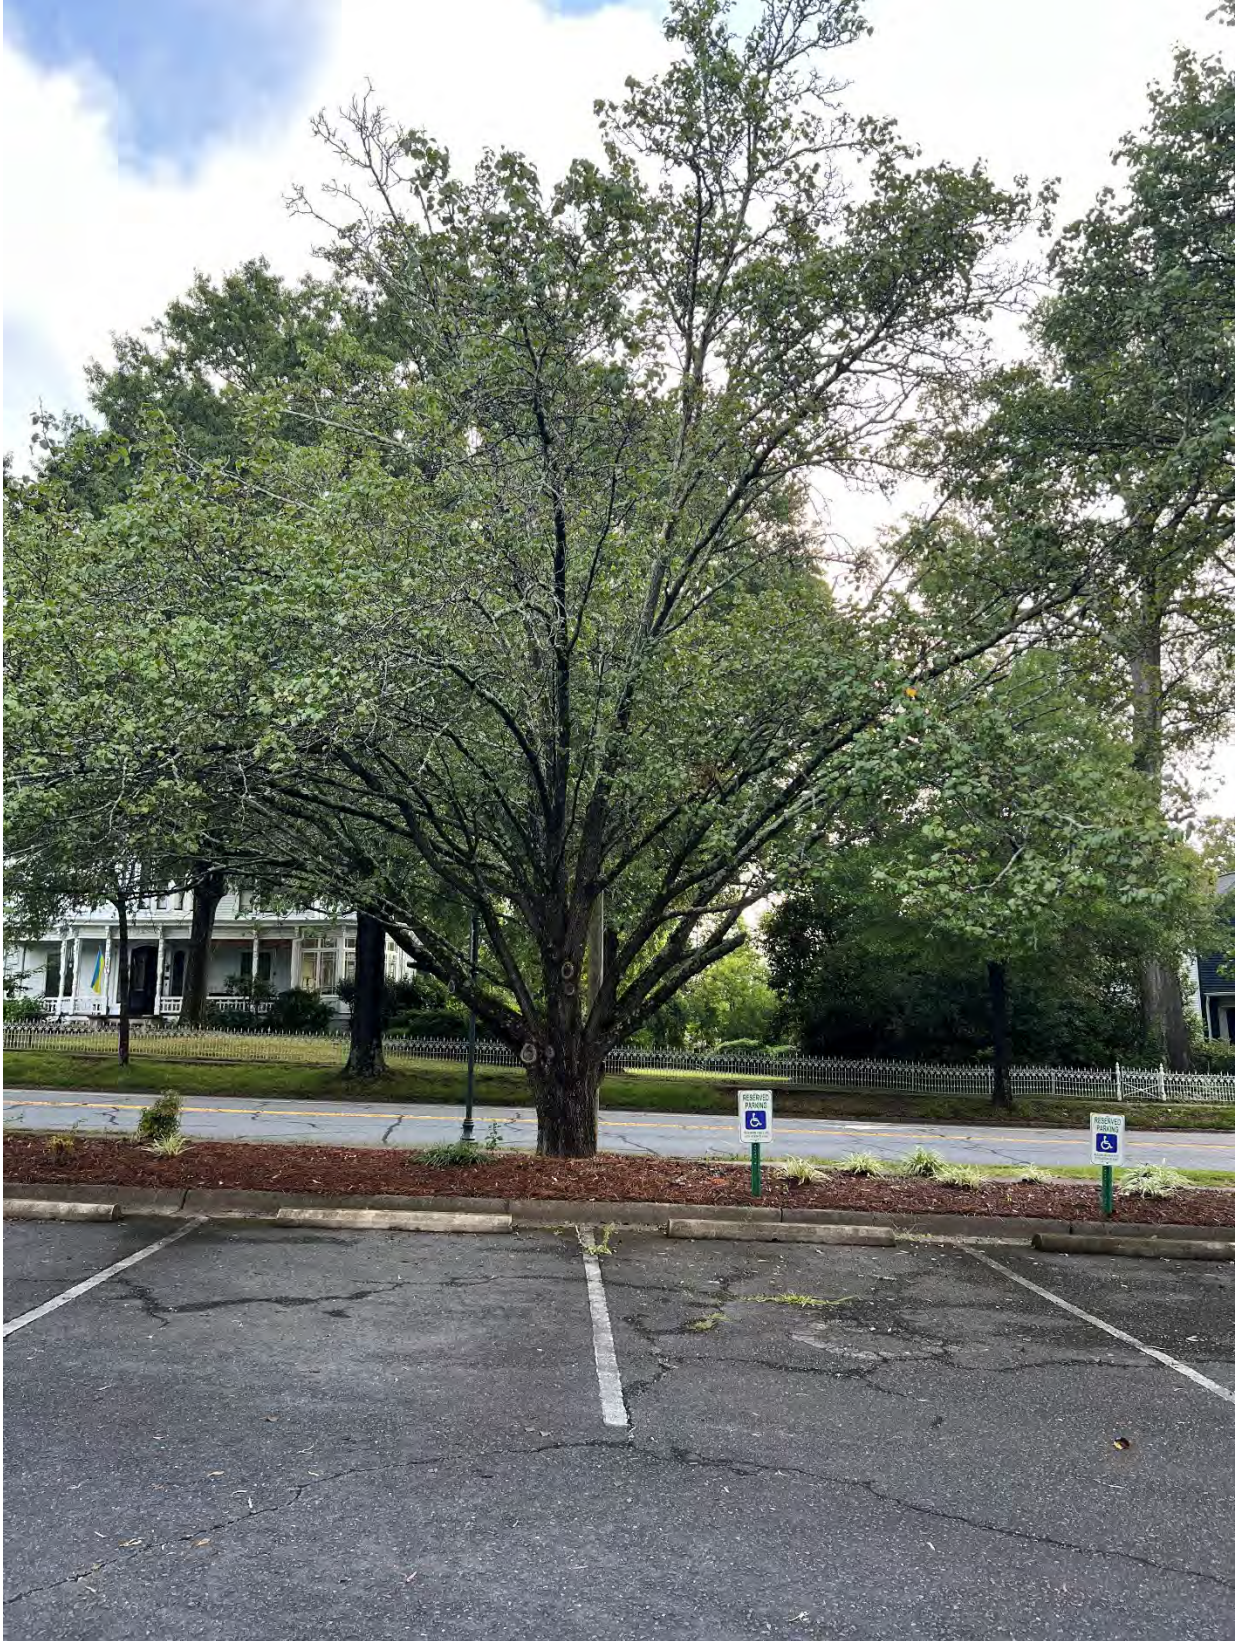
Pear 2

Tree #2: “This mature pear tree has weak branch unions as is typical of the species. There is dieback in several upper branches.” DBH 23.5” Height 20’ Spread 25’ (Exhibit F).

This mature pear tree has weak branch unions as is typical of the species. There is dieback in several upper branches.

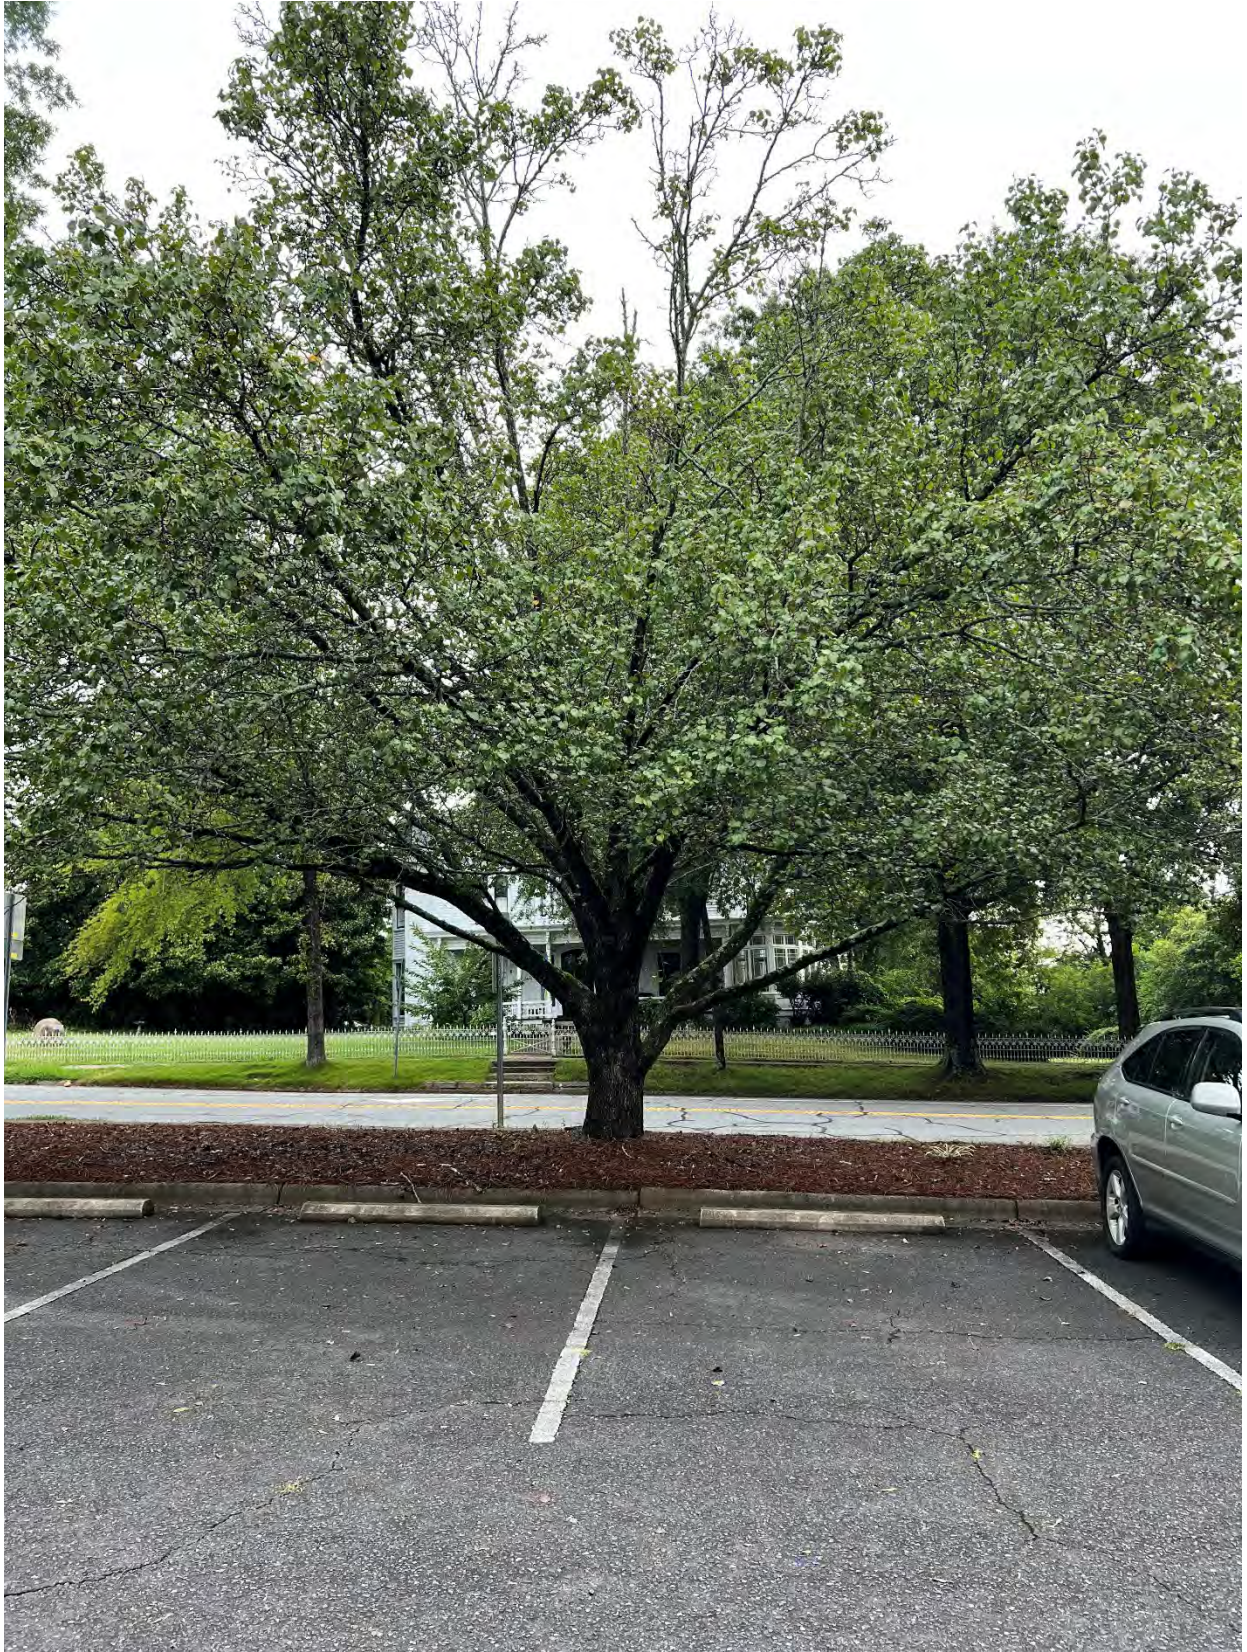
Pear 3

Tree #3: “This mature pear tree has weak branch unions as is typical of the species. There is dieback in several upper branches.” DBH 21.5” Height 20’ Spread 25’ (Exhibit G).

This mature pear tree has weak branch unions as is typical of the species. There is dieback in several upper branches.

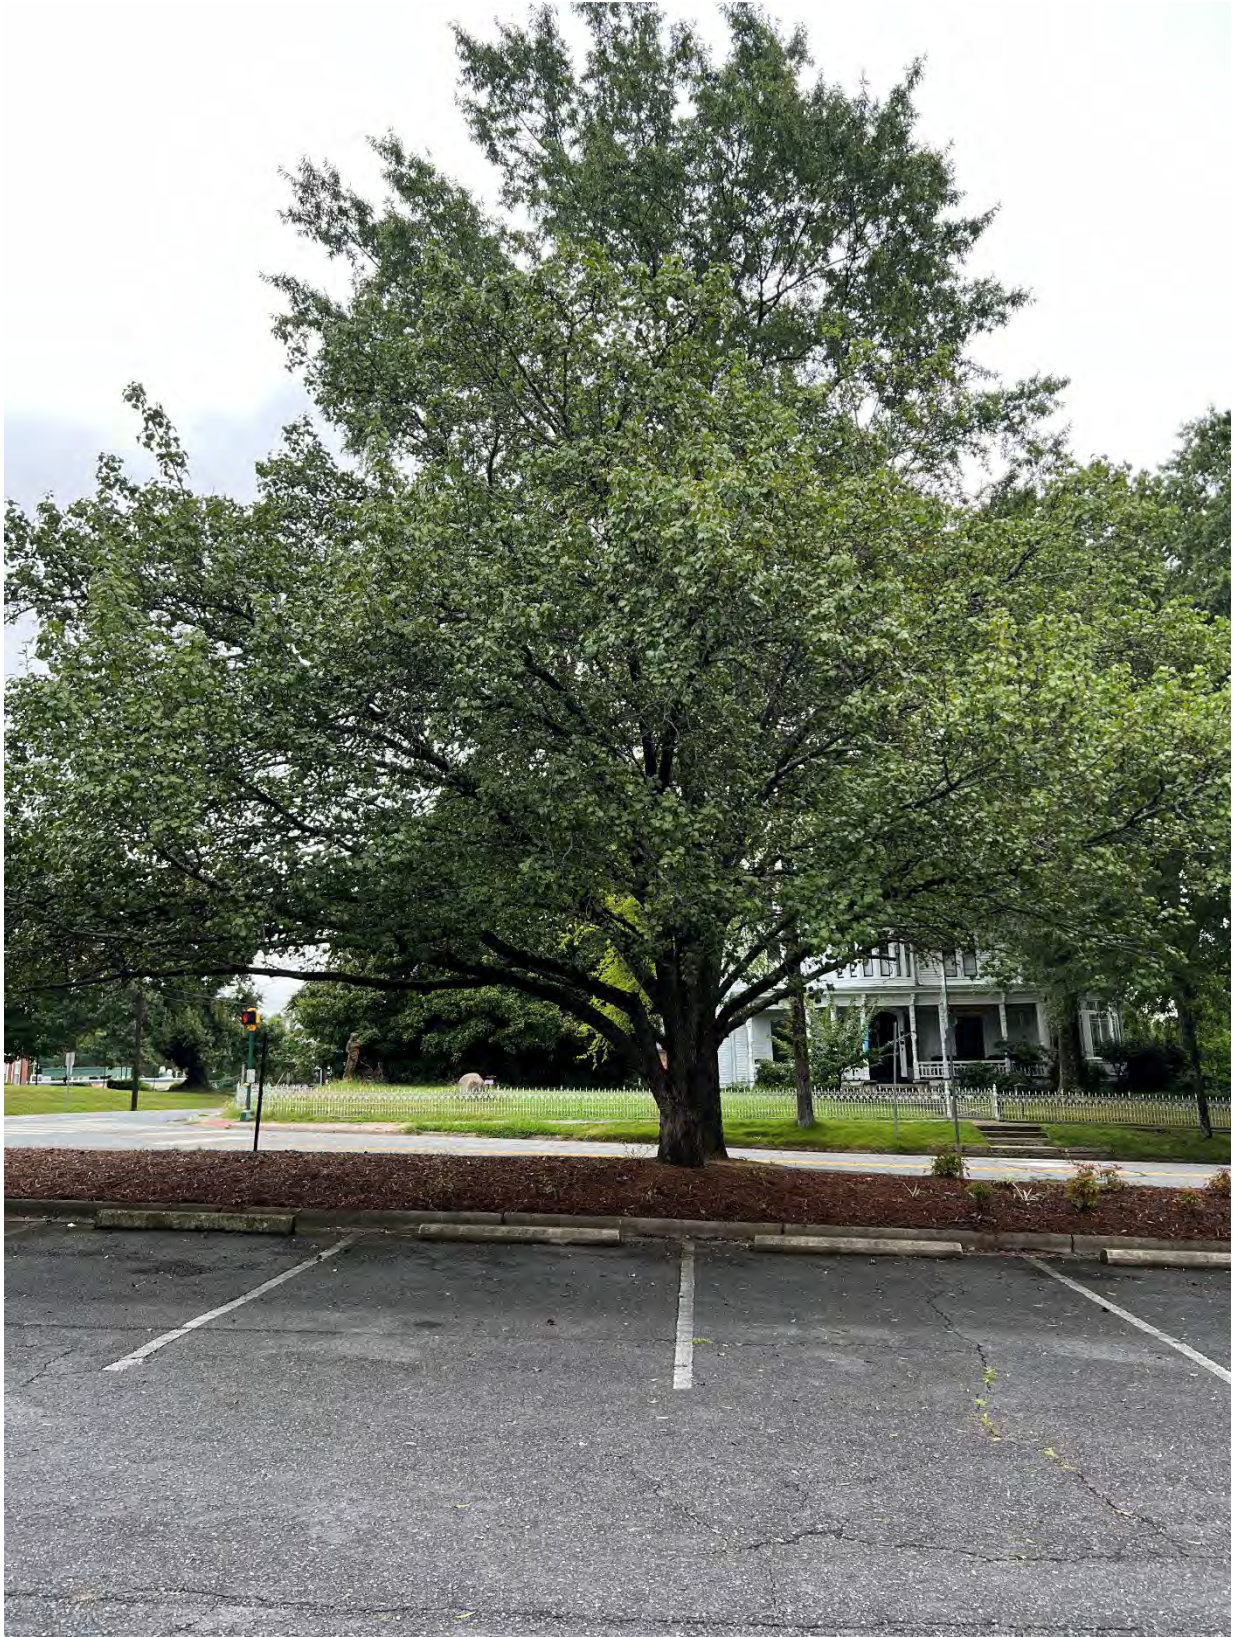
Pear 4

Tree #4: “This mature pear tree has weak branch unions as is typical of the species.” DBH 19” Height 20’ Spread 30’ (Exhibit H).

This mature pear tree has weak branch unions as is typical of the species.

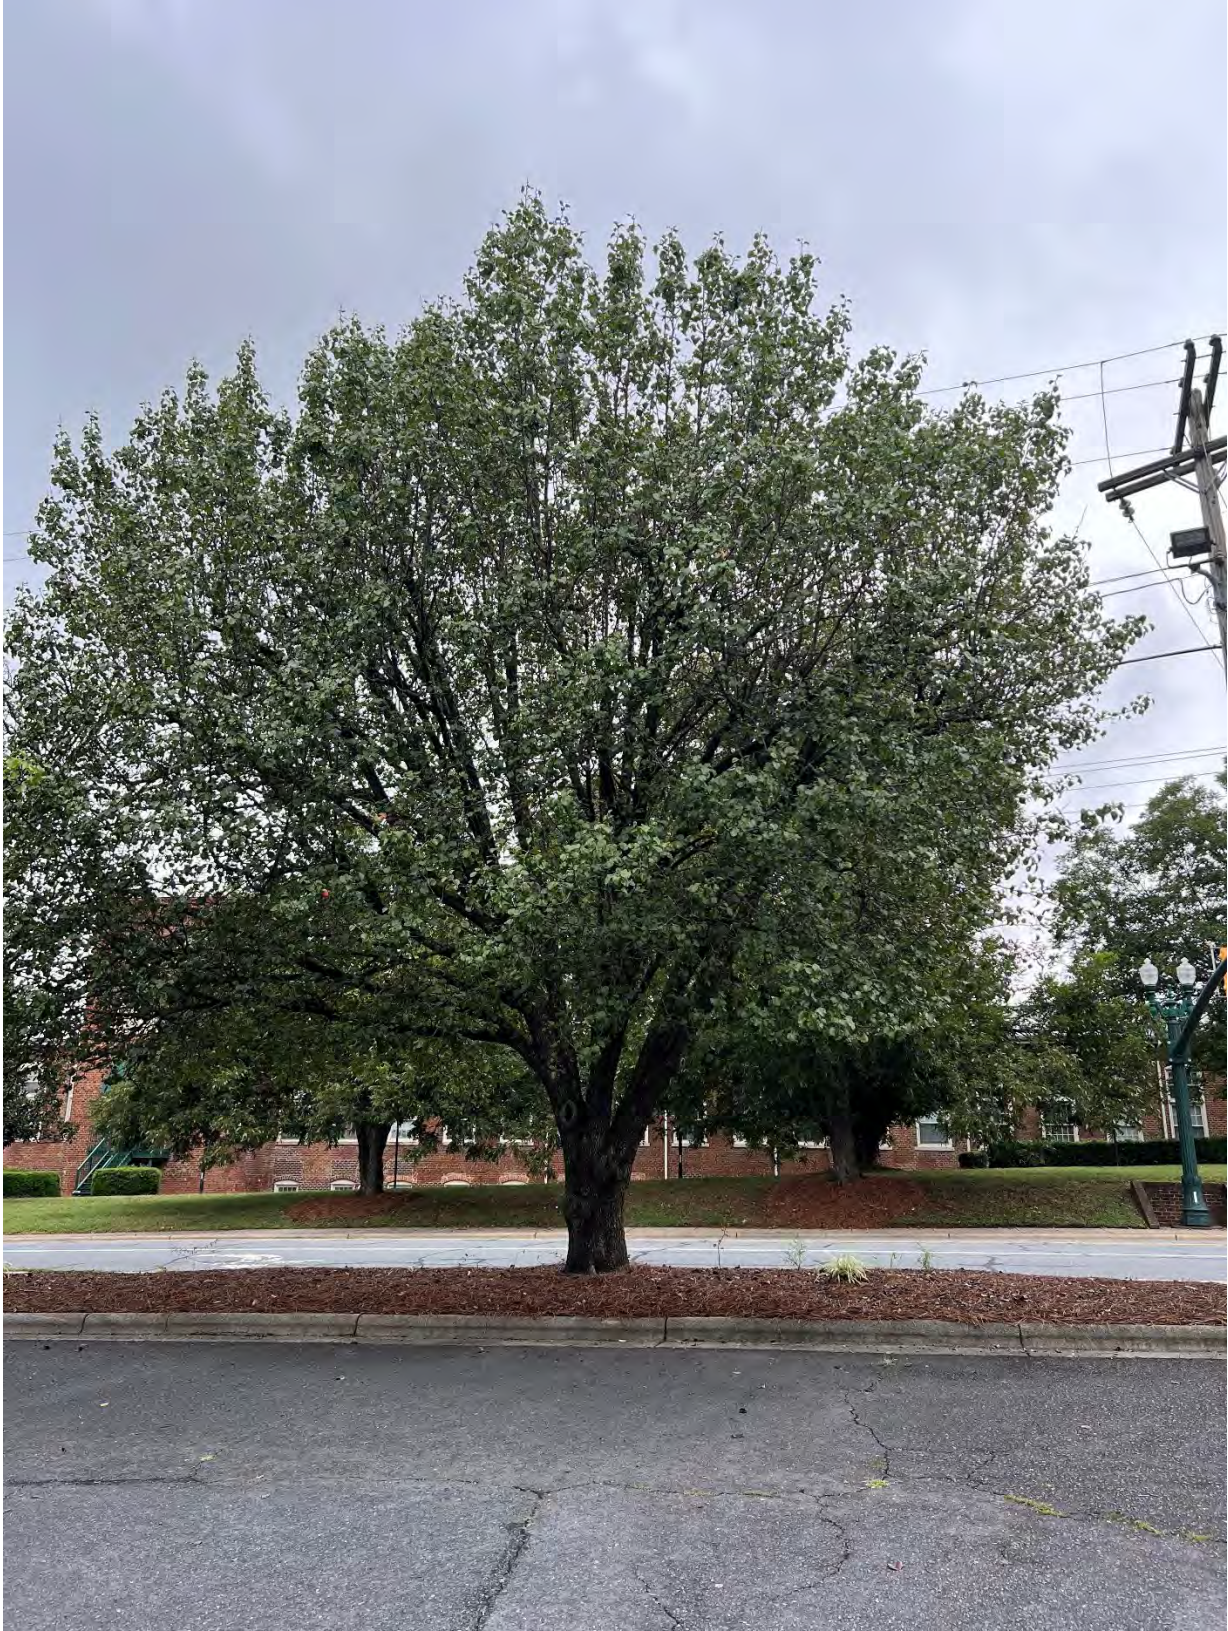
Pear 5

Tree #5: “This mature pear tree has weak branch unions as is typical of the species.” DBH 21” Height 20’ Spread 25’ (Exhibit I).

This mature pear tree has weak branch unions as is typical of the species.

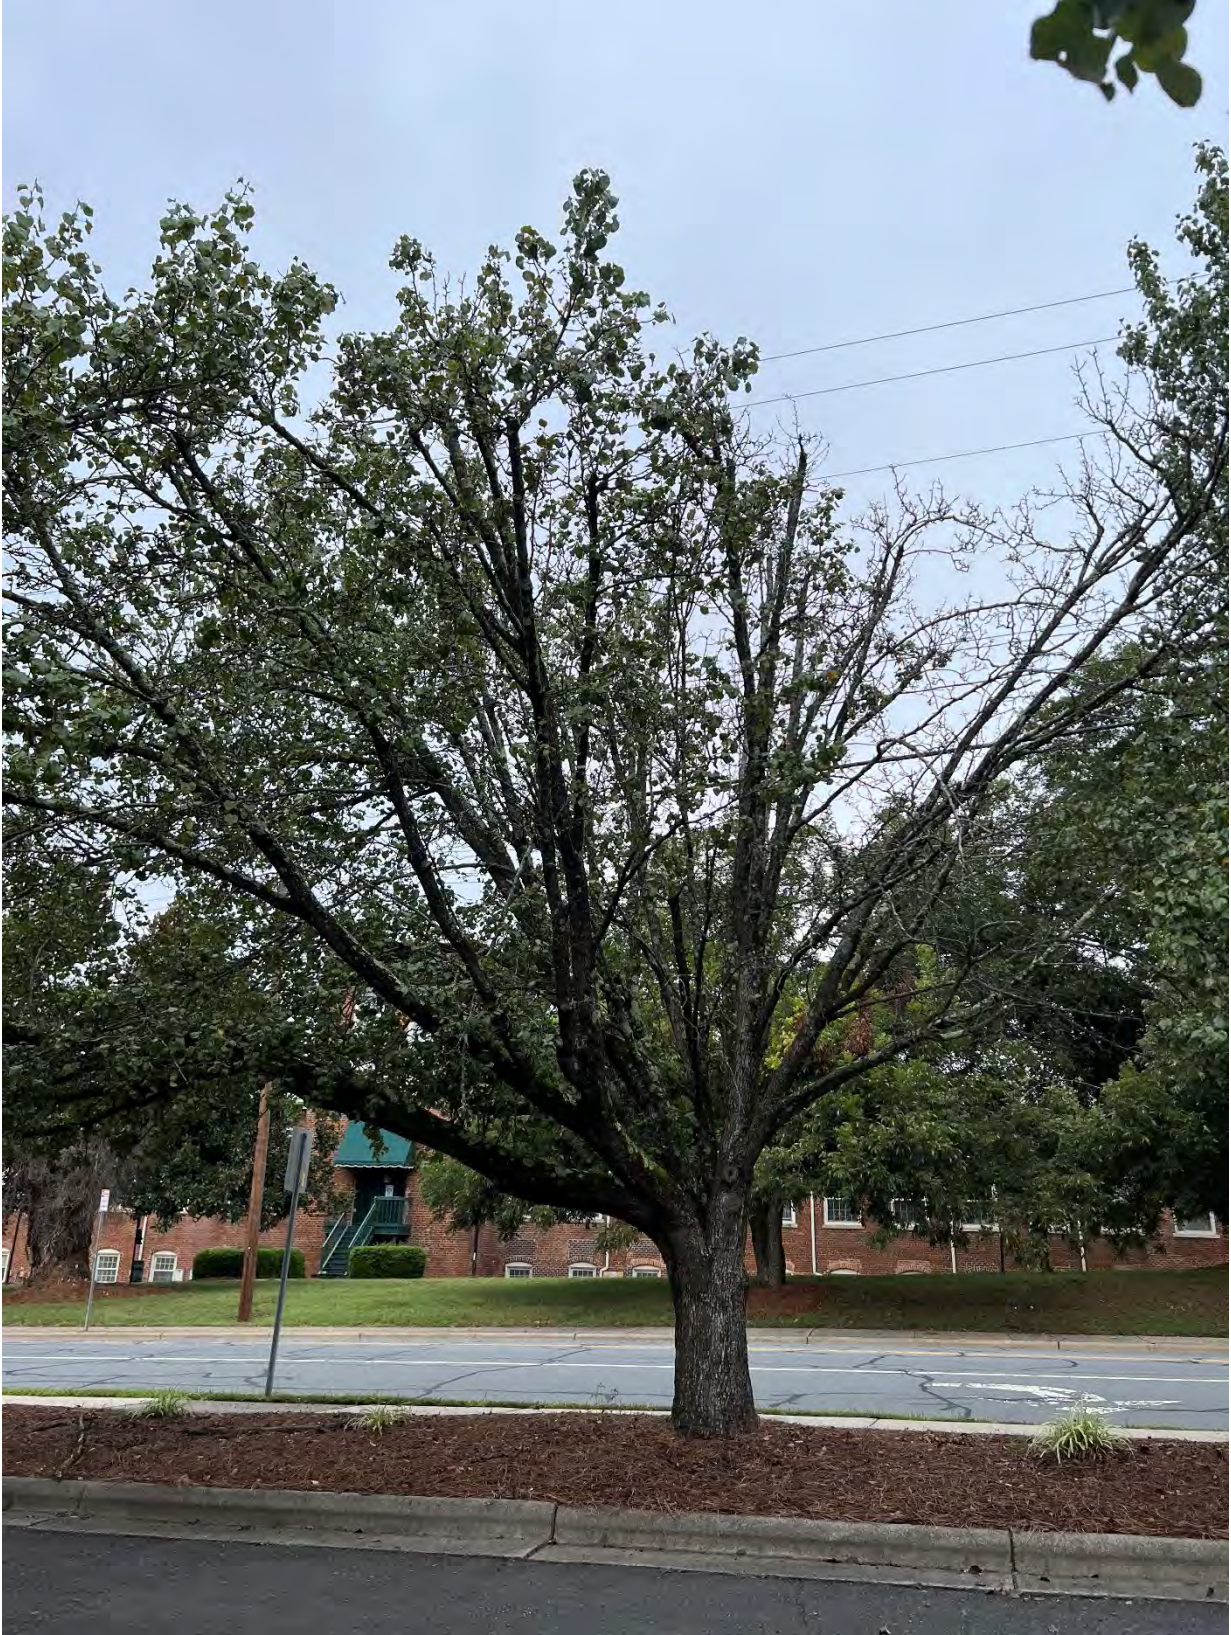
Pear 6

Tree #6: “This mature pear tree has weak branch unions as is typical of the species. This is dieback on several upper branches.” DBH 19” Height 15’ Spread 20’ (Exhibit J).

This mature pear tree has weak branch unions as is typical of the species. This is dieback on several upper branches.

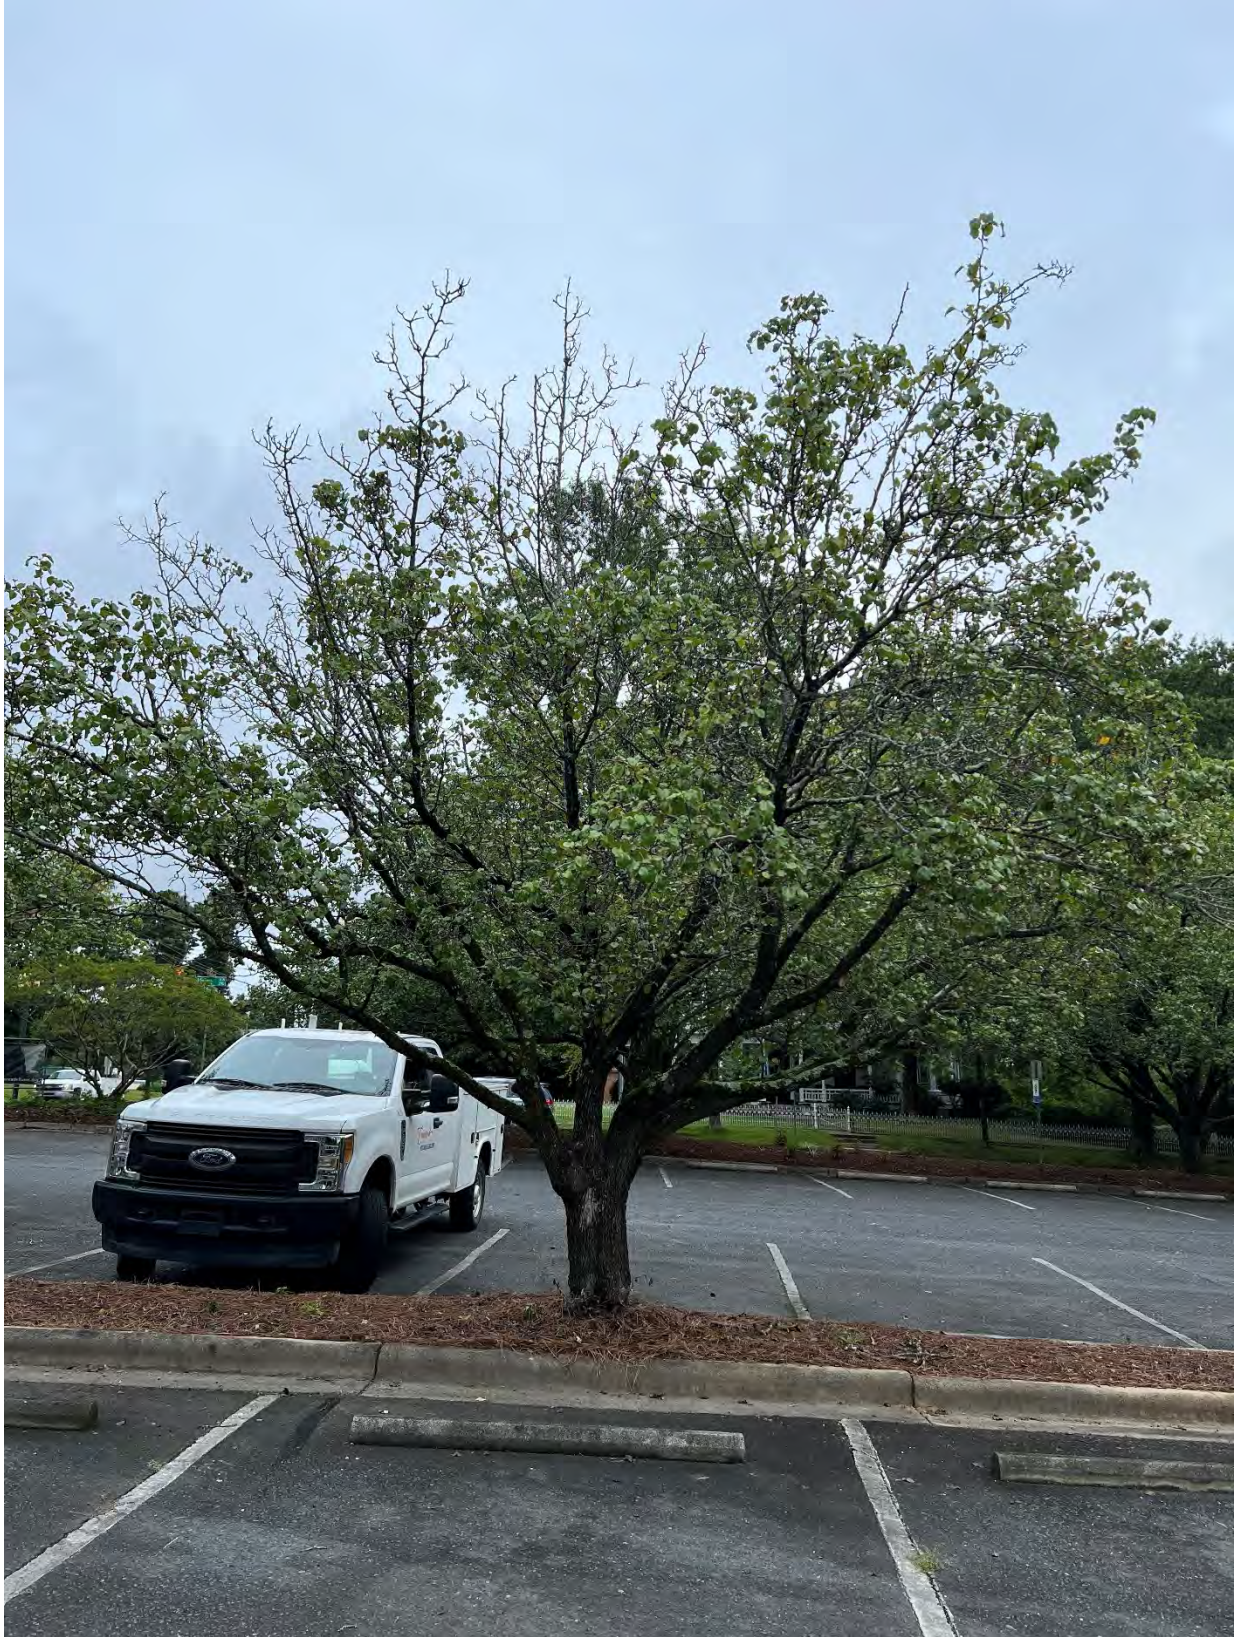
Pear 9

Tree #9: “This mature pear tree has weak branch unions as is typical of the species. This is dieback on several upper branches.” DBH 14.5” Height 12’ Spread 15’ (Exhibit K).

This mature pear tree has weak branch unions as is typical of the species. This is dieback on several upper branches.

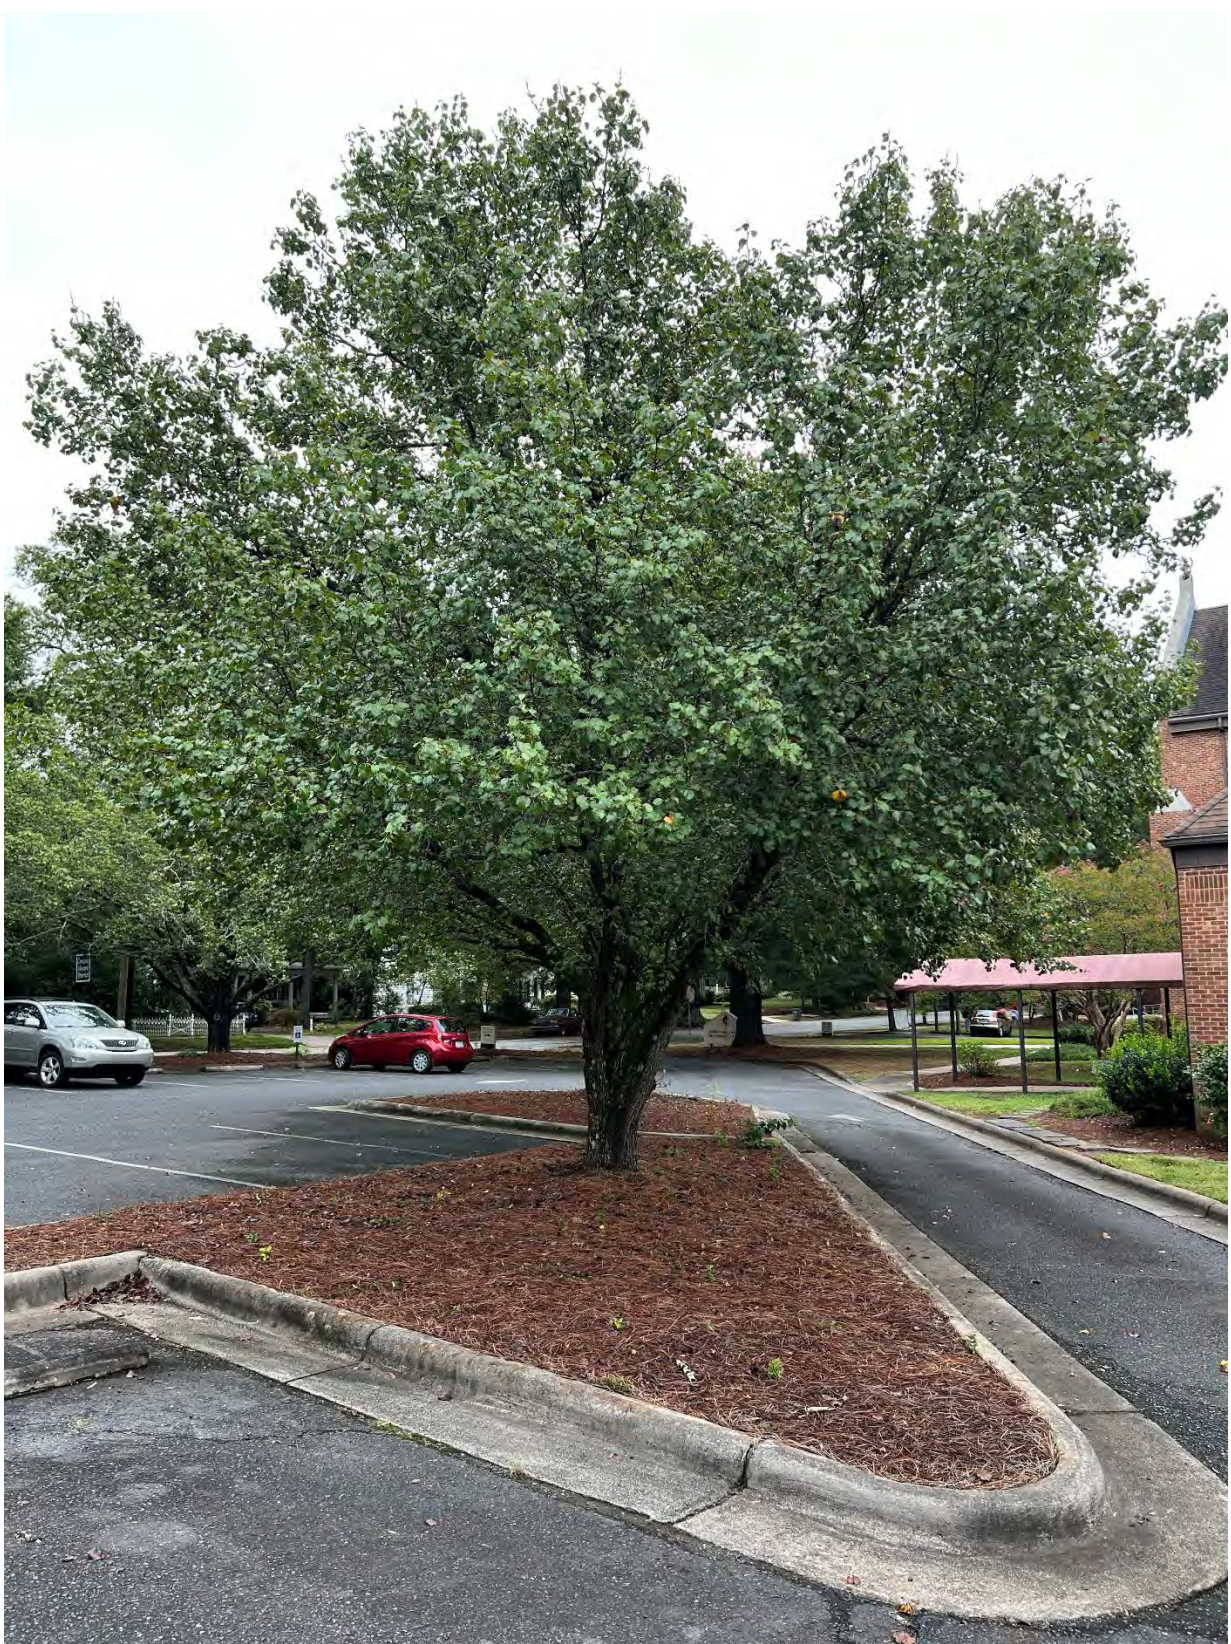
Pear 10

Tree #10: “This mature pear tree has weak branch unions as is typical of the species.” DBH 19” Height 20’ Spread 30’ (Exhibit L).

This mature pear tree has weak branch unions as is typical of the species.
