**DATE:** October 14, 2020

<u>Certificate of Appropriateness Request:</u>	H-24-20
<u>Applicant:</u>	Forest Hill United Methodist Church, Scott Dyer
<u>Location of subject property:</u>	251 Union St. N
<u>Staff Report prepared by:</u>	Katherine Godwin, Sr. Planner

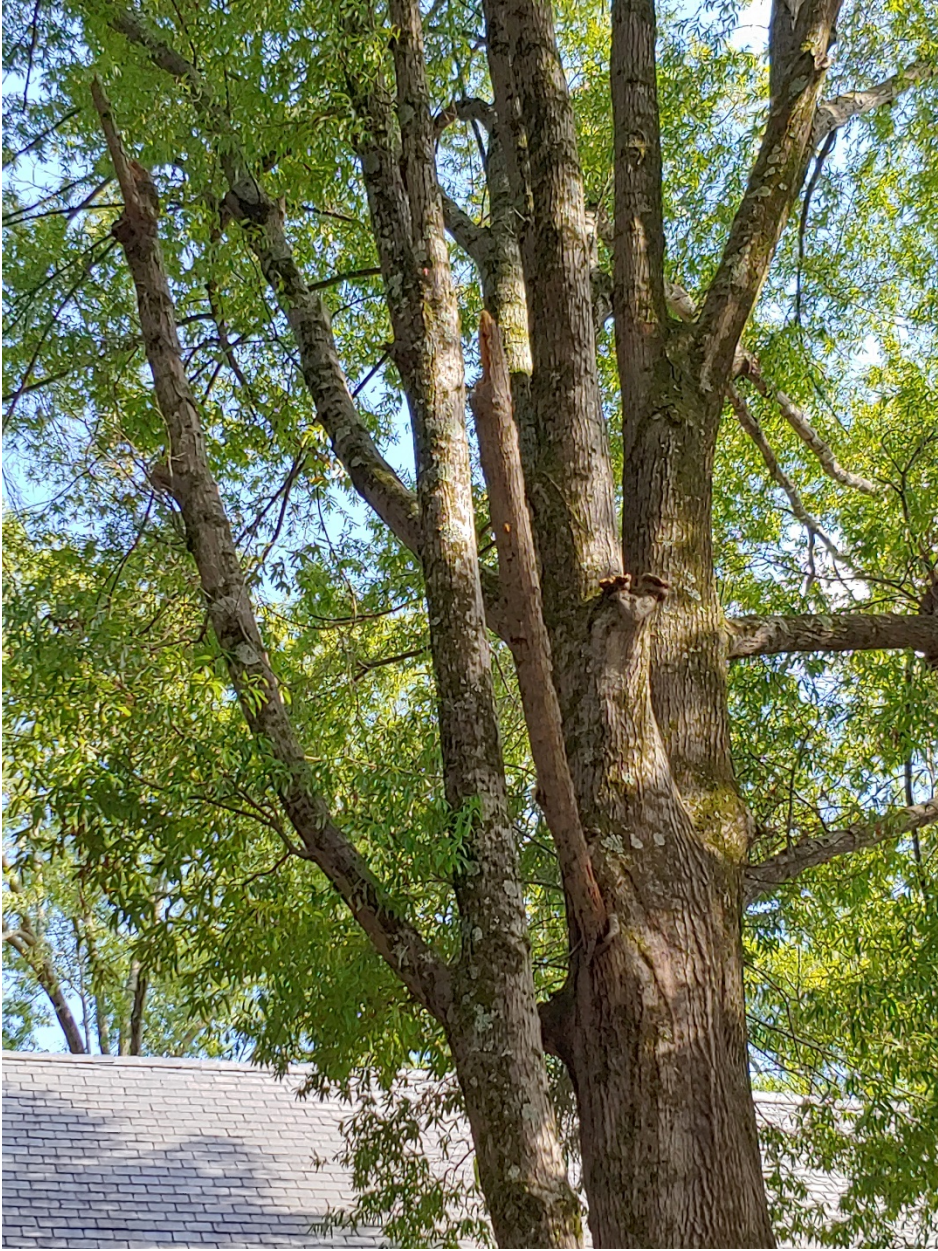
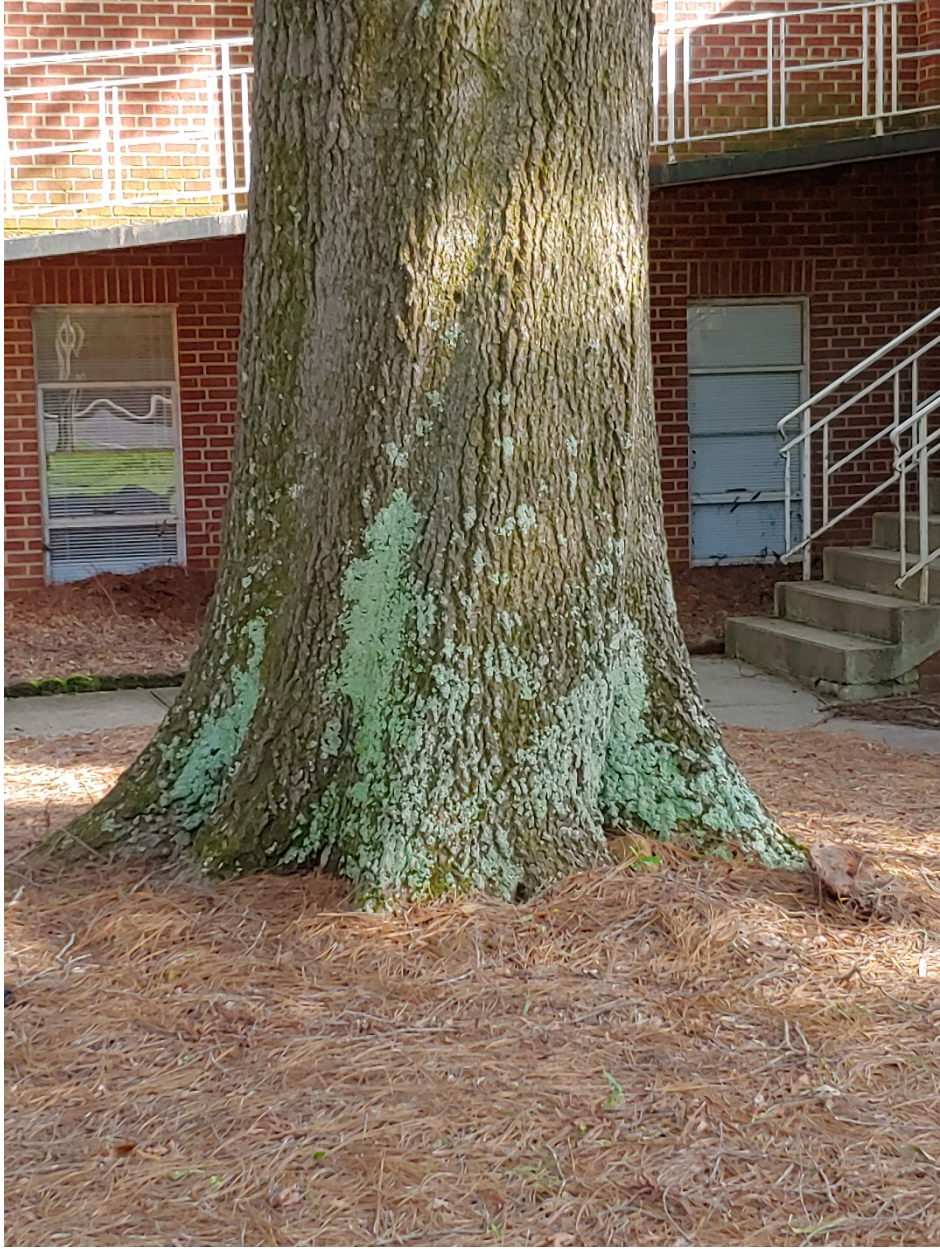
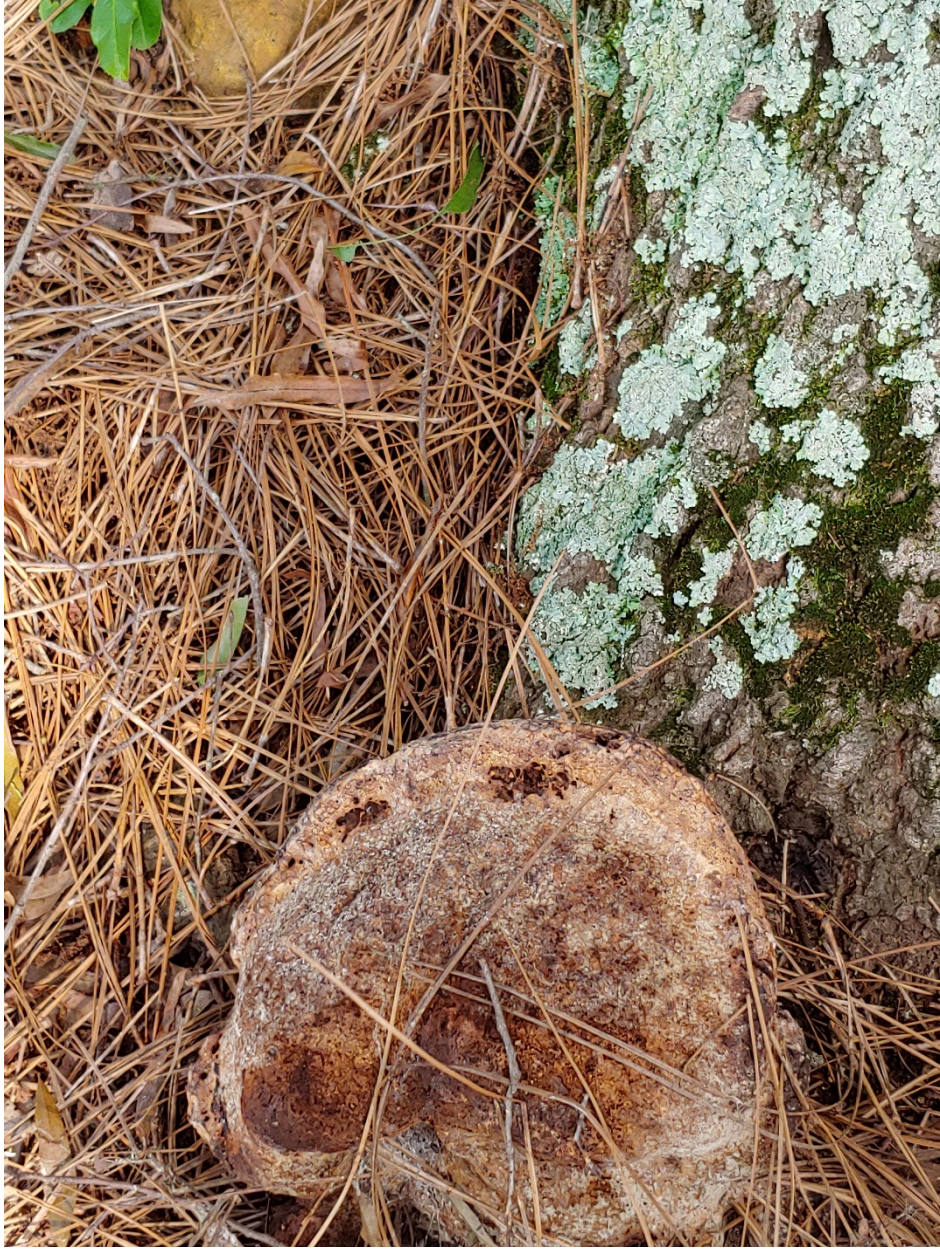
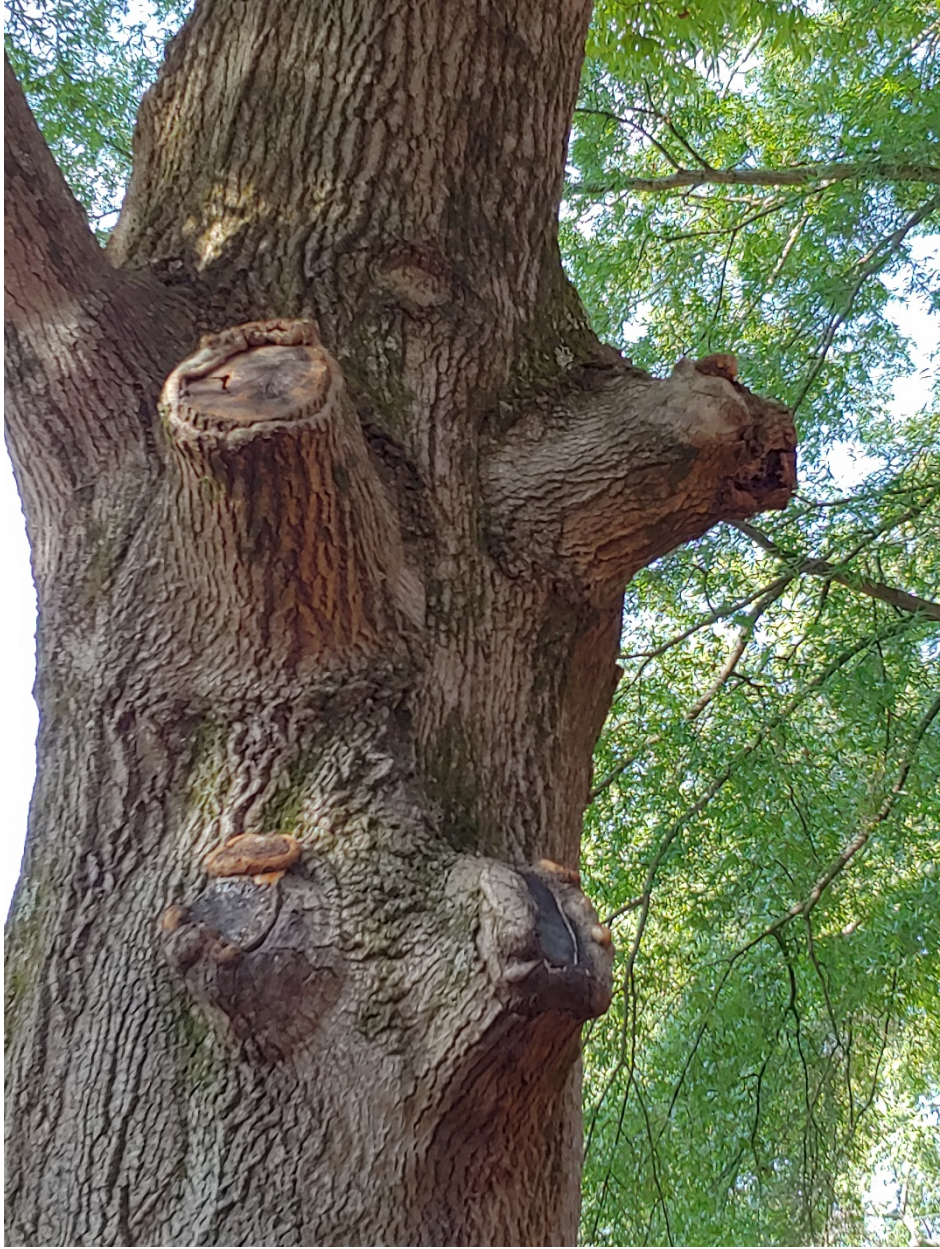
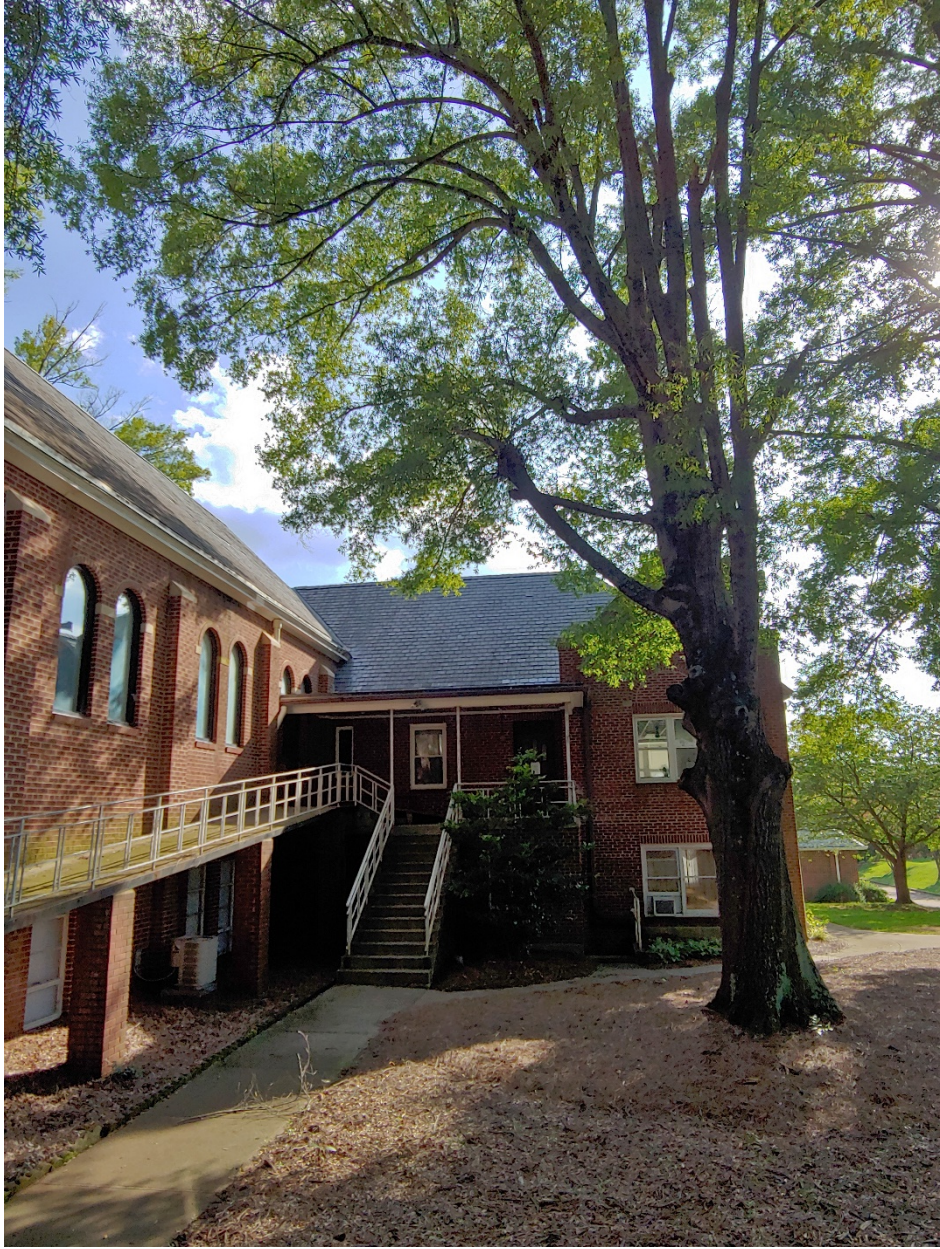
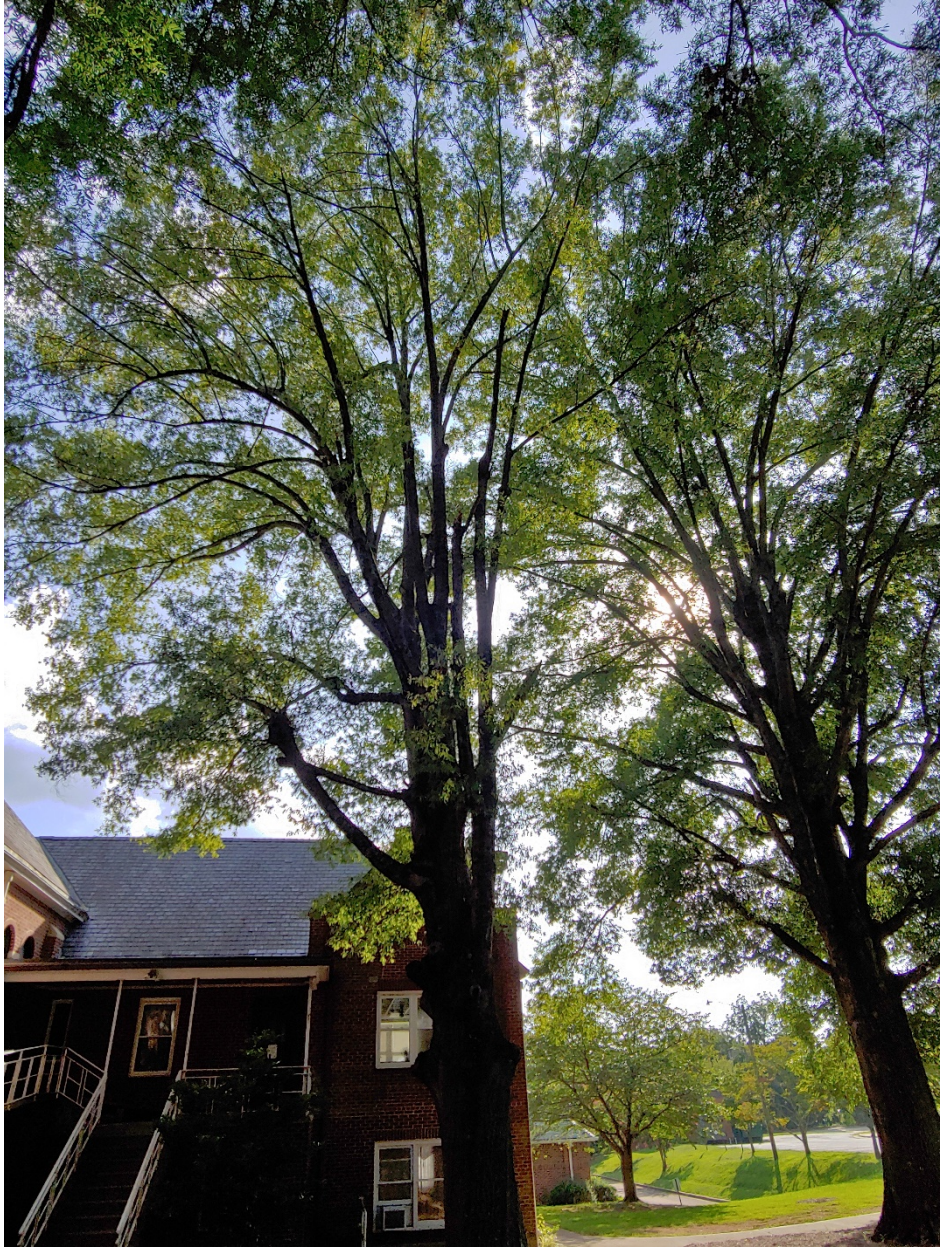
**Exhibit F**

The applicant has stated (Exhibit B) that the declining Willow Oak tree will be replaced as directed by the City Arborist. Several photographs have been submitted by the applicant (Exhibit F) to demonstrate the health, condition, and location of the tree. If removal is approved, the applicant would like to replant one Maple tree of 1.5” to 2” caliper in the general vicinity of the existing tree once the stump is removed (Exhibit B and E).

Suspect root rot: YES      Mushroom/conk/bracket present: YES      ID: Inonotus dryadeus

This tree is in fair condition. It is structurally stable but is showing signs of decline. There are small areas of decay in the trunk and evidence of root decay fungi.

**Remove tree**     If replaced, a similar sized tree species would be appropriate in same location
