HISTORIC PRESERVATION COMMISSION MEETING AGENDA

Wednesday, July 12, 2023 at 6:00 PM

H-13-23 (Quasi-Judicial Hearing)

H-14-23 (Quasi-Judicial Hearing)

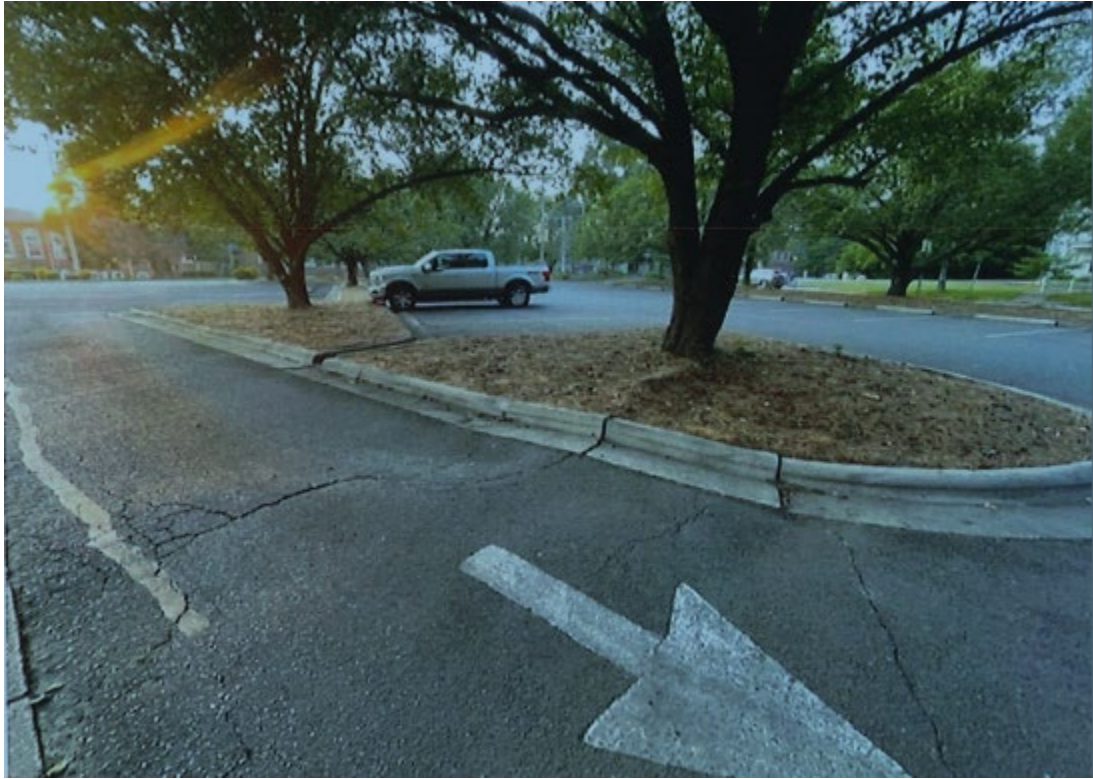
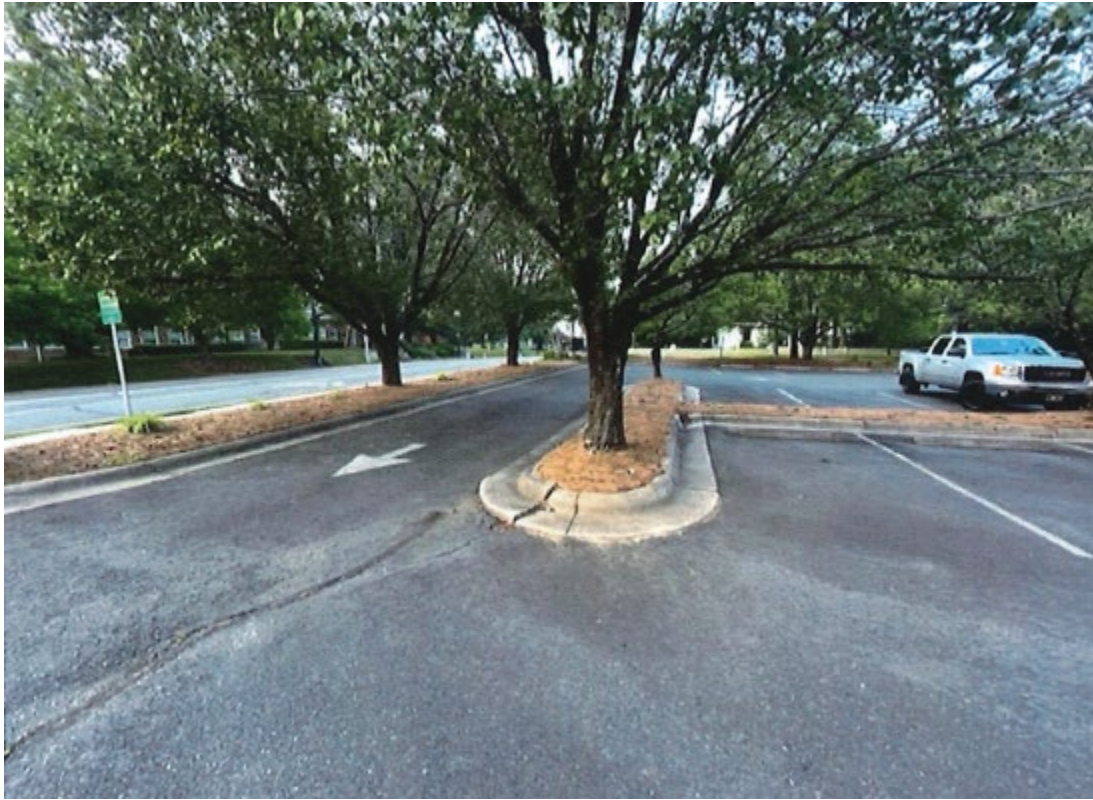
H-14-23

Tree #1 (Bradford Pear / *Pyrus calleryana*) was assessed by City Arborist, Bill Leake, on June 21, 2023, and was assigned a Risk Rating of 4. As noted, “This mature pear tree has weak branch unions as is typical of the species and a small area of decay at the first branch union.” The assessment also noted that if removed, a similar sized replacement tree species would be appropriate in the same general location, or an alternate location. DBH 21” Height 20’ Spread 35’(Exhibit D).

Tree #2 (Bradford Pear / *Pyrus calleryana*) was assessed by City Arborist, Bill Leake, on June 21, 2023, and was assigned a Risk Rating of 4. As noted, “This mature pear tree has weak branch unions as is typical of the species. The tree is showing signs of decline due to small soil volume and high surface temperatures typical of parking lot islands.” The assessment also noted that if removed, a similar sized replacement tree species would be appropriate in an alternate location. DBH 16” Height 15’ Spread 20’(Exhibit D).

This mature pear tree has weak branch unions as is typical of the species and a small area of decay at the first branch union.

Both of the trees requested for removal are ordinance required trees (Concord Development Ordinance Article 11.6 Parking Lot Yards) and will need to be replaced. There is concern from the applicant that replacing the two trees in the same parking lot landscape island area would allow the roots to continue ruining the parking lot asphalt. The City Arborist, Bill Leake, has noted that these trees can be located at an alternate location on the property.
