Certificate of Appropriateness Request:

H-01-24

238 Union St. N

**Not for Construction**  
**Master Landscape Plan**  
**Rogers Residence**  
 238 Union Sreet, North  
 Concord, North Carolina

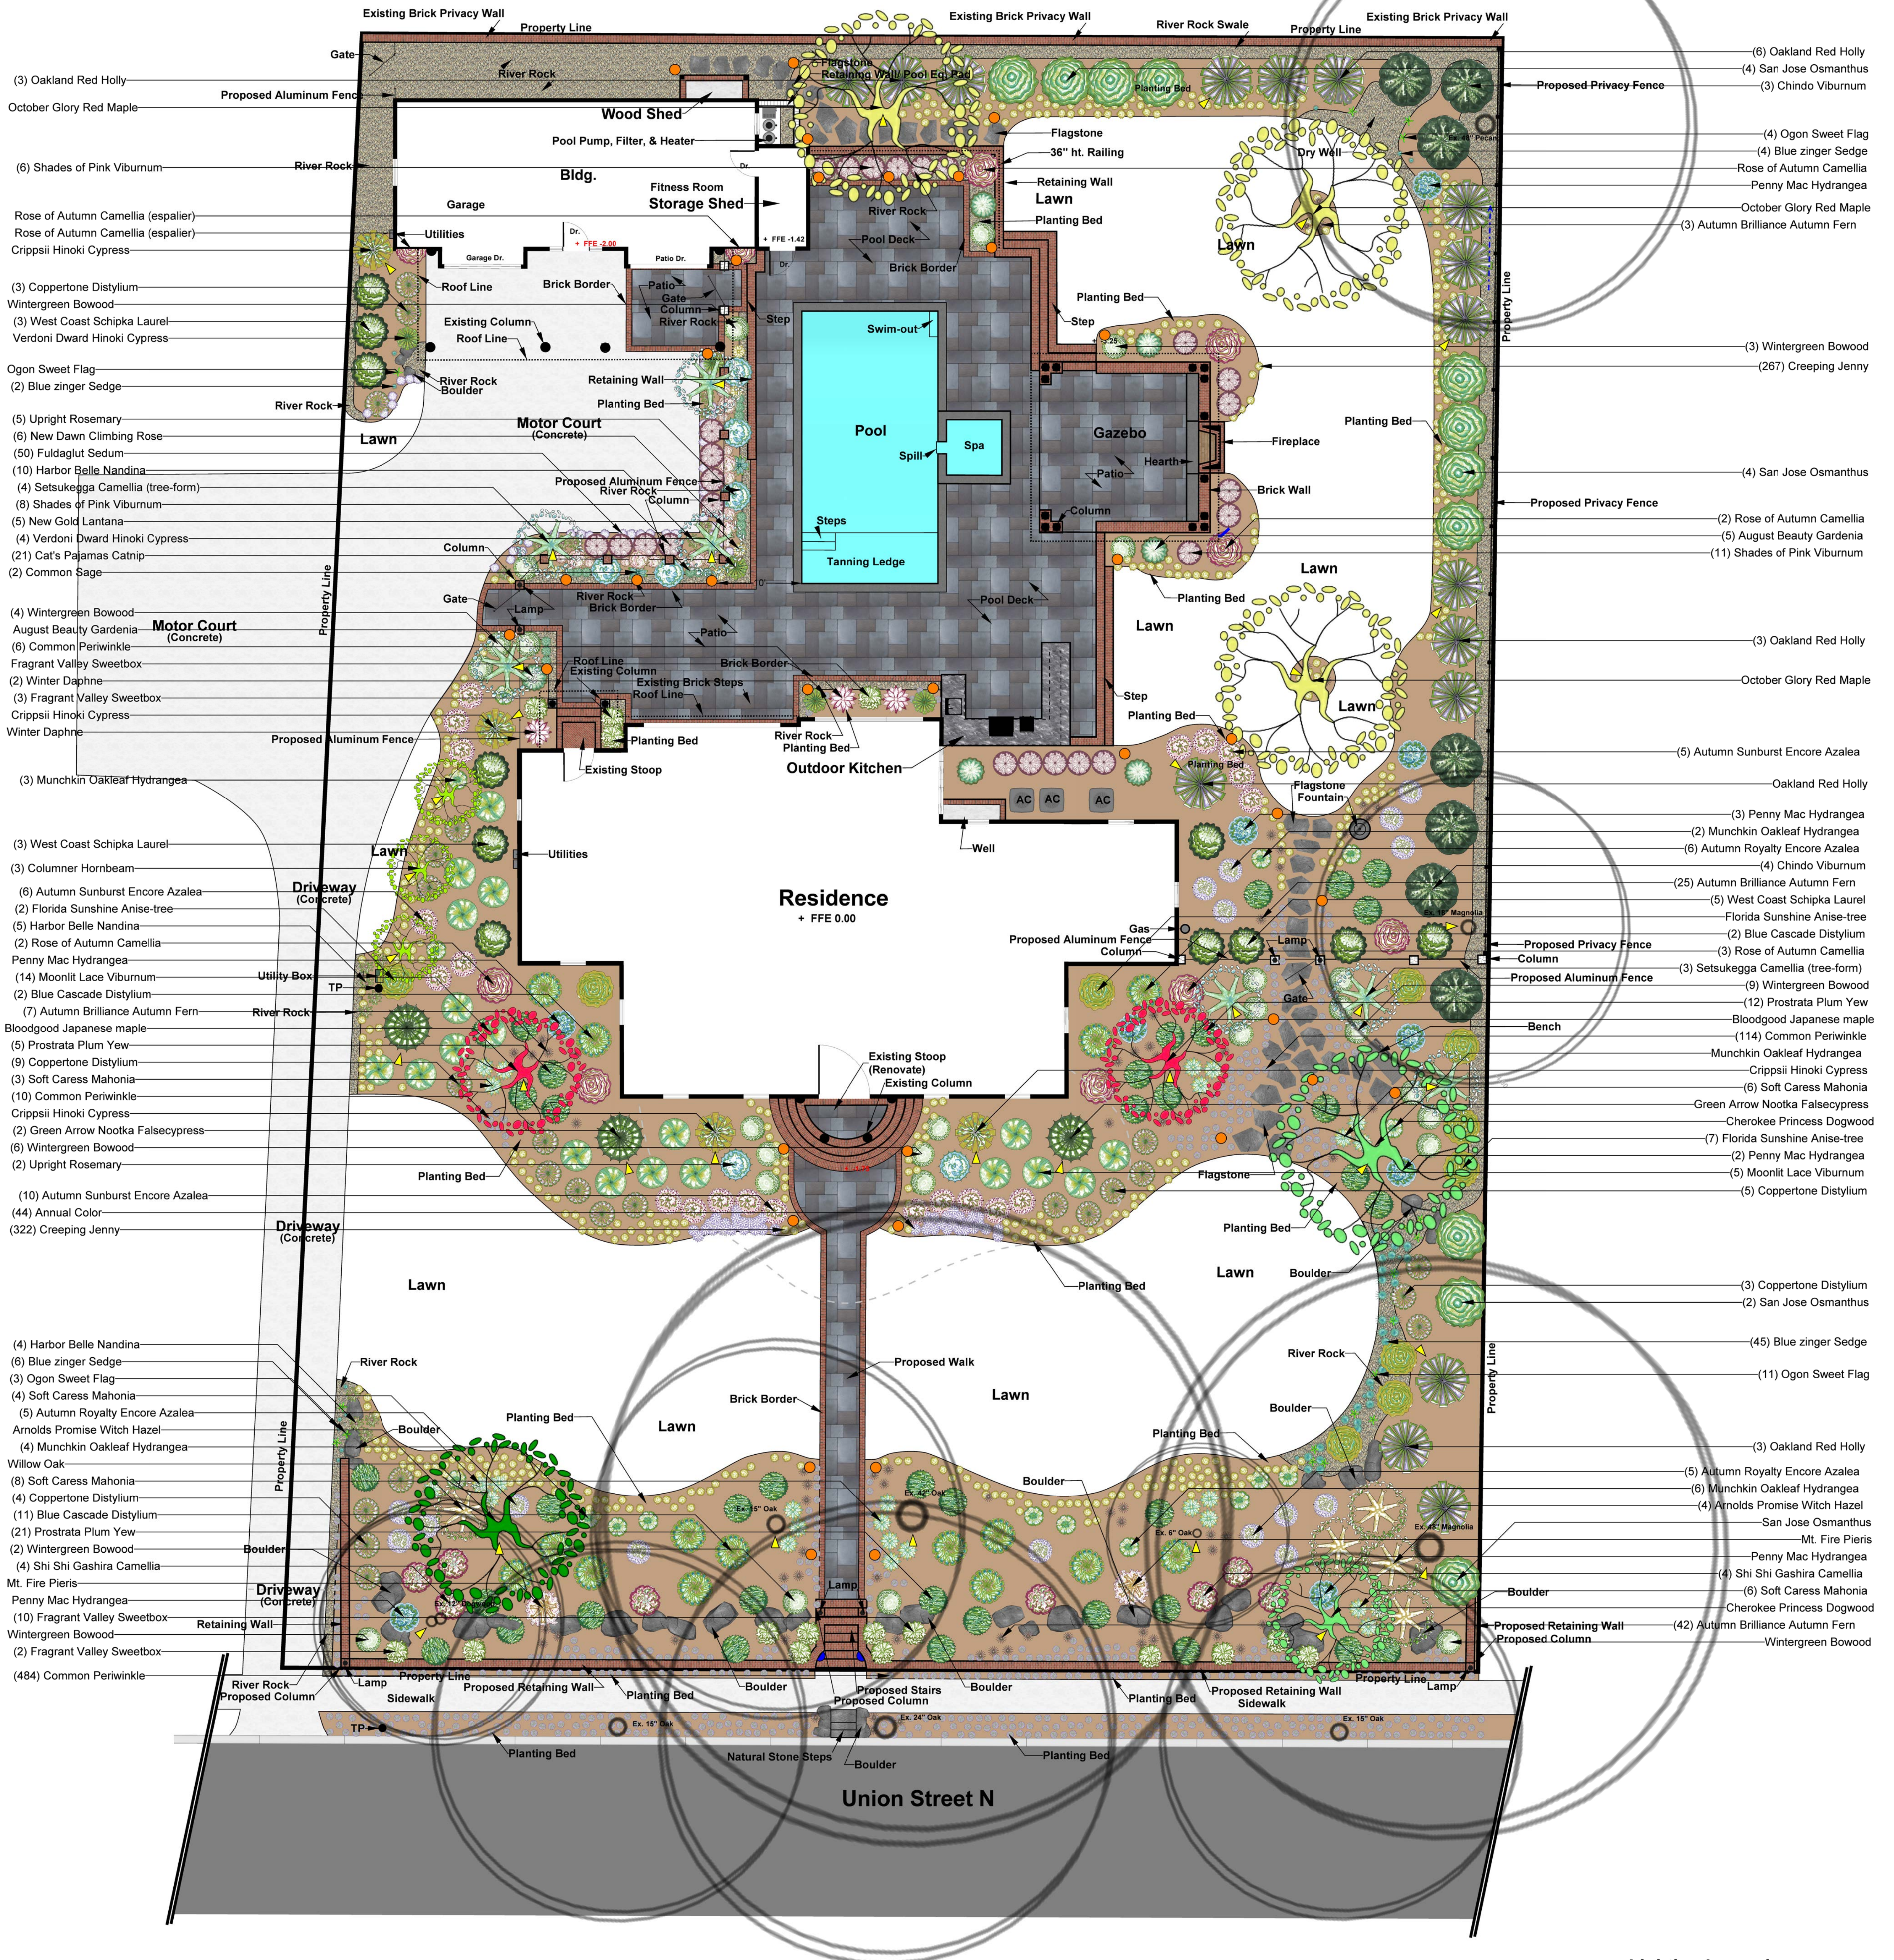
- (3) Oakland Red Holly
- October Glory Red Maple
- (6) Shades of Pink Viburnum
- Rose of Autumn Camellia (espalier)
- Rose of Autumn Camellia (espalier)
- Crippsii Hinoki Cypress

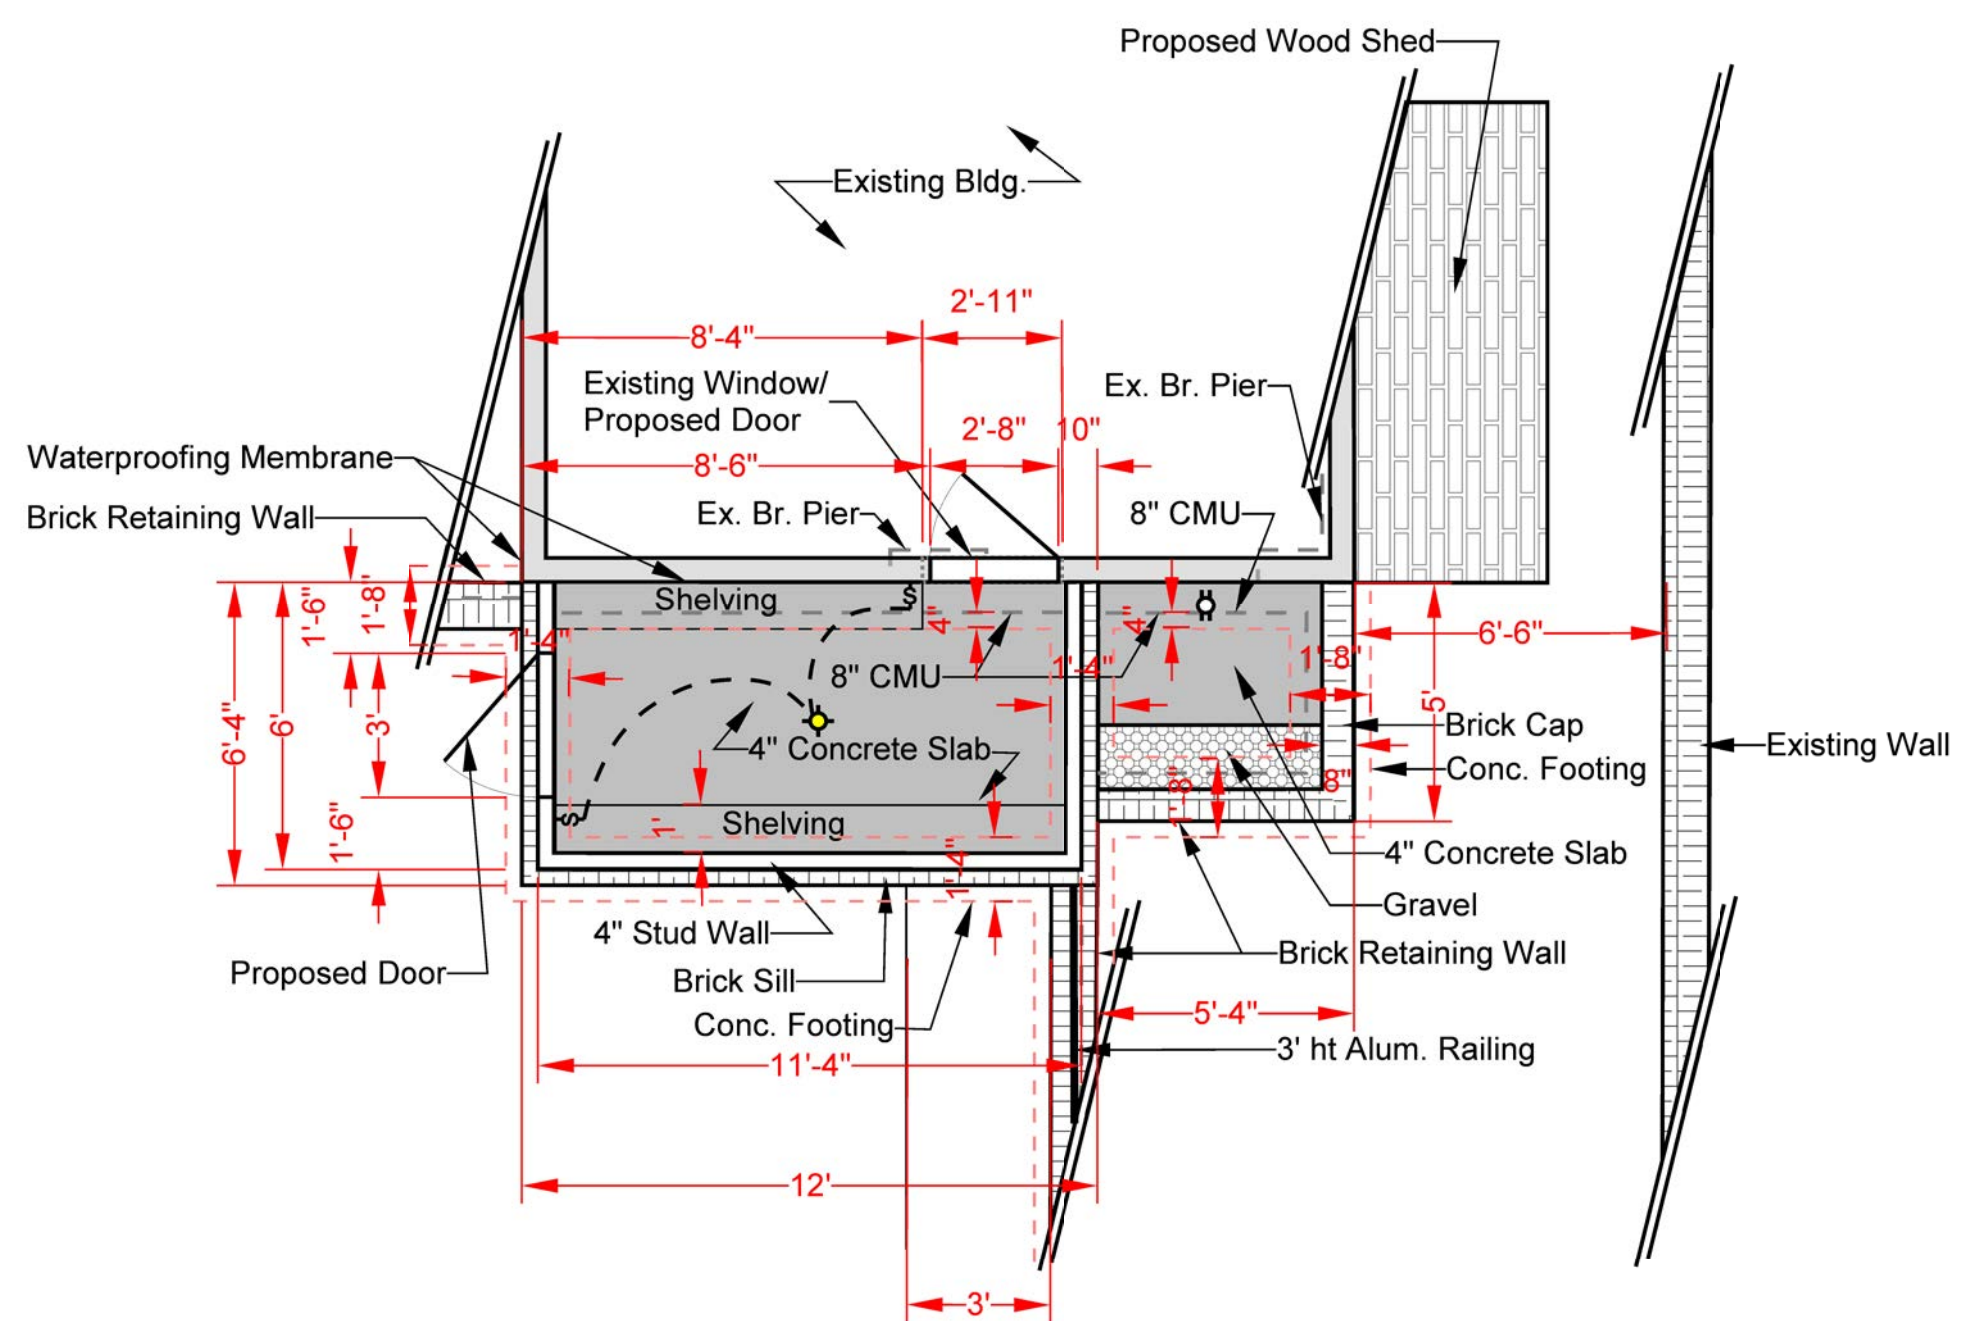
(Not for Construction)  
Storage Shed Plan View

- A storage shed will be located adjacent to the existing garage building and will be 12' w x 7' l x 10'6" h with asphalt shingles, fascia, gutters and clapboard siding. There will be an 8" concrete masonry unit (CMU) foundation on concrete footing, mortar filled, with brick veneered exposed walls and caps.
- A woodshed will be 10' w x 3'3" l x 9'4" h, located to the rear of the existing garage building, with asphalt shingles, fascia, and clapboard siding. There will be pressure treated pine beam and framing over 6" x 6" pressure treated pine posts on concrete slab and footing. A proposed 3' high x 33' long black aluminum railing will be centered and cored on top of the brick veneered wall cap at the back of the woodshed (Exhibit D).

**Storage Shed- Roof Shingles (to match residence), Fascia (to match residence), Gutters (to match residence), Clapboard Siding (to match garage/exercise bldg.), 8" CMU Foundation on Concrete Footing, Mortar Filled, w/ Brick Veneered Exposed Walls and Caps (to match residence).**  
(see details)

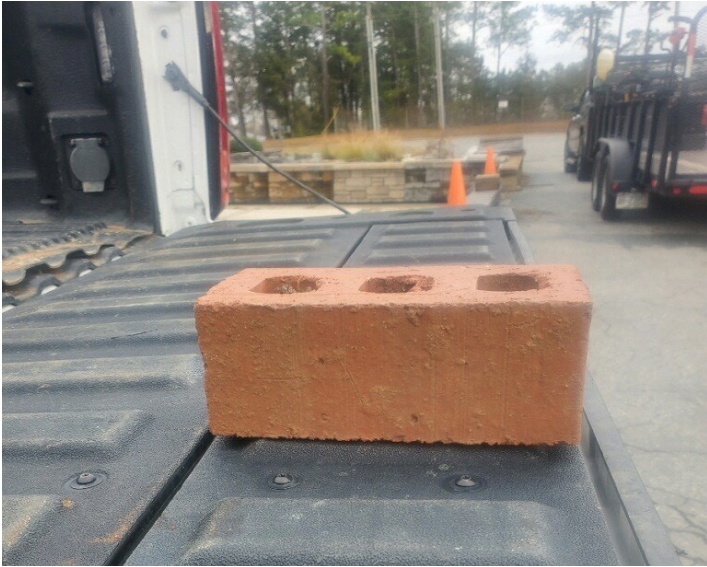
This color brick will be used for the whole project. We are having it made to match existing brick.

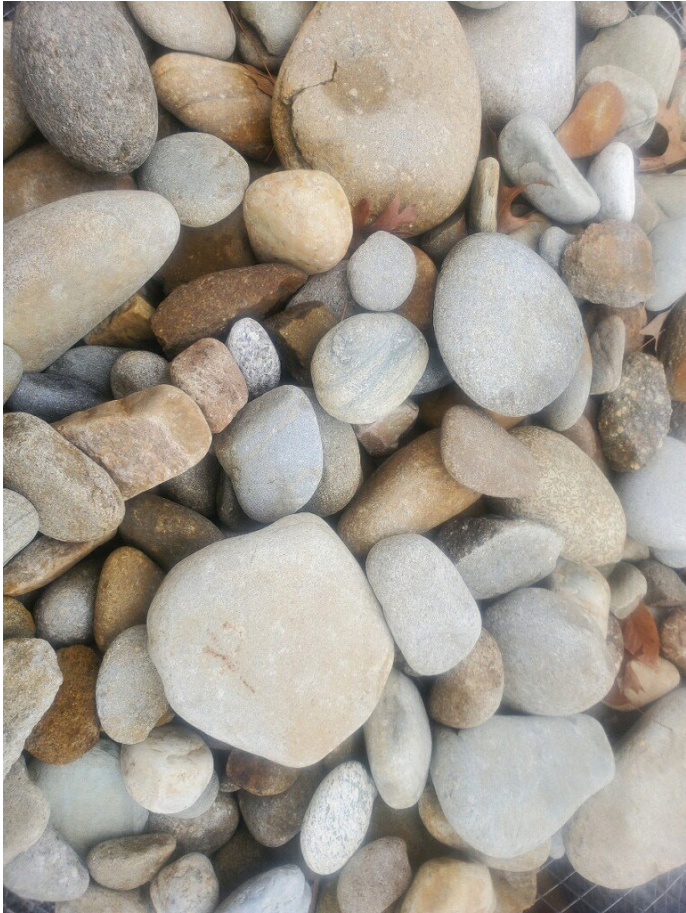
River rock to be used

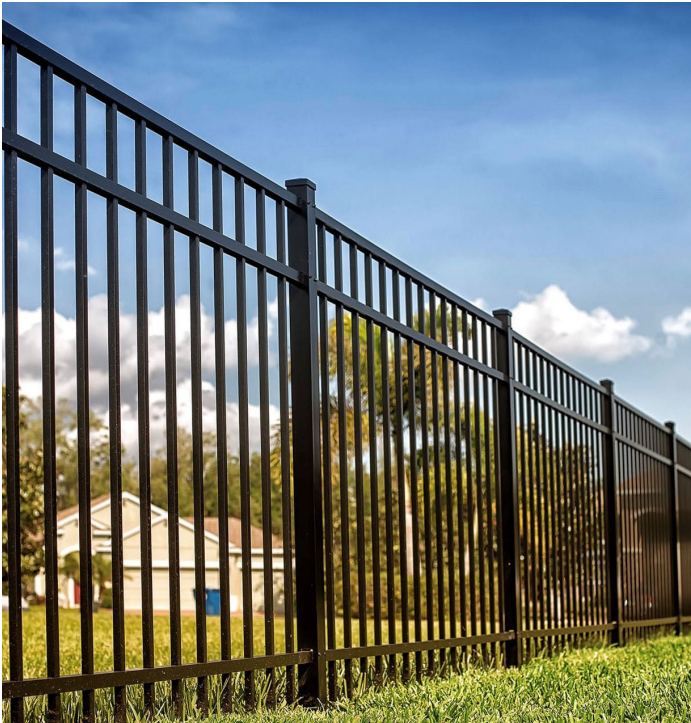
Fence: 54" high x 6' long panels  
Gates: 54" x 4'

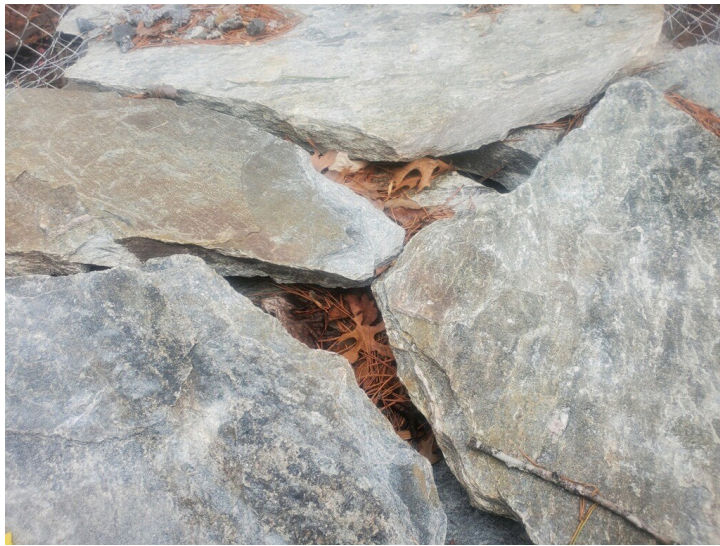
Flagstone to be used

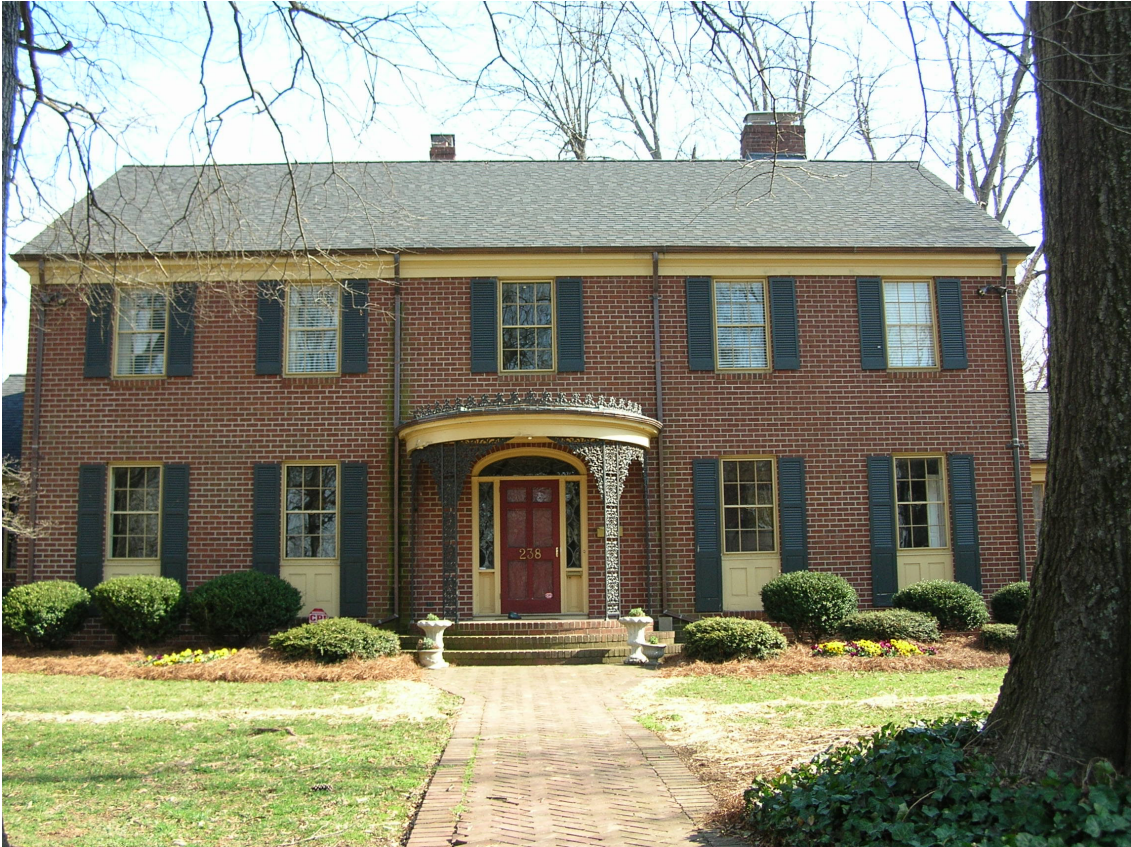
Inventory Photo: Front of house showing walkway and stoop

**Front Entrance Stoop- Renovate, replace Terra cotta mosaic w/ Full Color Cleft Patterned Bluestone, Mortar set. Brick Treads & Risers replace, or point-up, as needed.**
