**DATE:** June 13, 2018

<u>Certificate of Appropriateness Request:</u>	H-07-18
<u>Applicant:</u>	James David Ford
<u>Location of subject property:</u>	229 Union St N
<u>Staff Report prepared by:</u>	Scott Sherrill, Sr. Planner

- The subject property is site of a “Contributing” structure and is located in the North Union Street Historic District. (Exhibit A)
- Date of home construction: 1907
- Picturesque, two-story, frame Queen Anne style residence with charming porch. House has L-shaped form characteristic of Queen Anne style designs with two-story gable-front wing projecting forward of hip-roofed main block. The house has a strong vertical emphasis created by the narrow, two-bay façade. The tall 1/1 sash windows, and the high, nearly pyramidal hip roof. The porch shelters the south (left) bay and one bay of the south side – a circular pavilion with a witch’s cap roof and a finial adjoins the corner of the porch.
- Applicant is seeking after the fact approval for a tree pruning and approval for a fence installation.

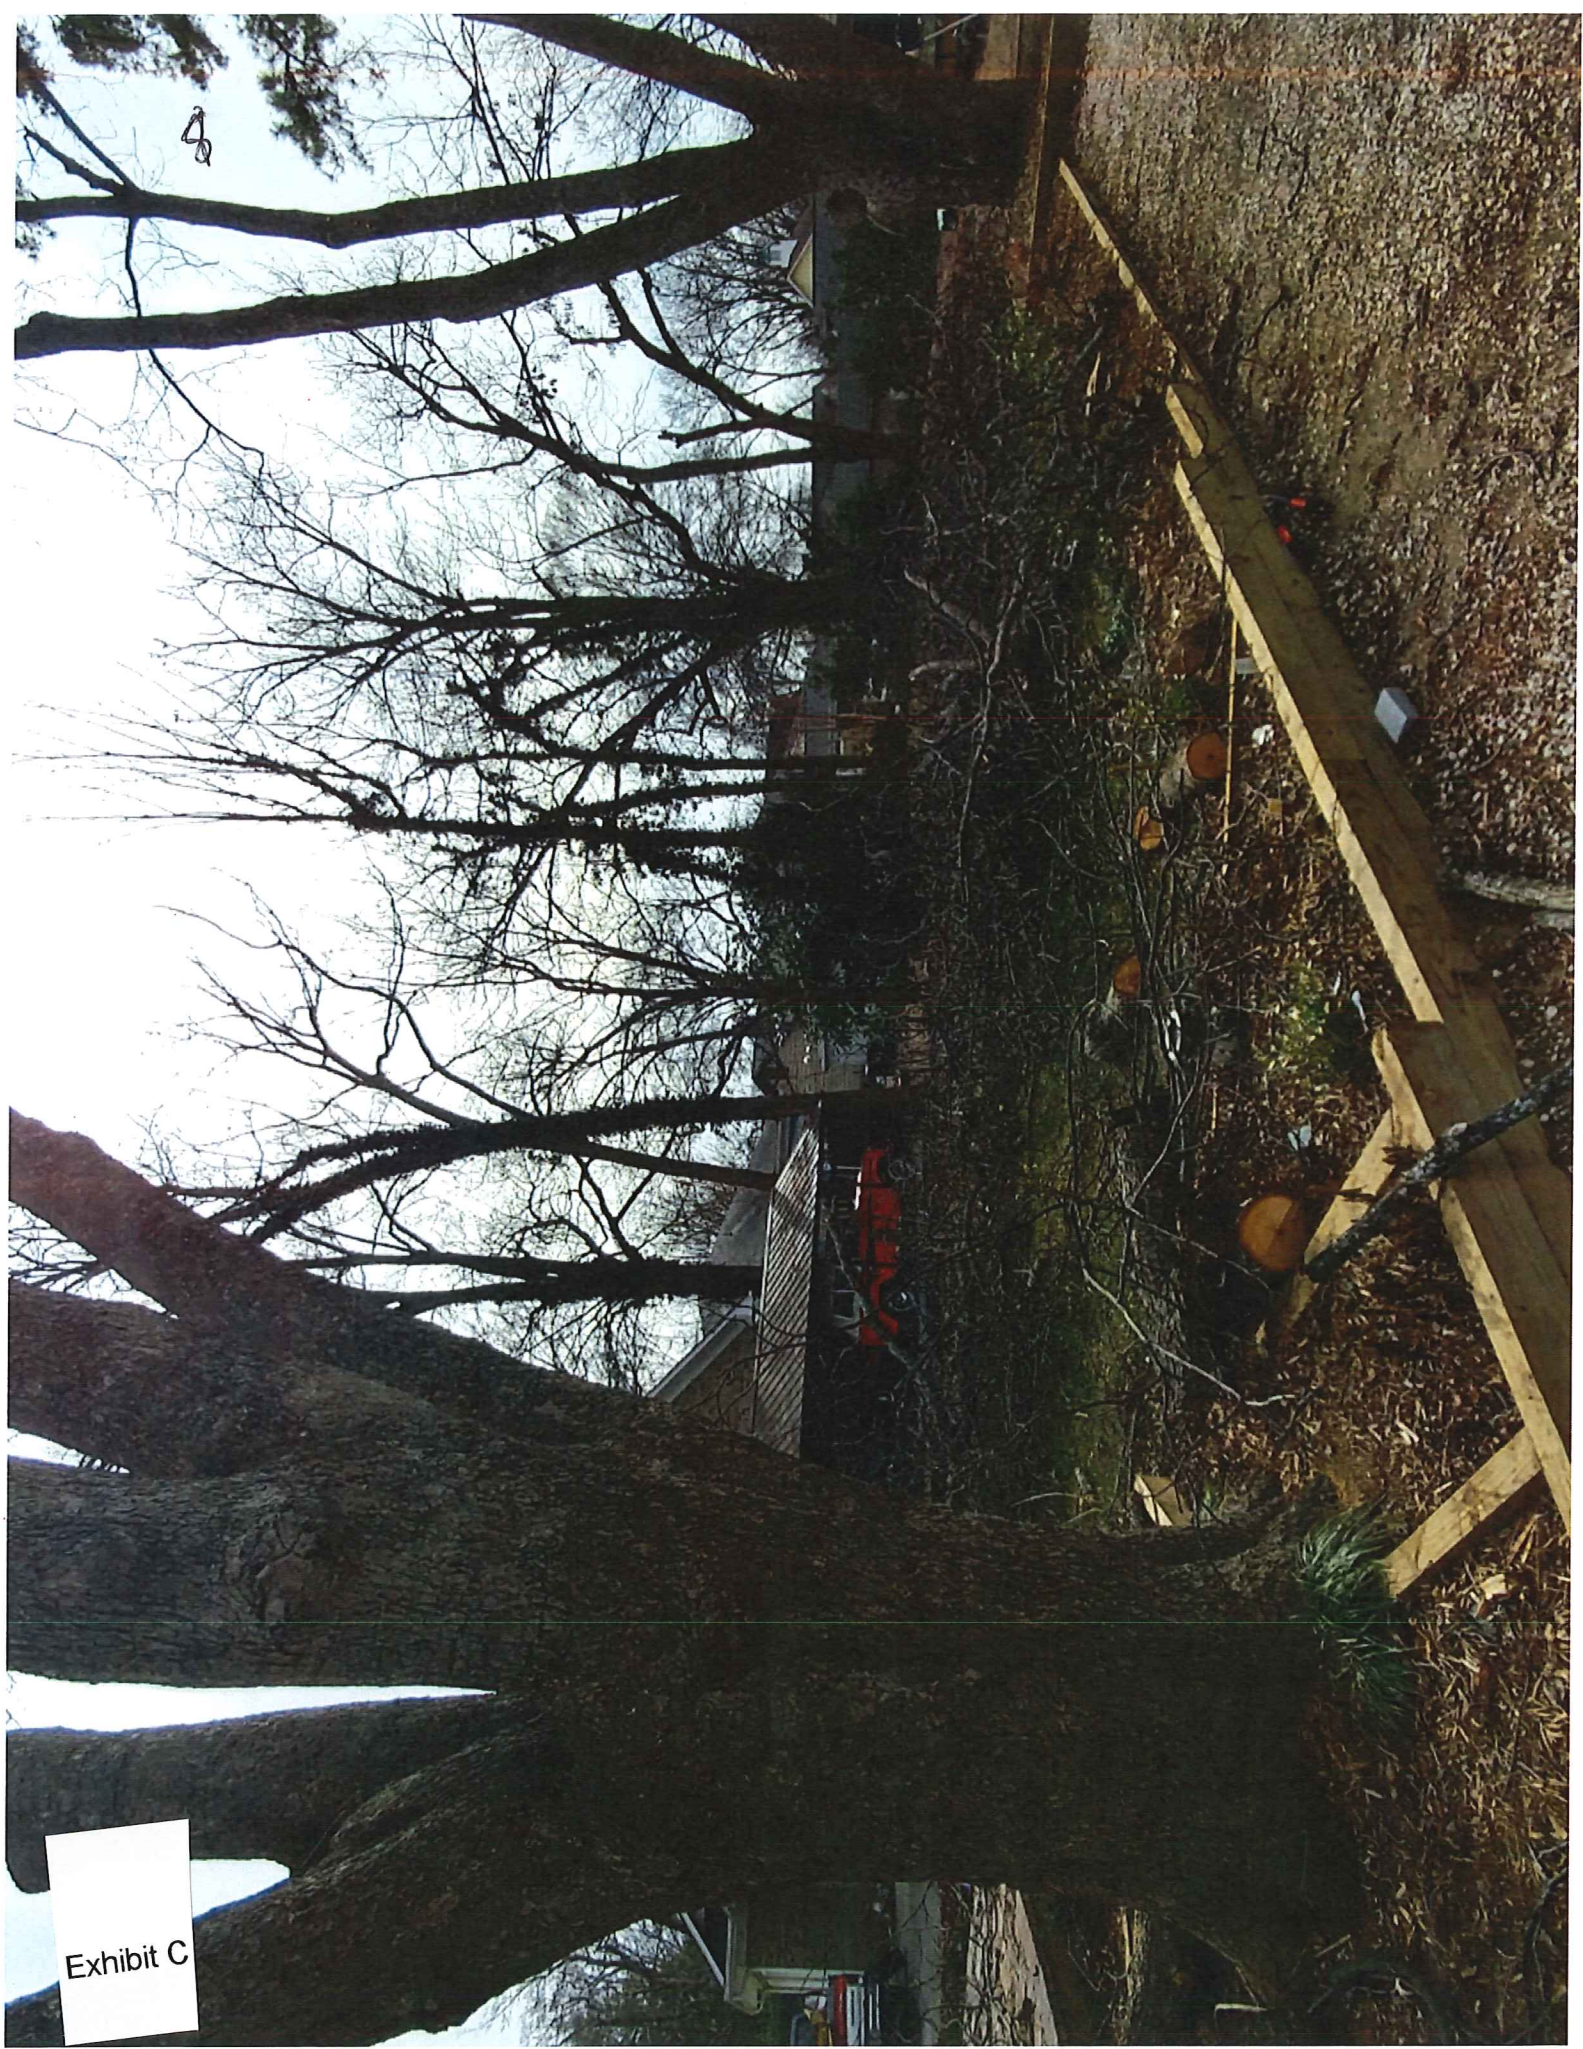
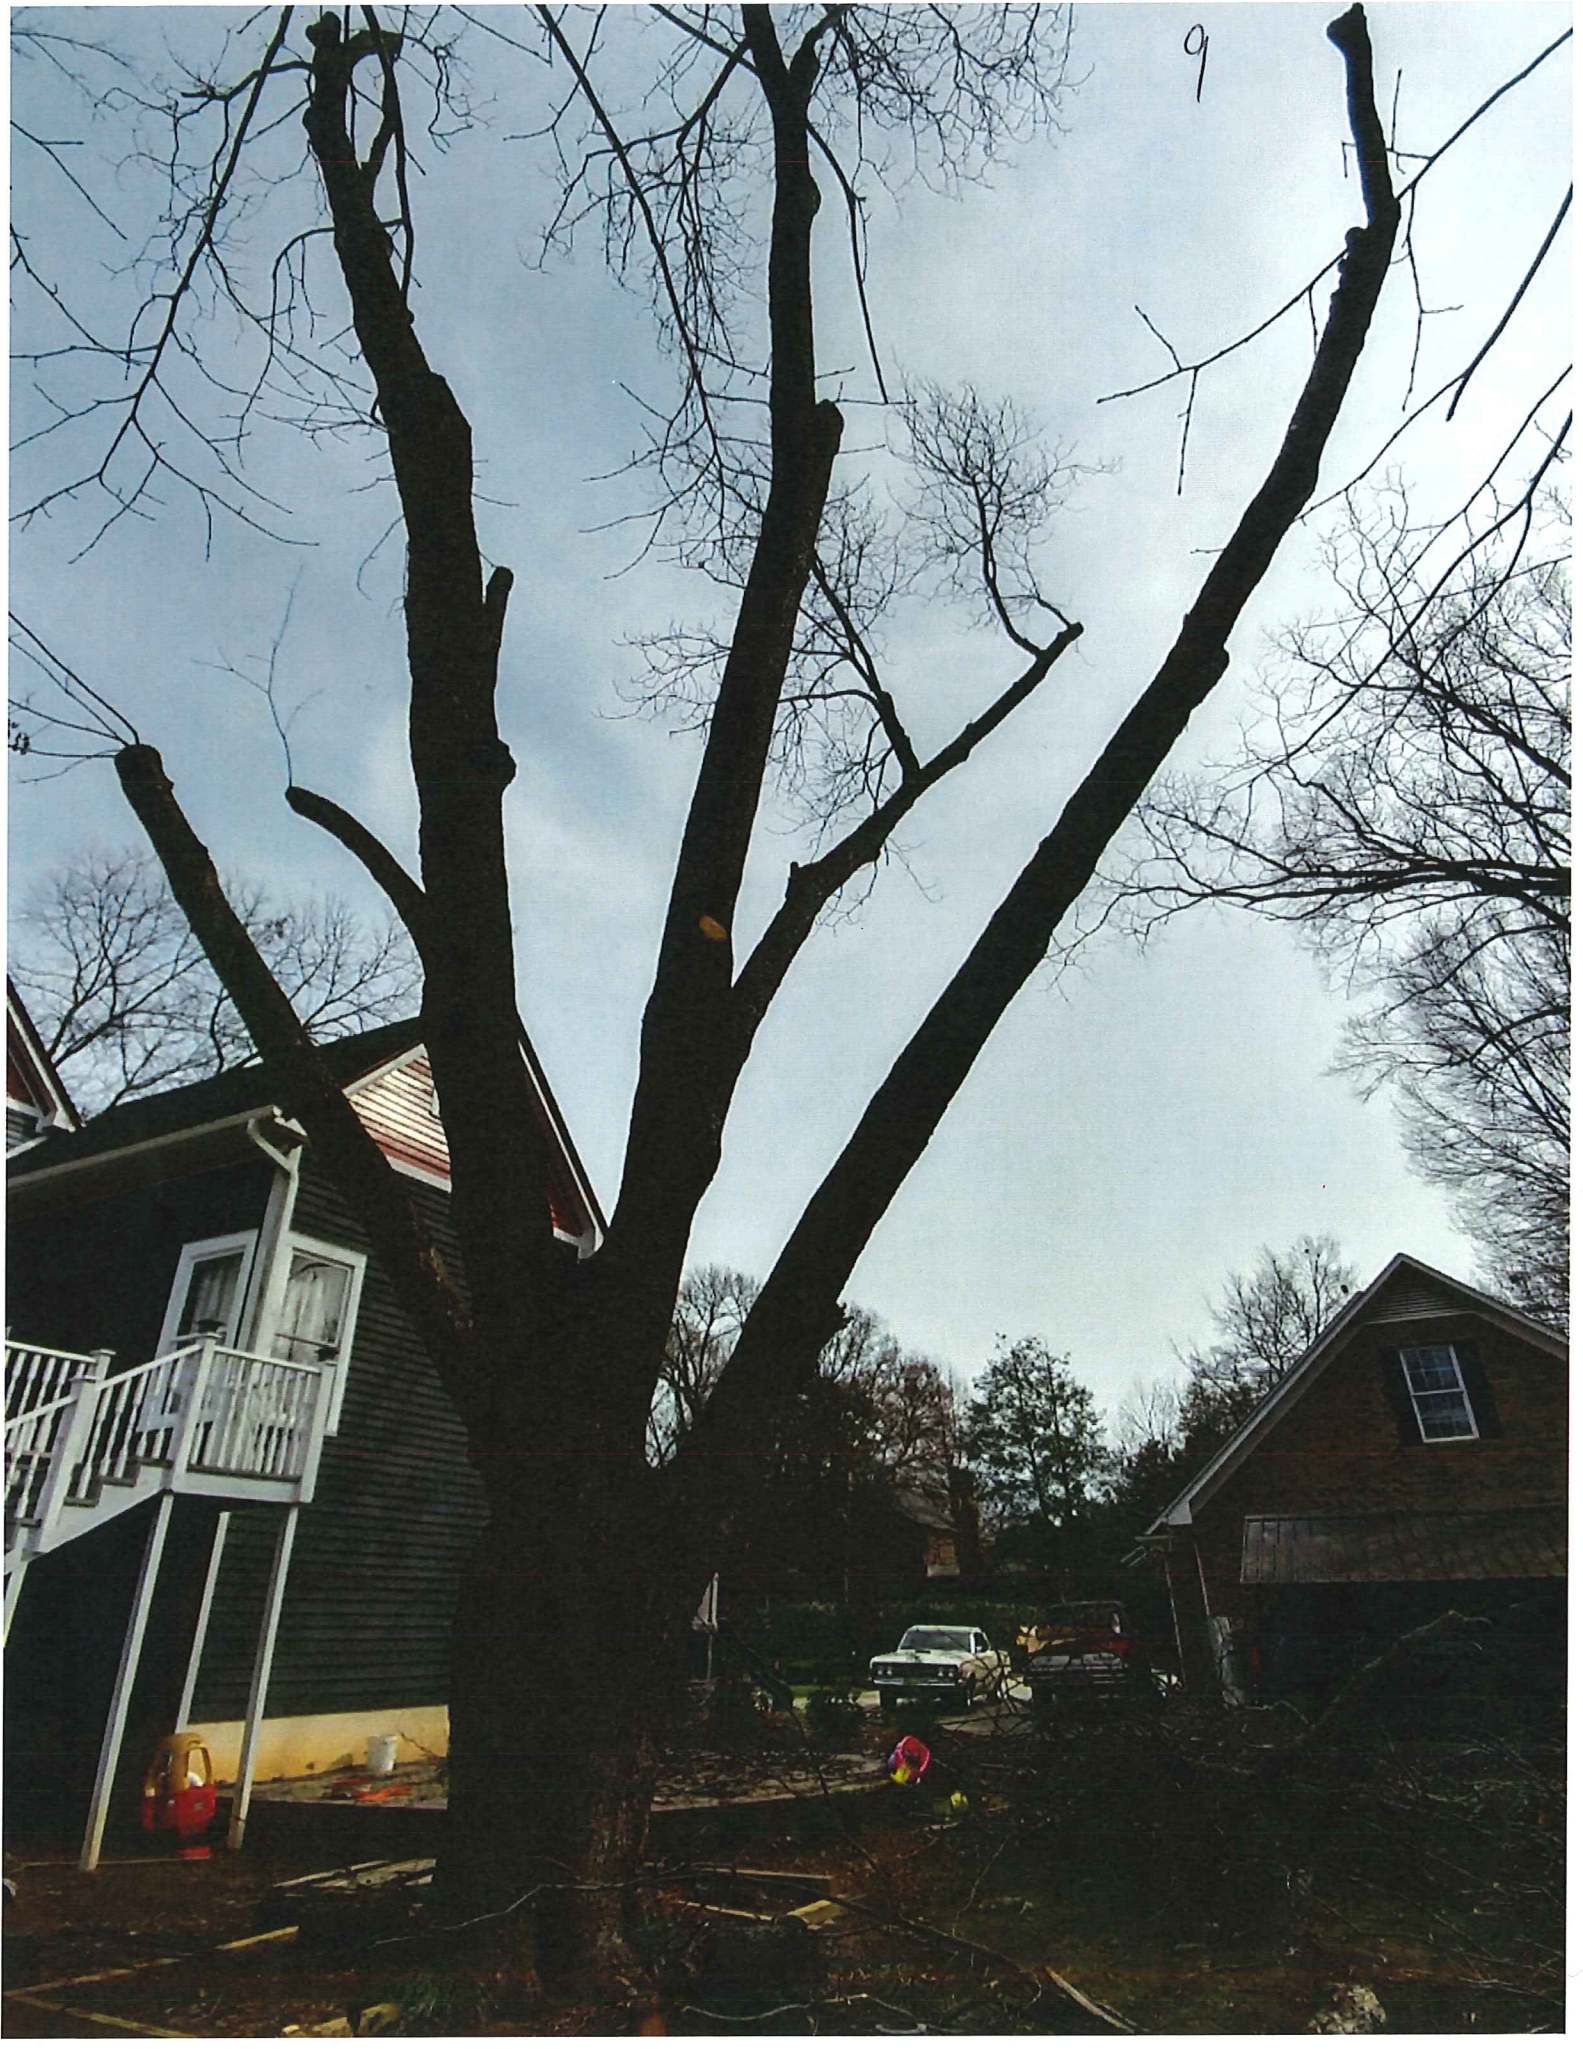
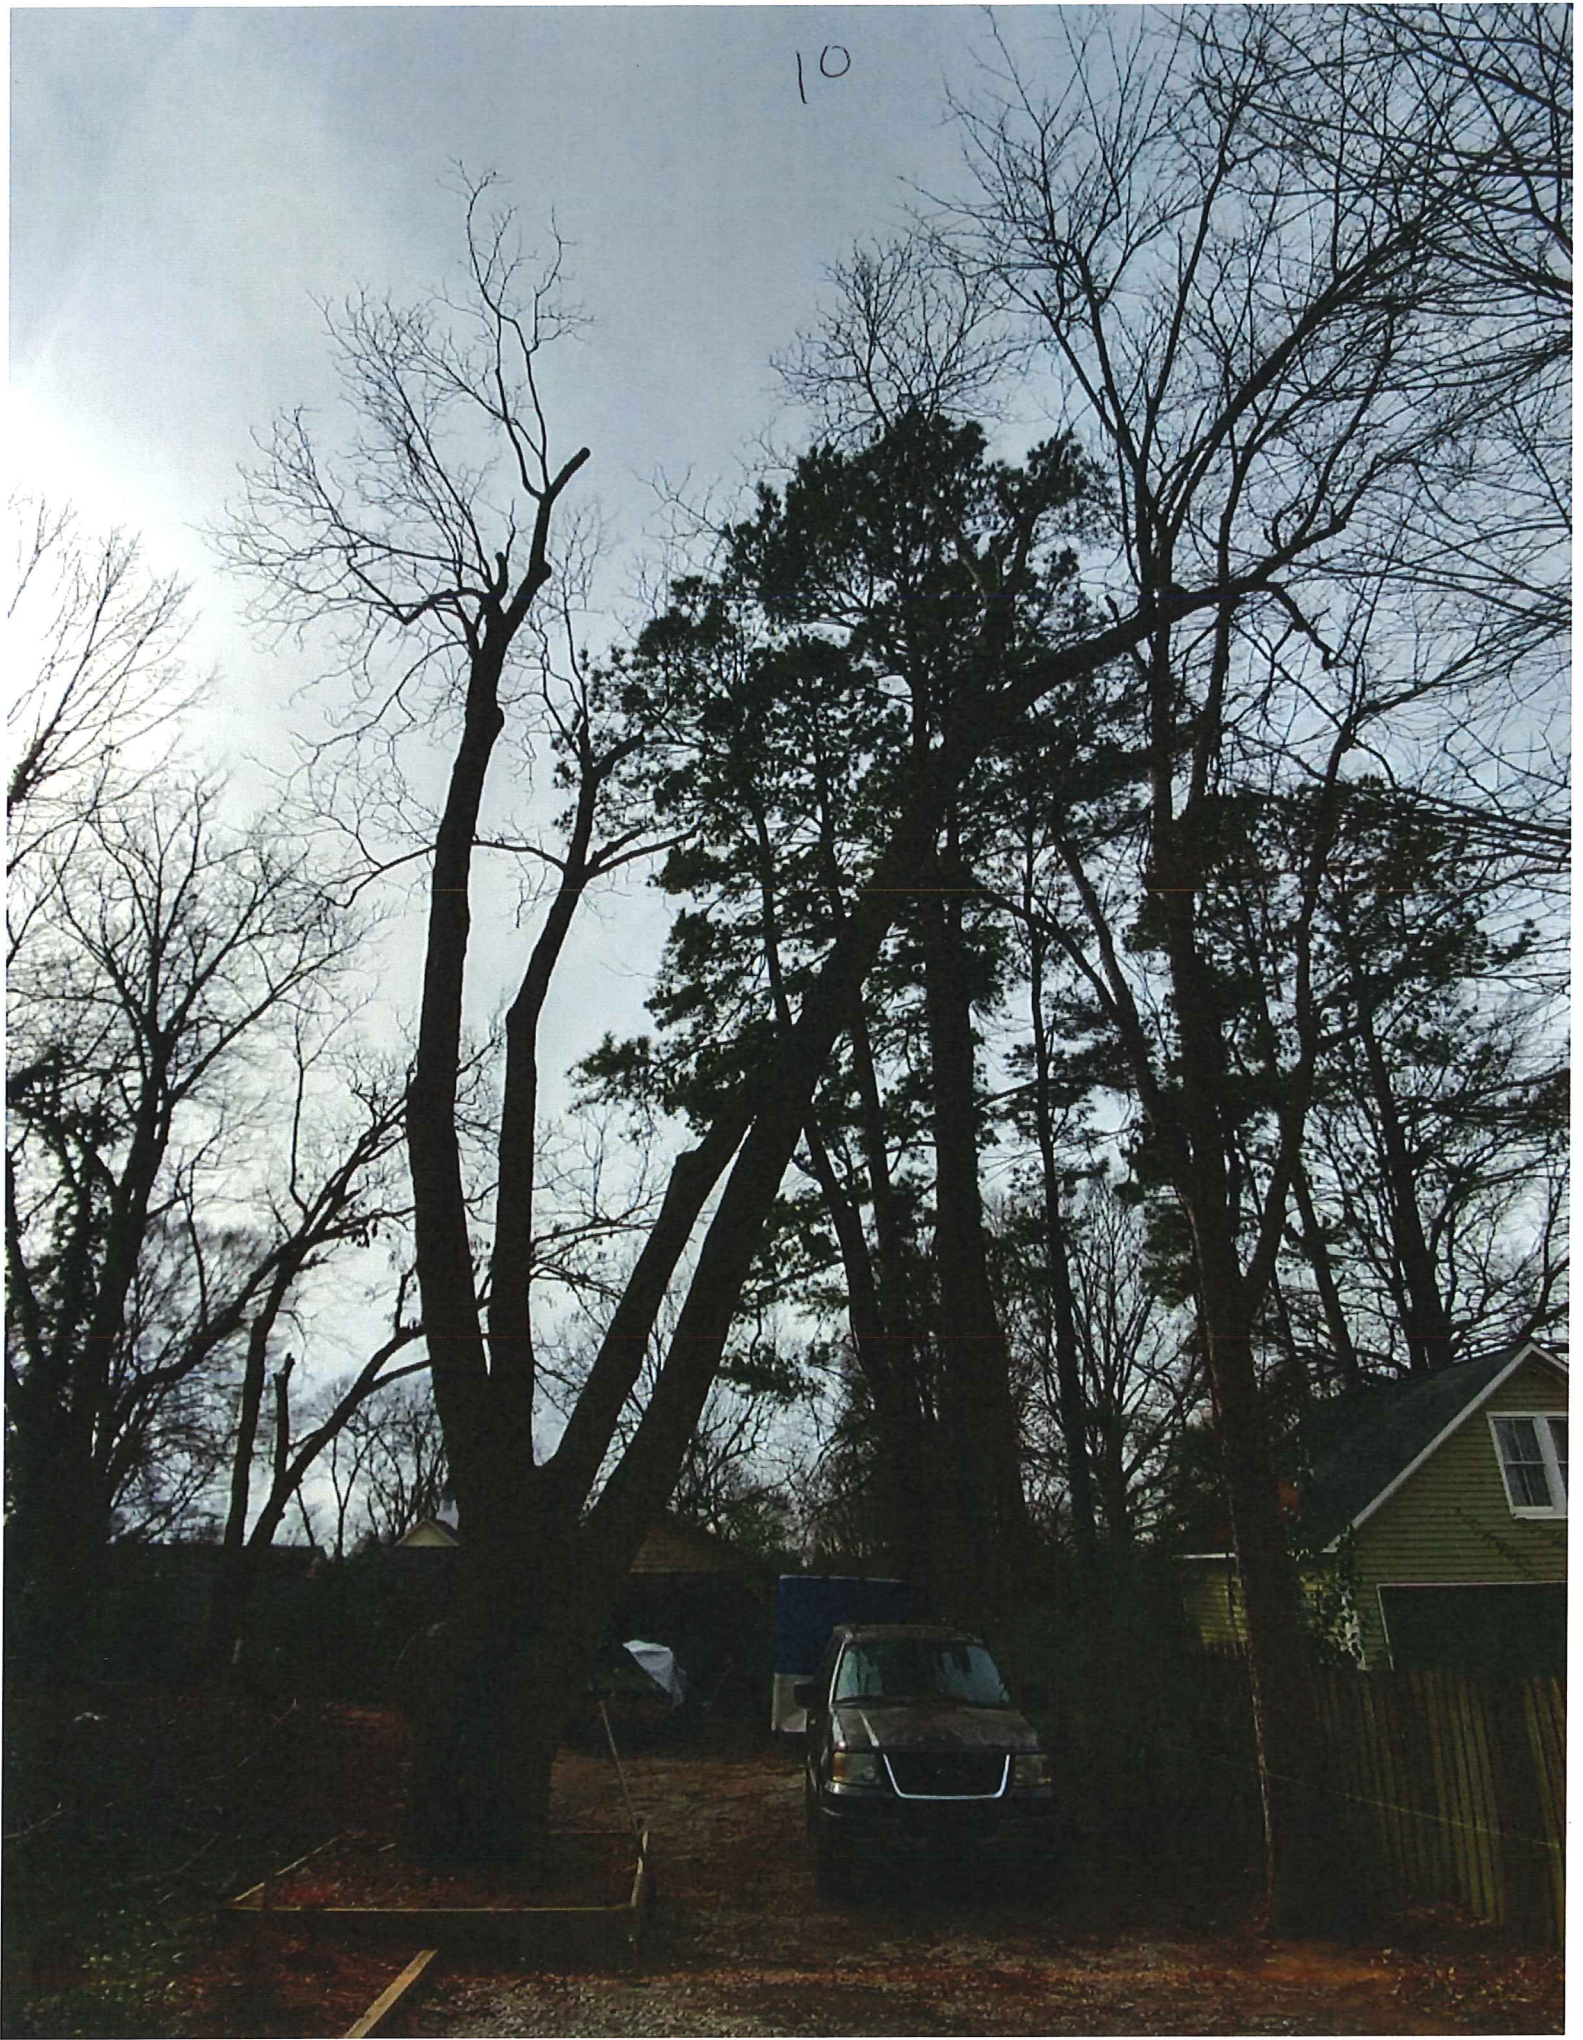
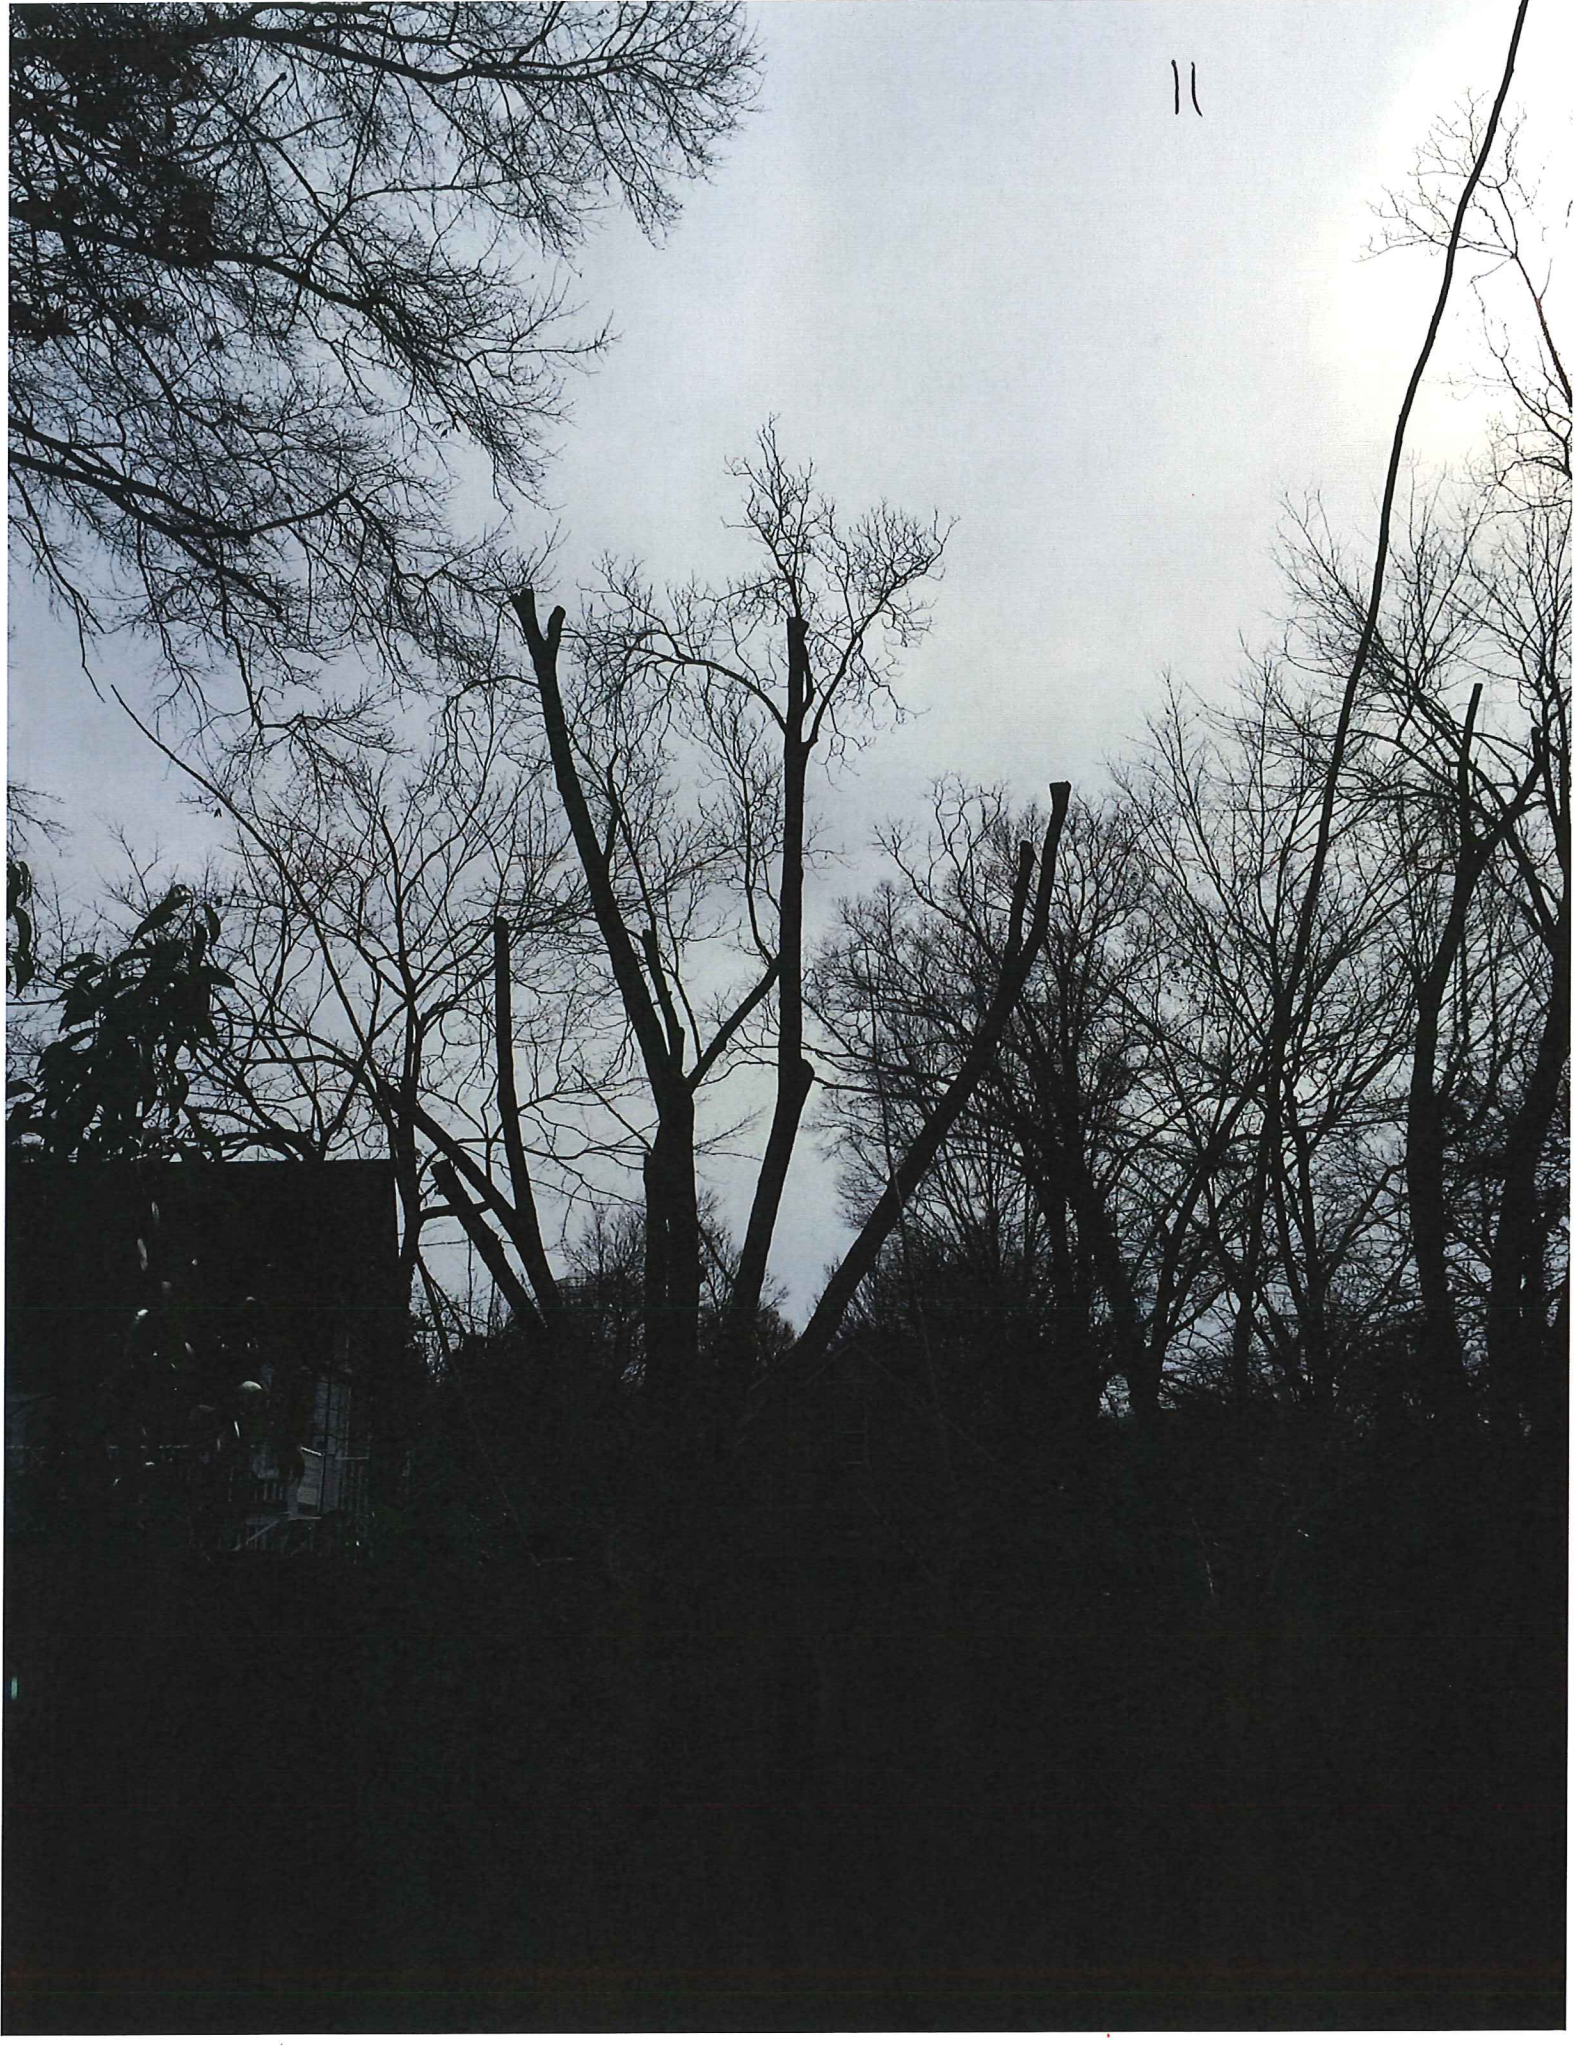
Exhibit C

An in-house approval was issued for the removal and replacement of a pecan tree with a 4 foot trunk diameter on October 21, 2013. The work for which the certificate of appropriateness was issued was never completed, but on or around January 22, 2018, city staff and code enforcement observed that tree limbs had been pruned without receiving the proper authorization, necessitating after the fact review. The Commission has two basic courses of action, it can deny the Certificate of Appropriateness, which would result in a notice of violation and a seven-day window to bring the property into compliance without incurring a fine—presumably by requesting a COA for staff approval of the removal, which would be granted. These COAs require replacement with a similar species. Or the Commission can grant the COA, but impose conditions on the approval, such as requiring the planting of additional trees.
