DATE: May 9, 2018

<u>Certificate of Appropriateness Request:</u>	H-07-18
<u>Applicant:</u>	James David Ford
<u>Location of subject property:</u>	229 Union St N
<u>Staff Report prepared by:</u>	Scott Sherrill, Sr. Planner

BACKGROUND:

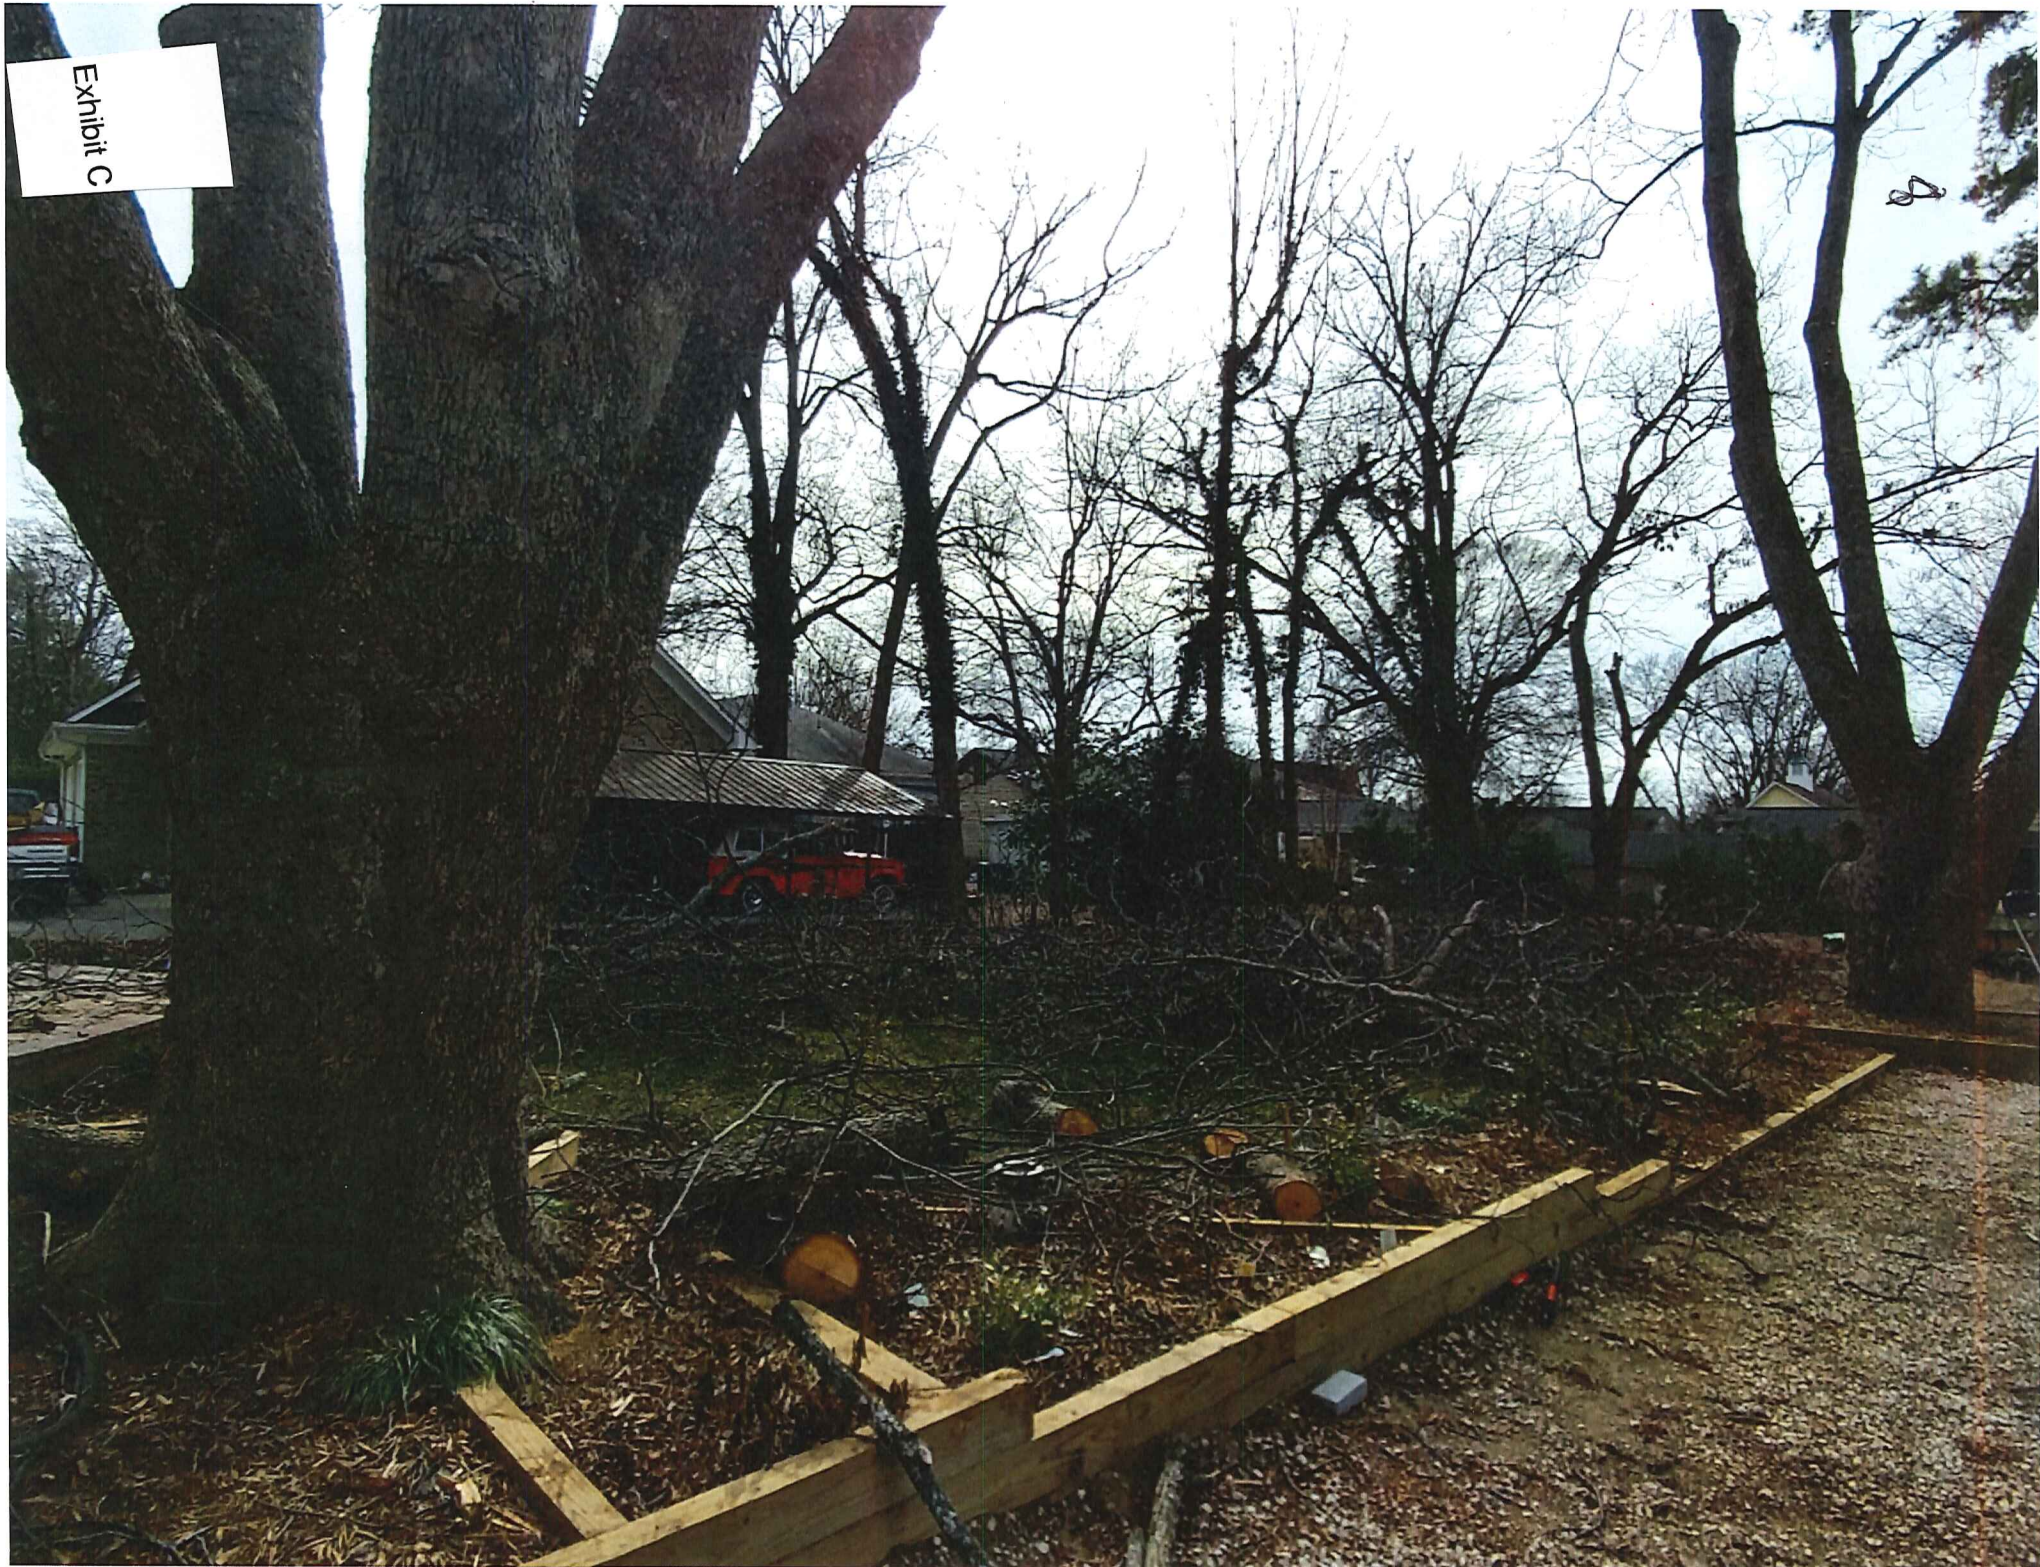
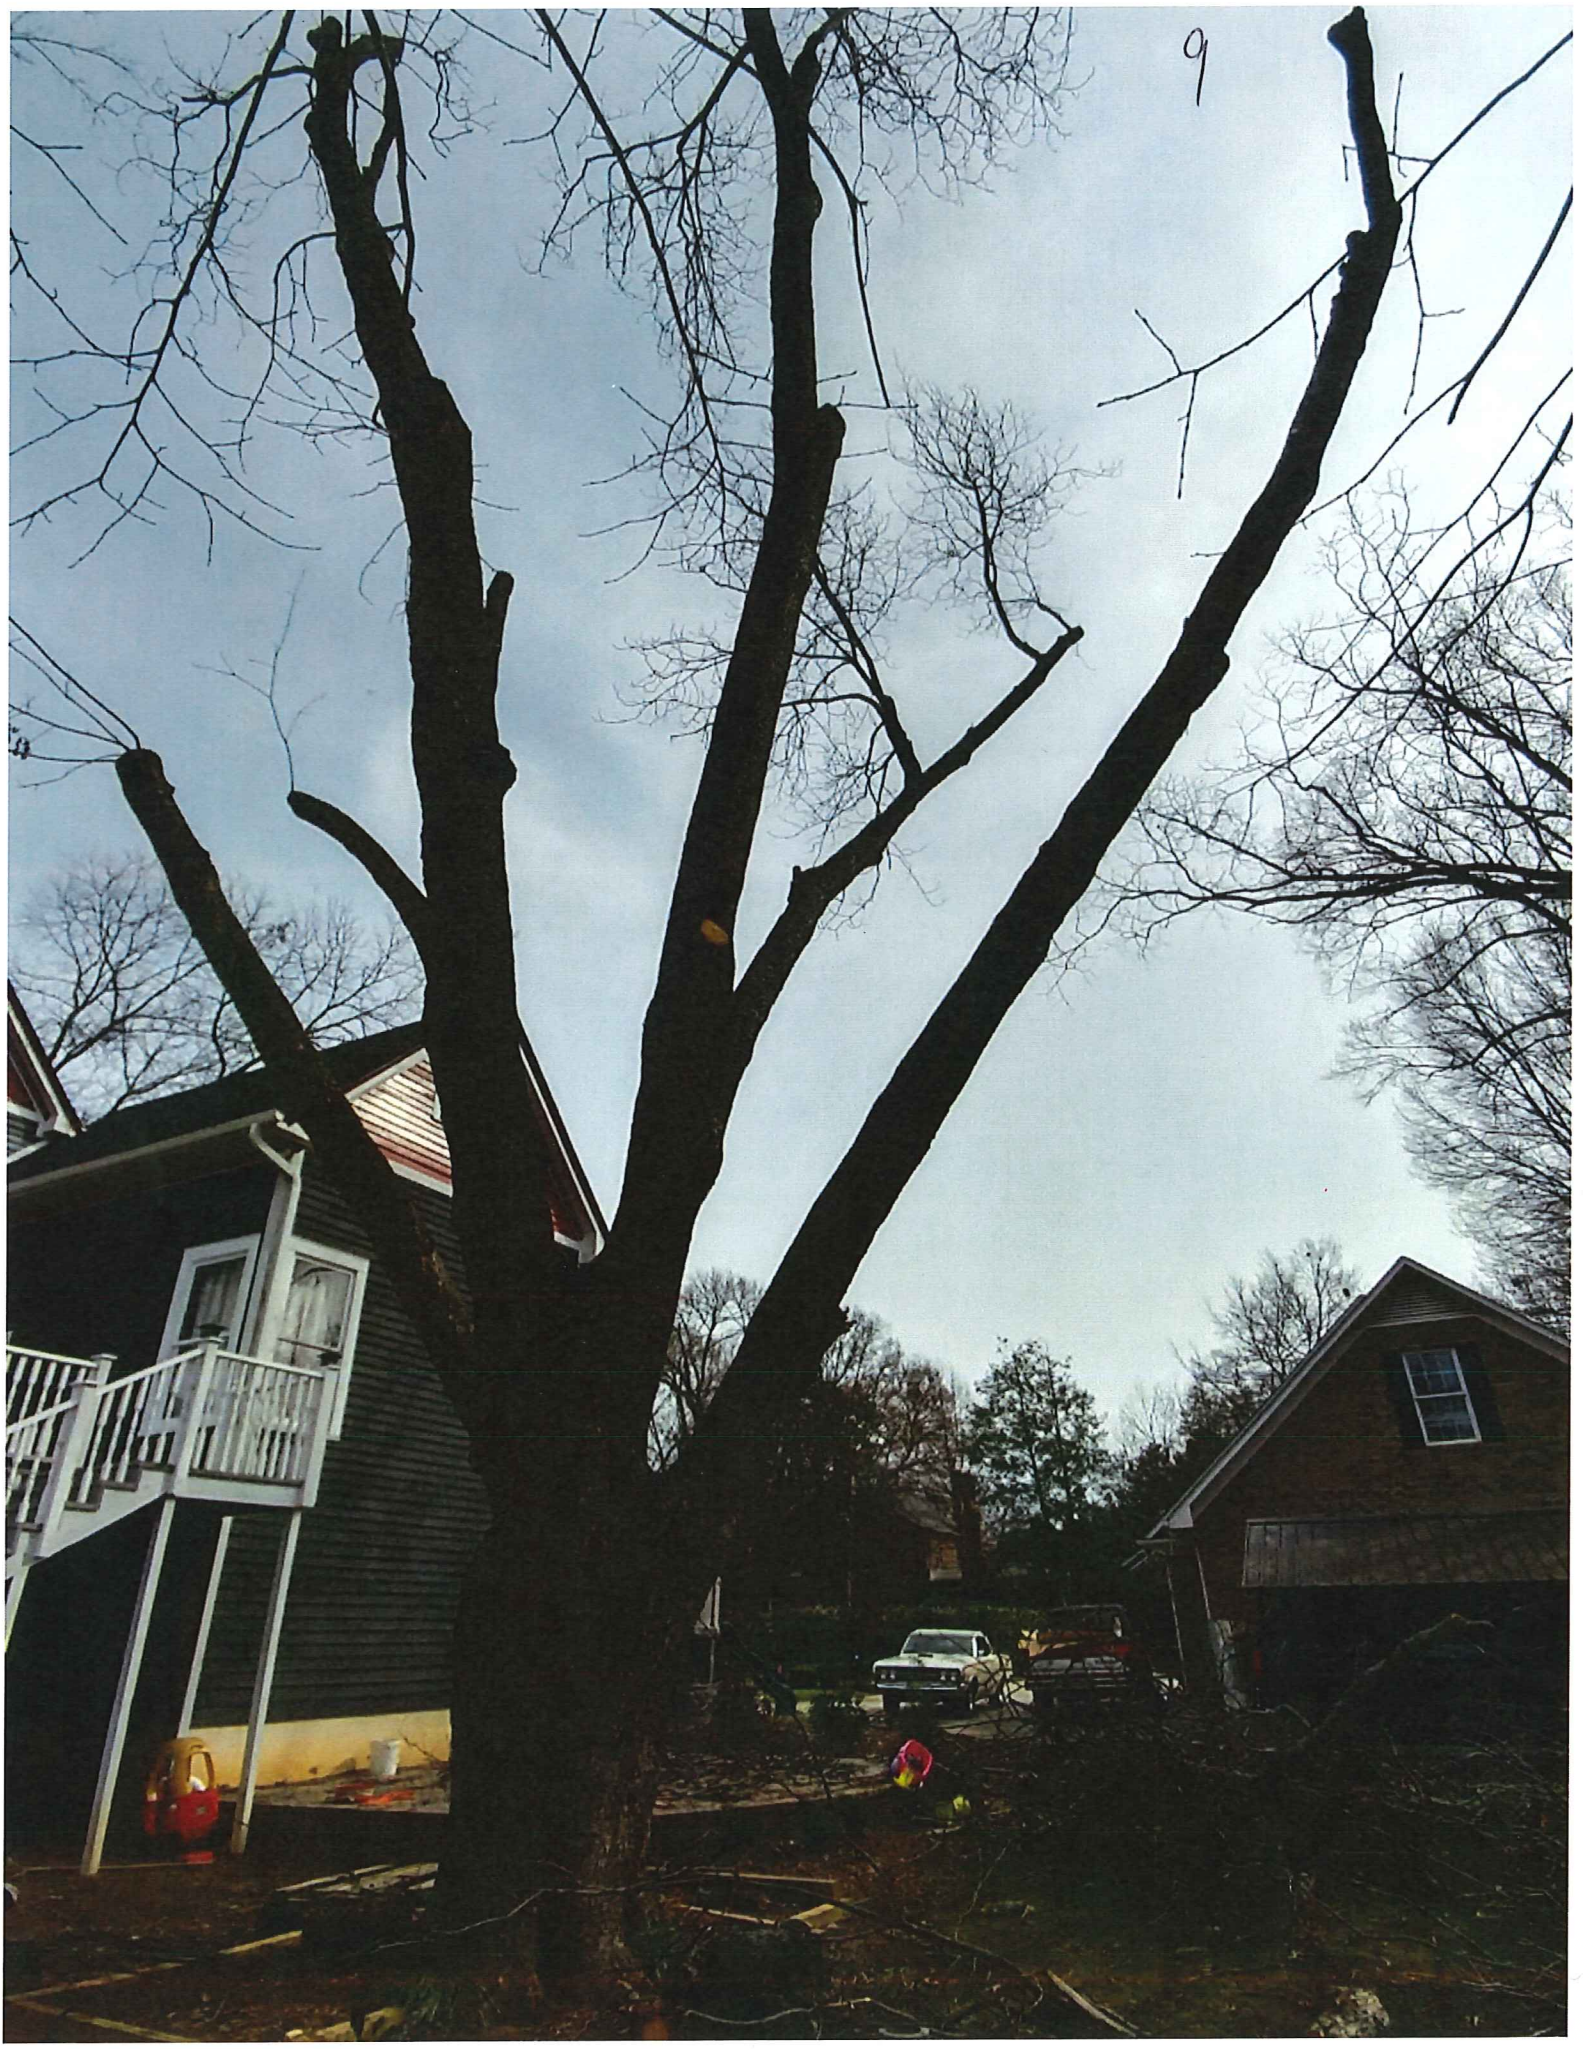
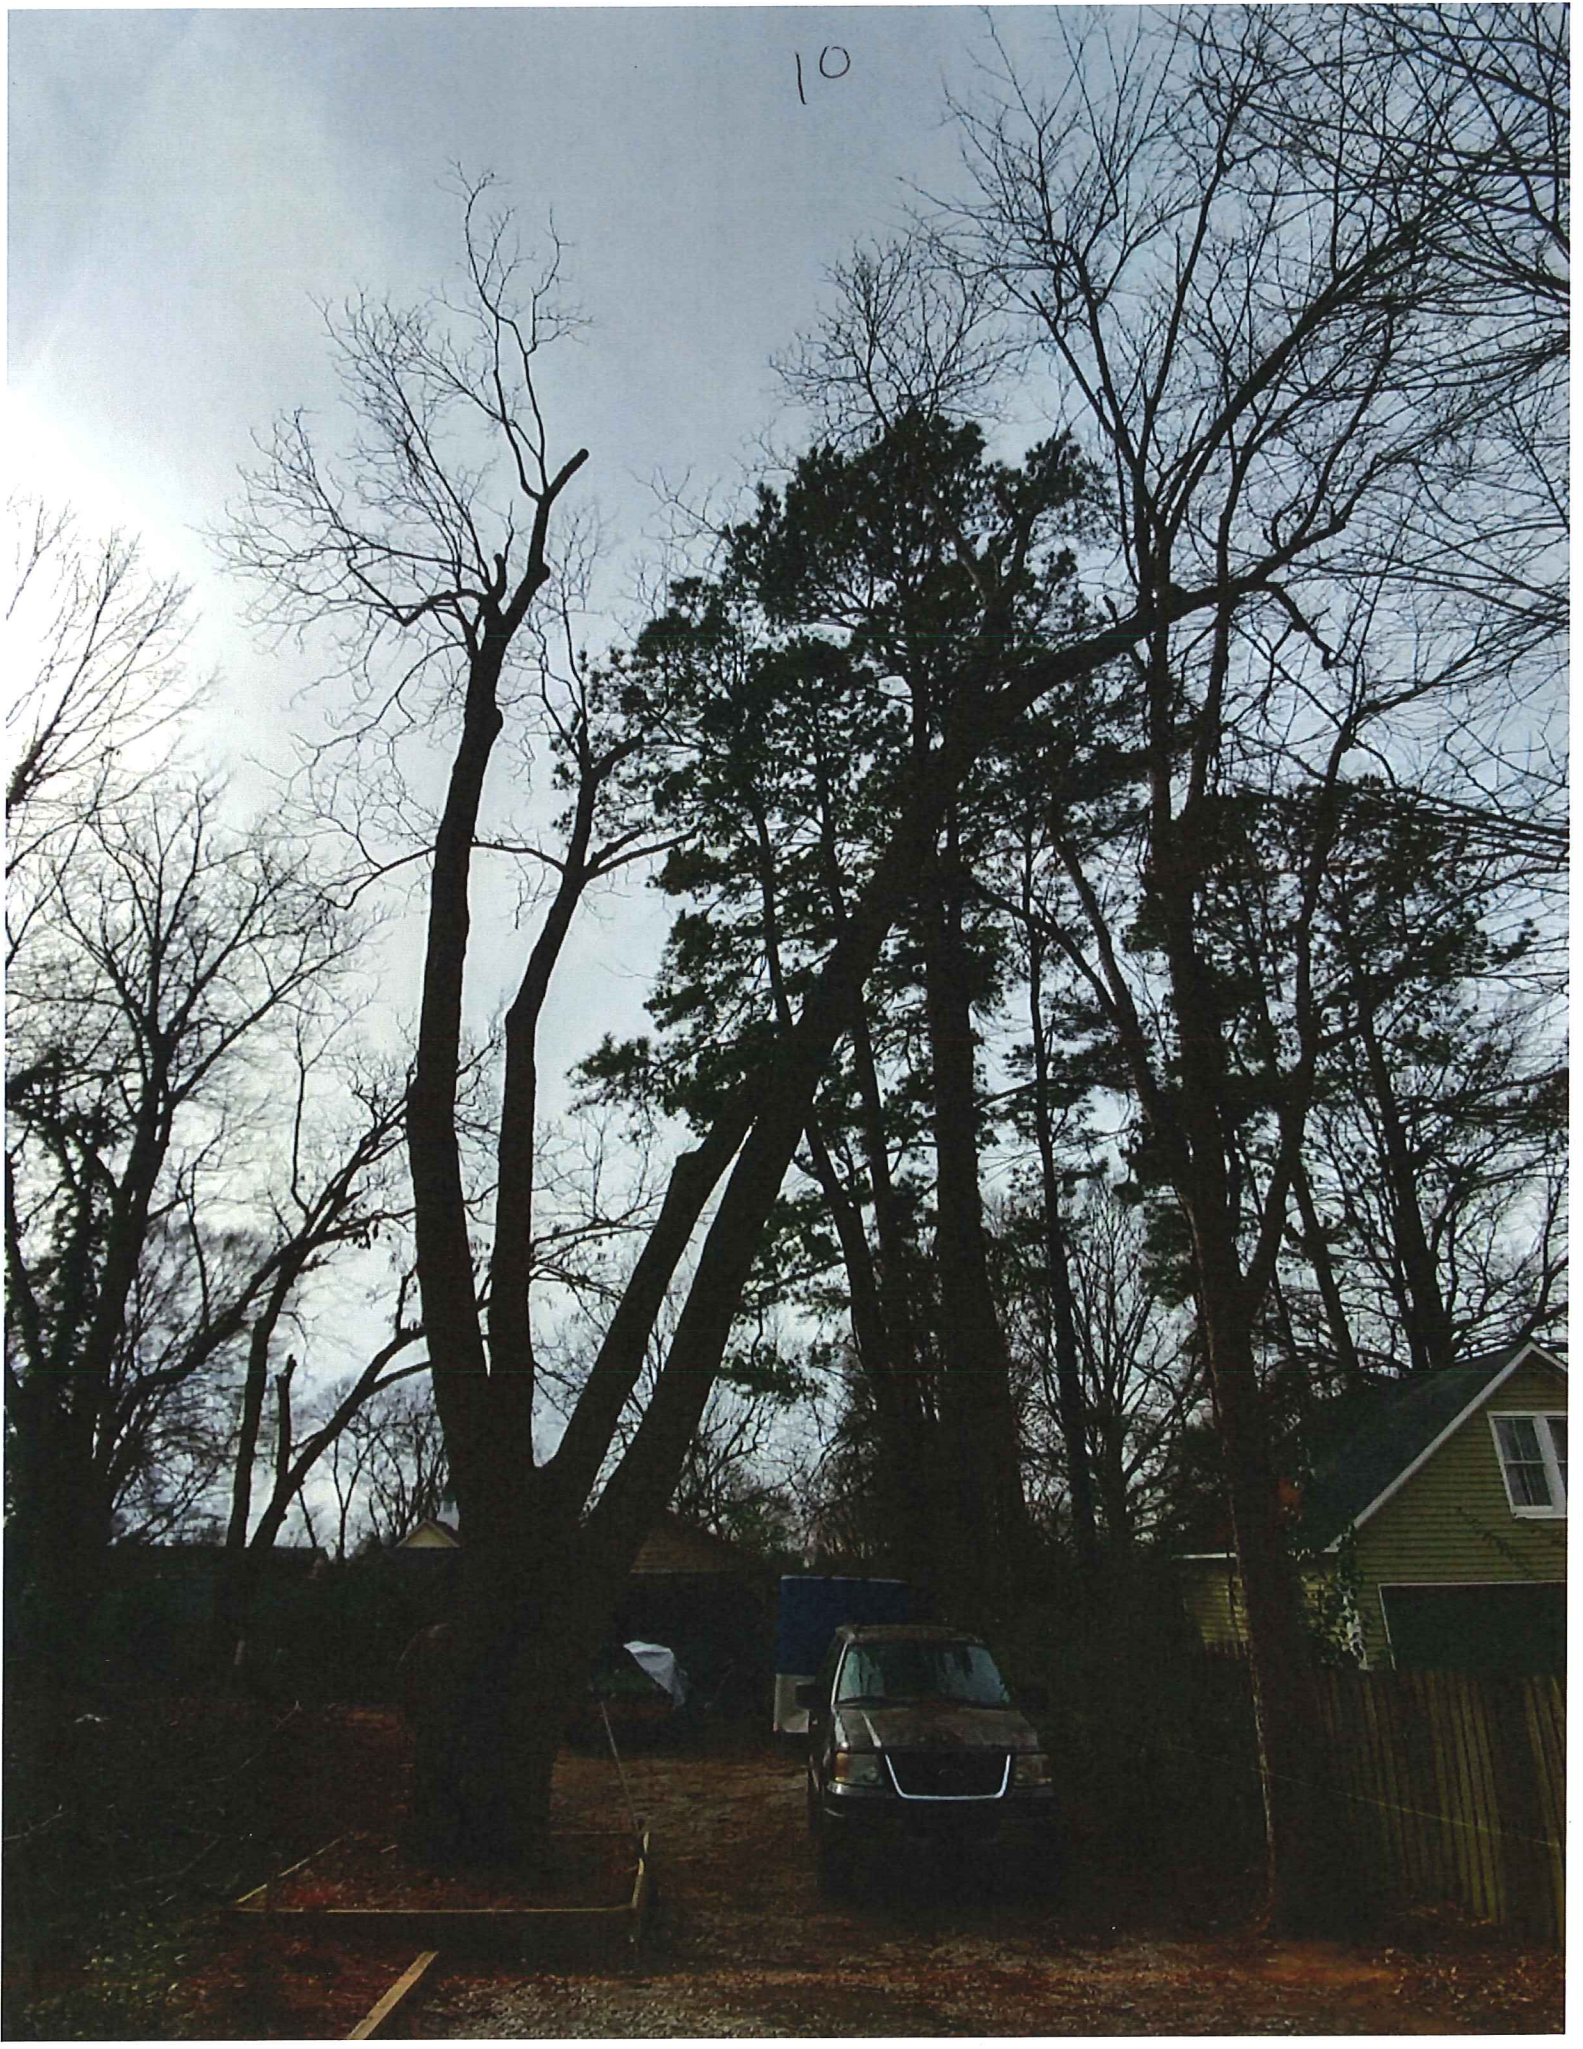
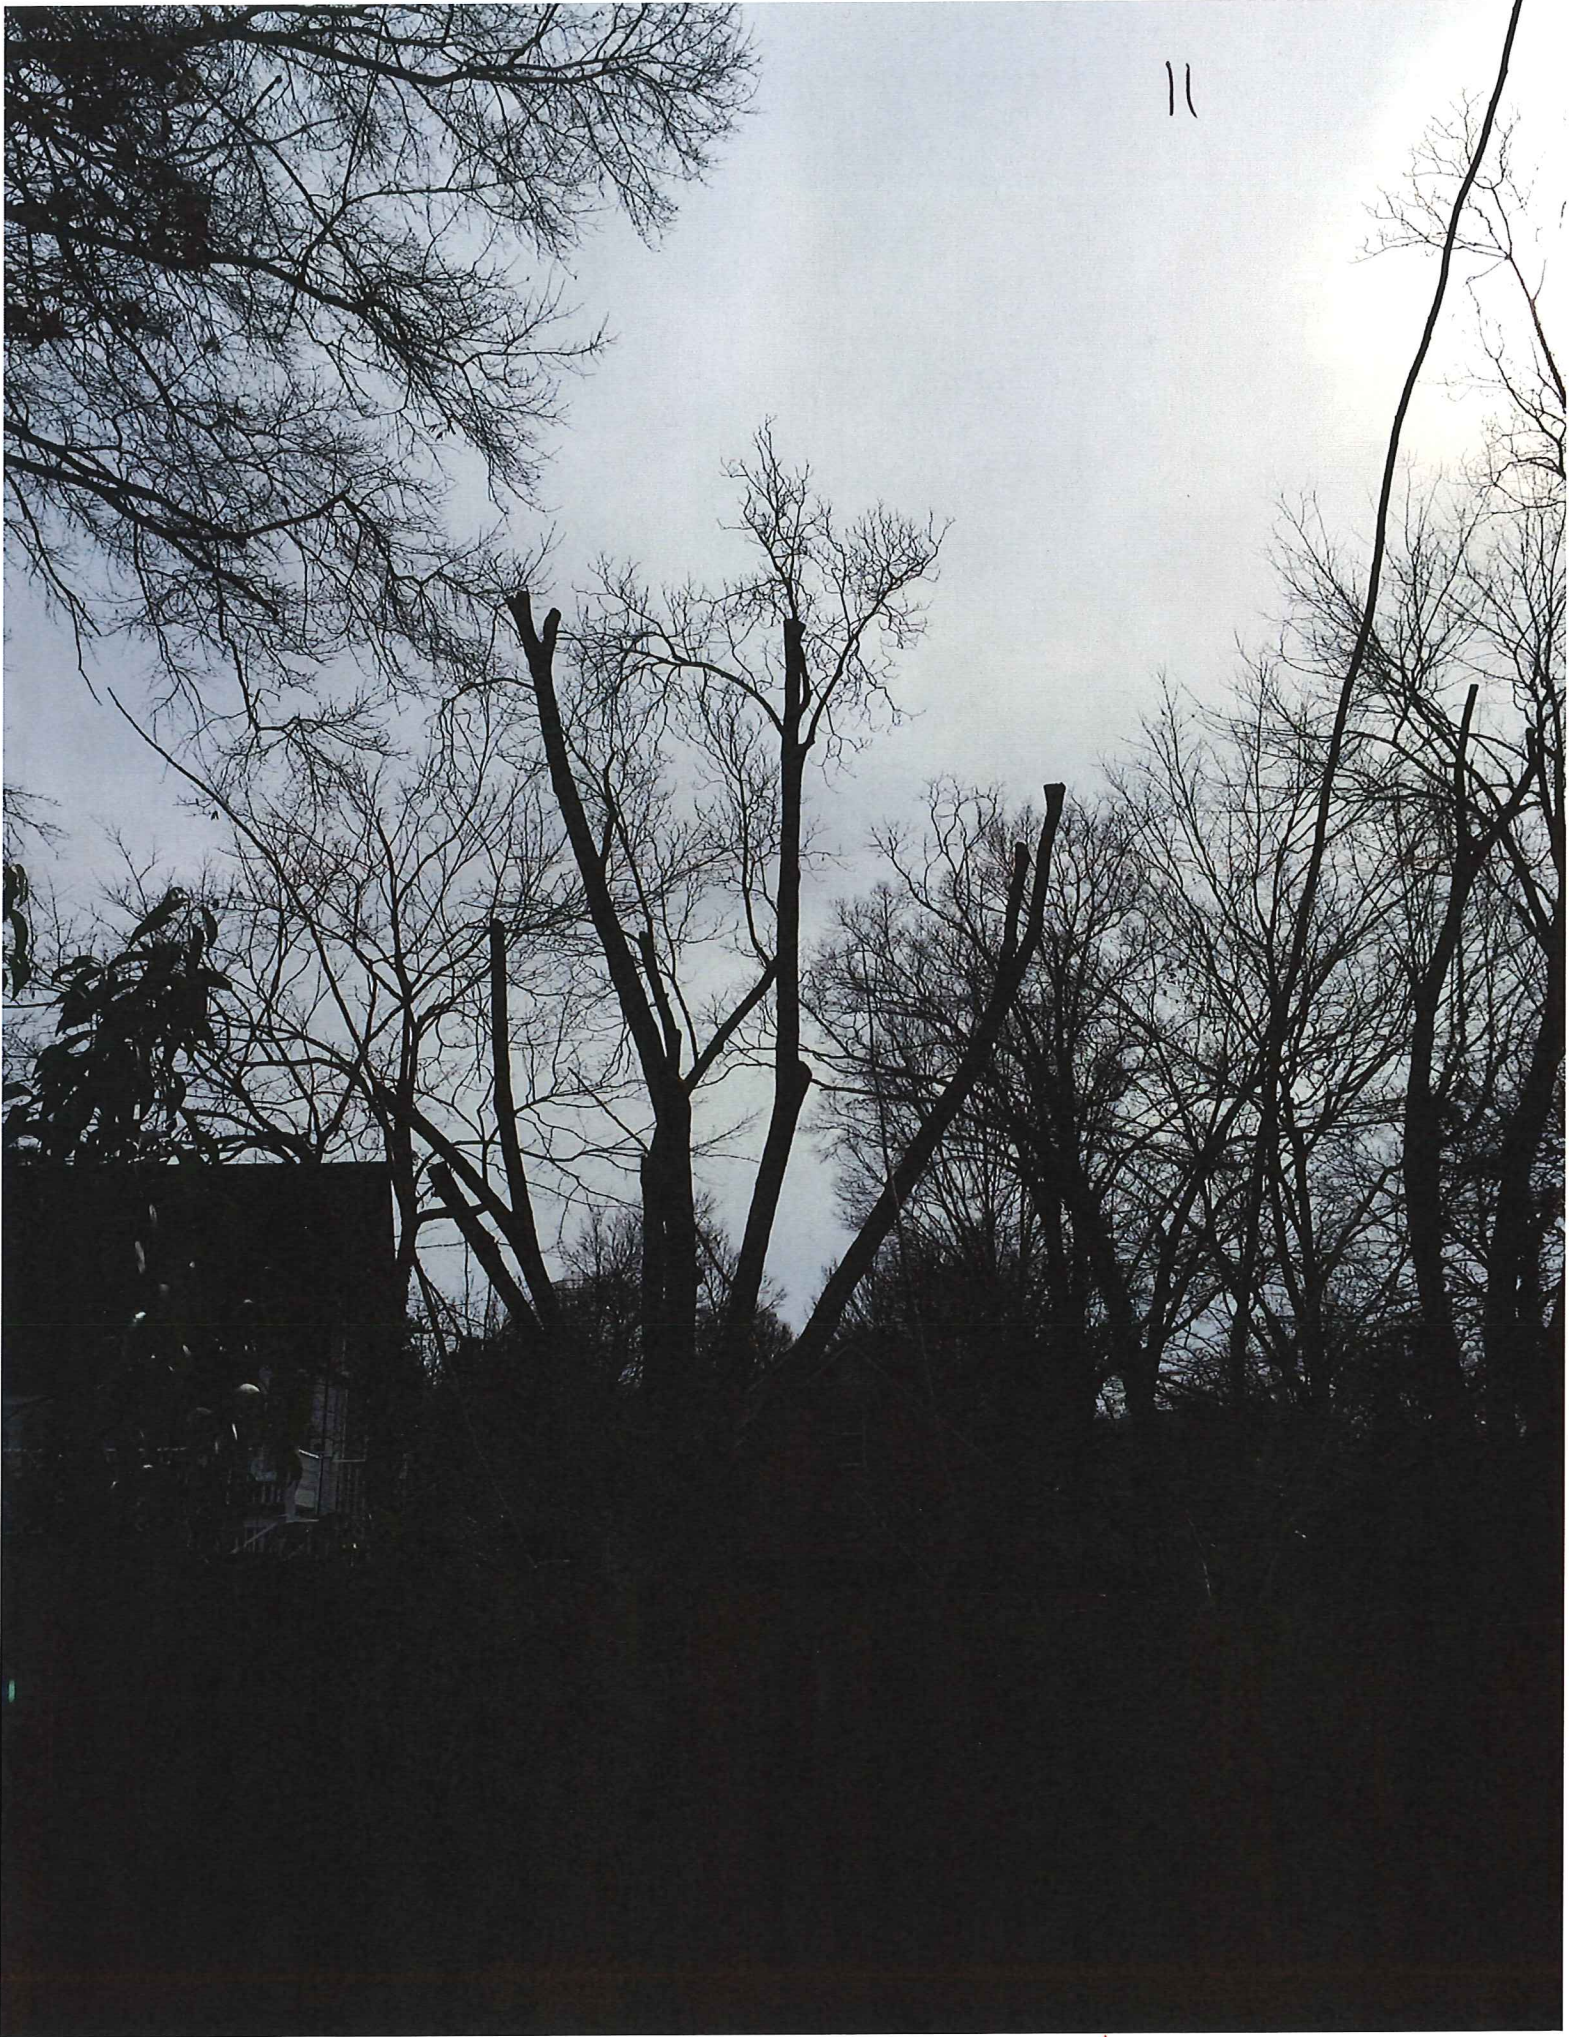
Exhibit C

An in-house approval was issued for the removal and replacement of a pecan tree with a 4 foot trunk diameter on October 21, 2013. The work for which the certificate of appropriateness was issued was never completed, but on or around January 22, 2018, city staff and code enforcement observed that tree limbs had been pruned without receiving the proper authorization, necessitating after the fact review.

1. The Historic Preservation Commission should consider the circumstances of this application for a Certificate of Appropriateness relative to the North and South Union Street Historic Districts Handbook and Guidelines and act accordingly.
2. If approved, applicant(s) should be informed of the following:
 - City staff and Commission will make periodic on-site visits to ensure the project is completed as approved.
 - Completed project will be photographed to update the historic properties survey.

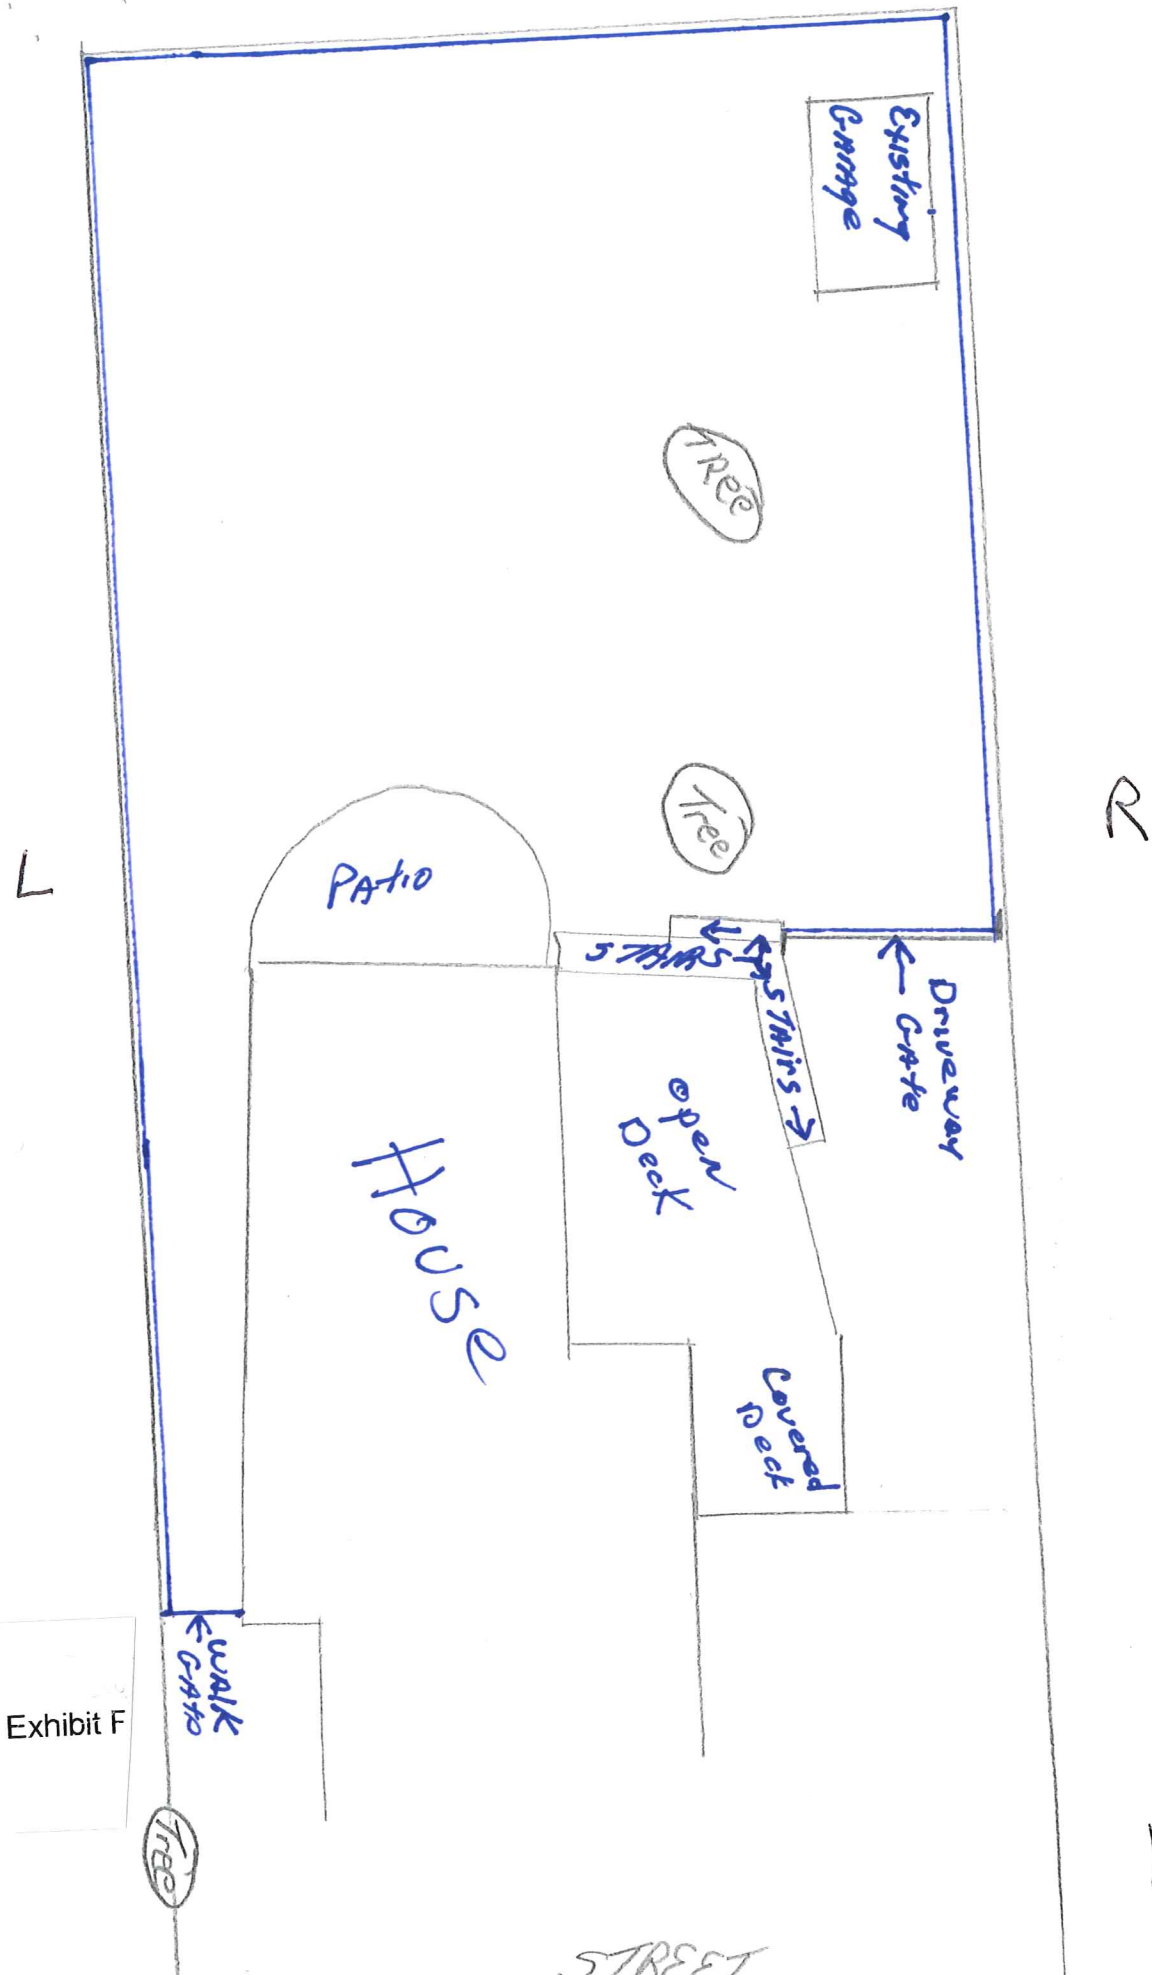
Exhibit G

Applicant has also applied to install a privacy fence, approximately 7 feet high, with 6 foot panels. The materials will be treated lumber using either 4x6, 4x4, 2x6, 2x4 and 5/8 panel slats. The fence would have either solar or low voltage lighting on each post, which would be approximately 6 feet apart at post center. The applicant has indicated that they may stain the fence white after completion and proper weathering.

app. 6'5" - 7' in height

outside Post 6'8"

panel face 6ft
