**DATE:** August 8, 2018

<u>Certificate of Appropriateness Request:</u>	H-23-18
<u>Applicant:</u>	Sari and Company
<u>Location of subject property:</u>	625 Main St SW
<u>Staff Report prepared by:</u>	Scott Sherrill, Sr. Planner

**COLEMAN MILL APARTMENTS**  
625 MAIN STREET SW CONCORD, CABARRUS COUNTY, NORTH CAROLINA

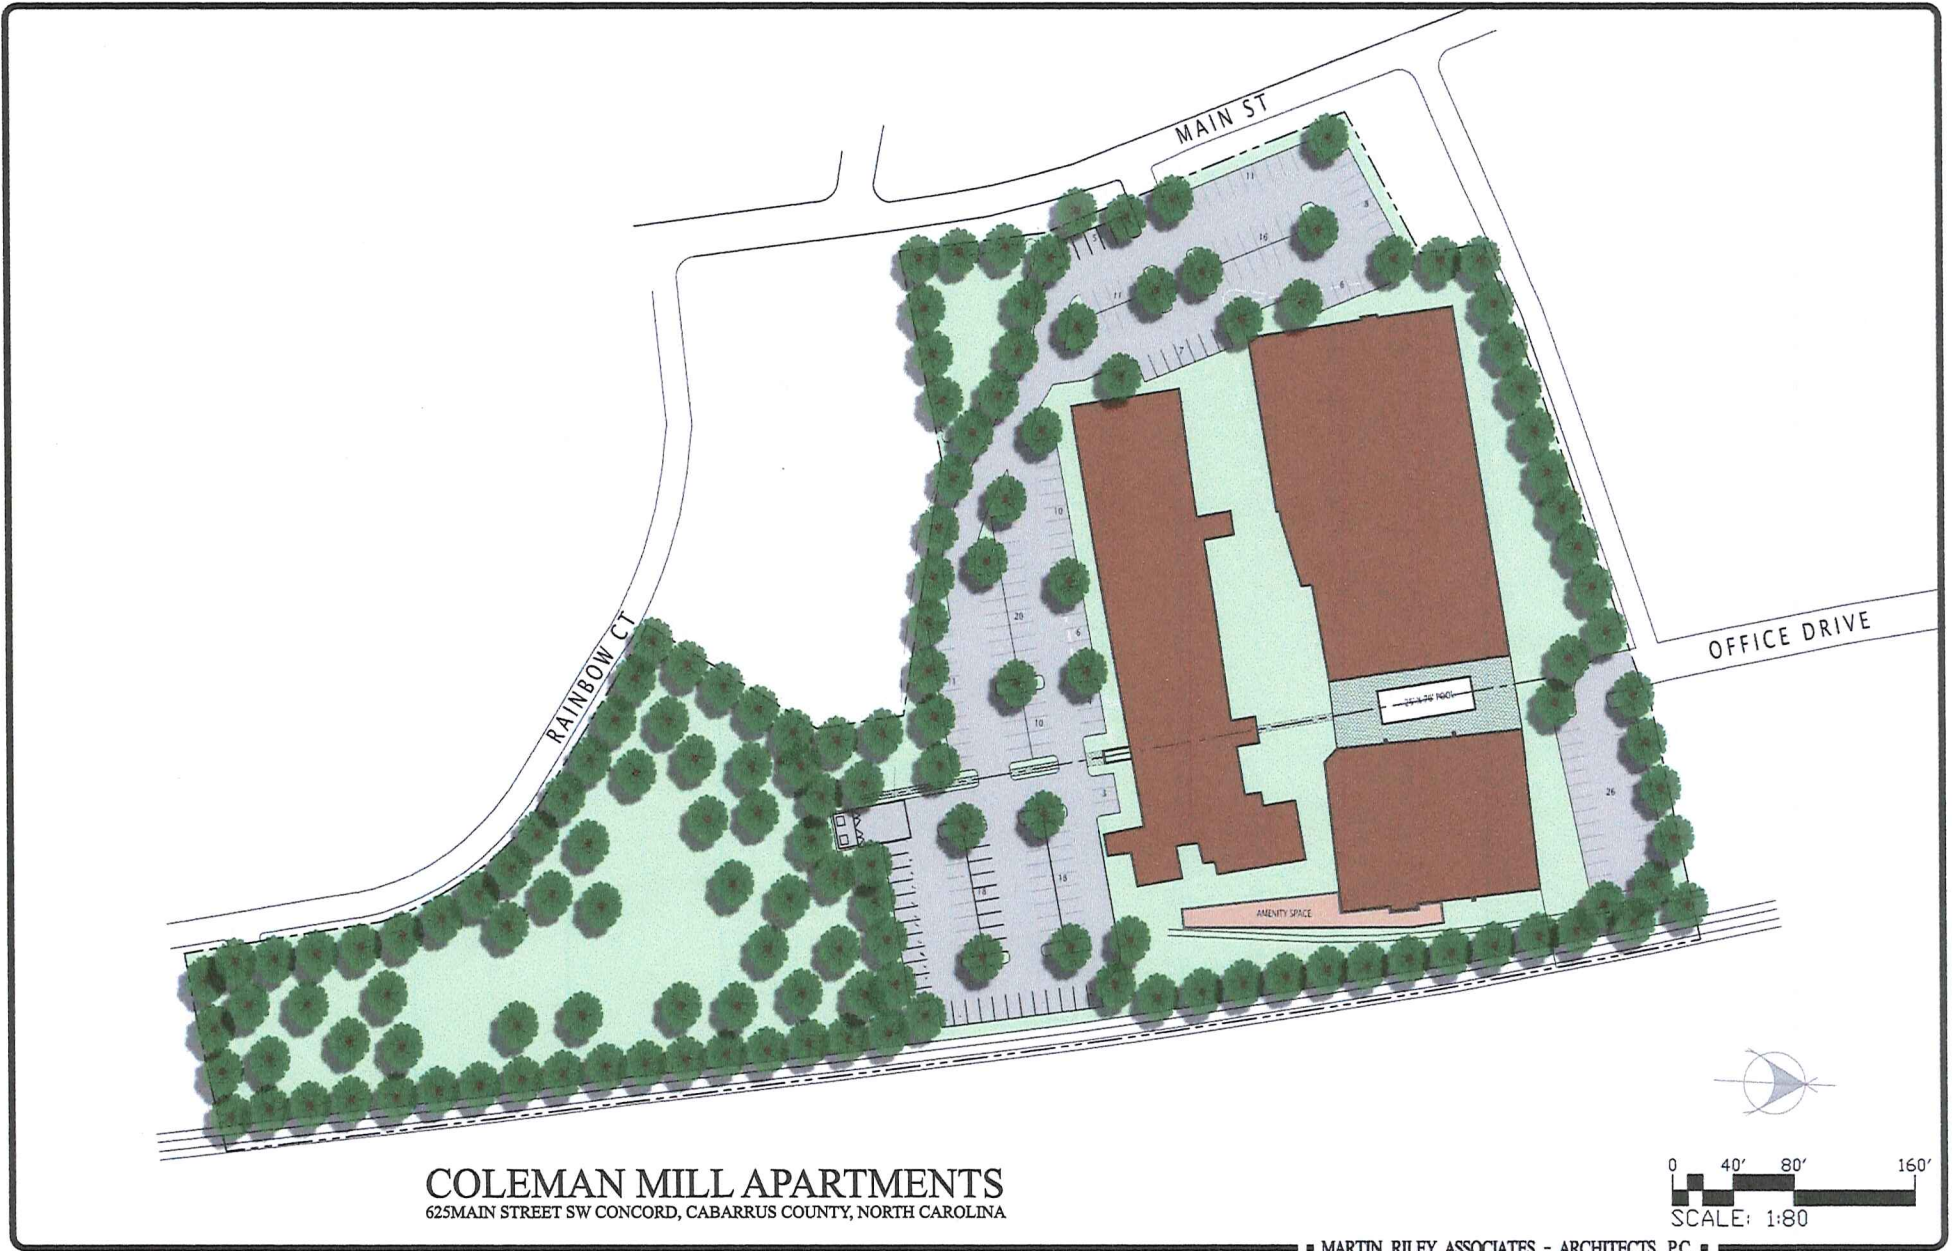
Proposed Site Plan

1. Existing brick
2. Windows replicating original windows
3. New windows to fill non-window openings acceptable to NPS
4. Metal siding matching original siding
5. Replacement roofing as necessary

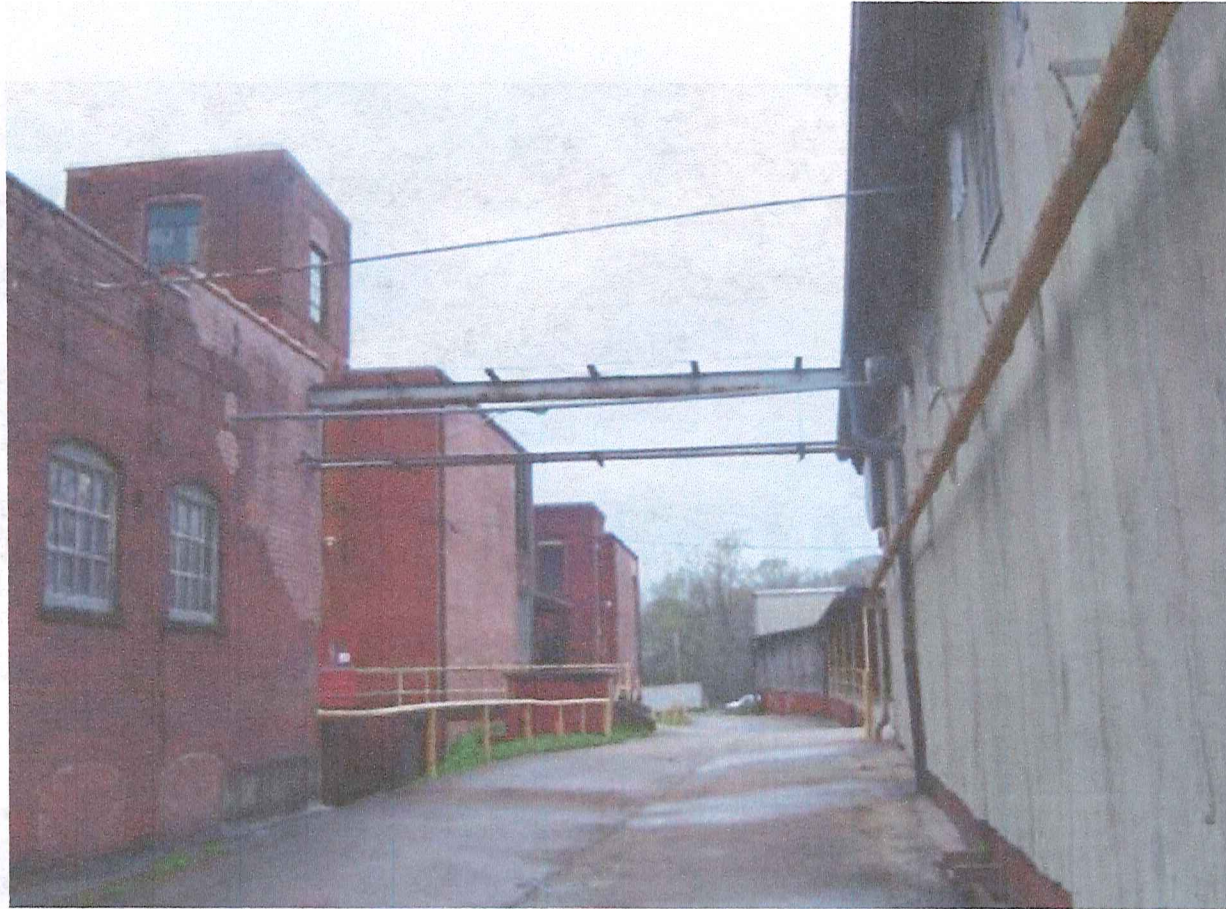
Between the East Cotton Warehouse and 1898,  
1912, 1950s, 1960s Contributing Building

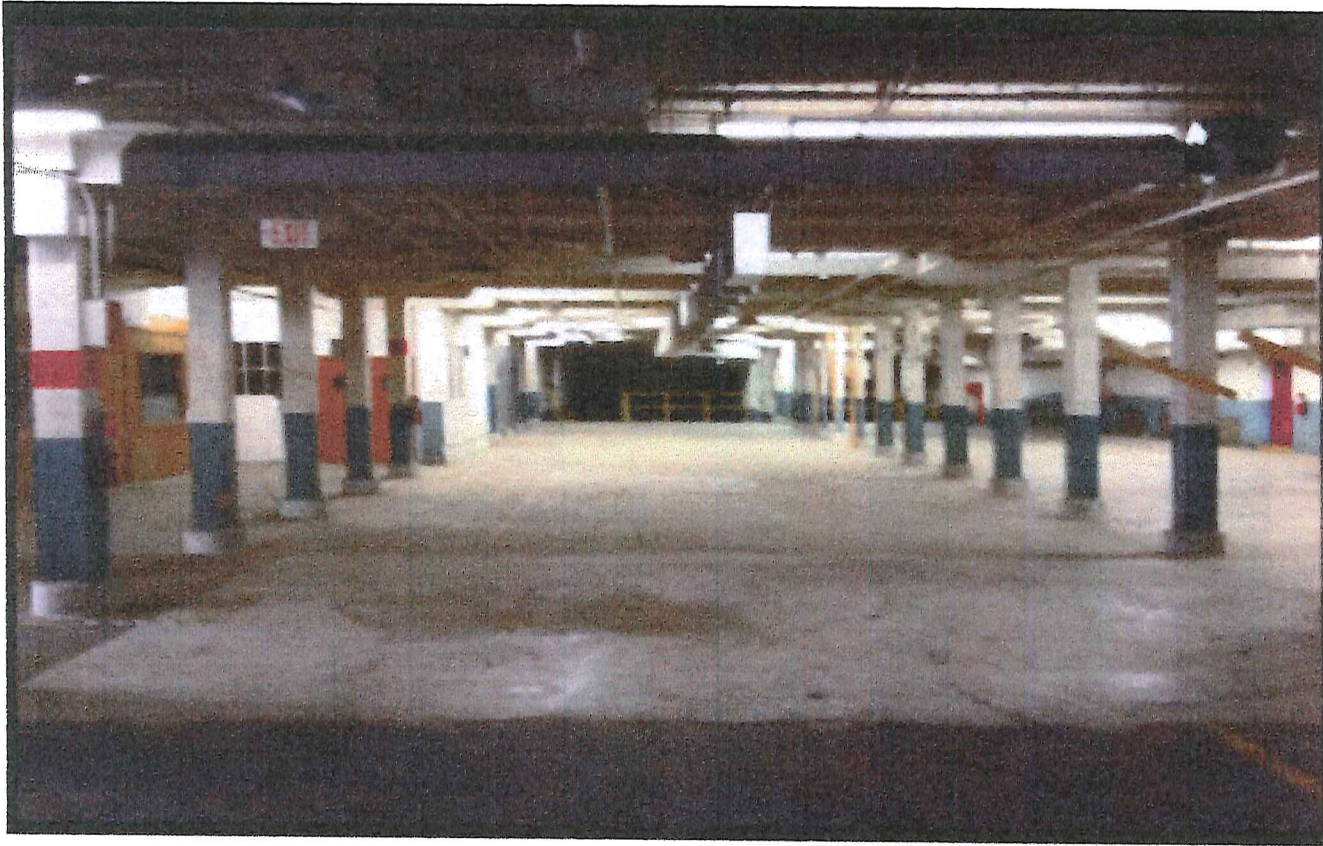
Interior--1898,1912,  
1950s, 1960s  
Contributing Building

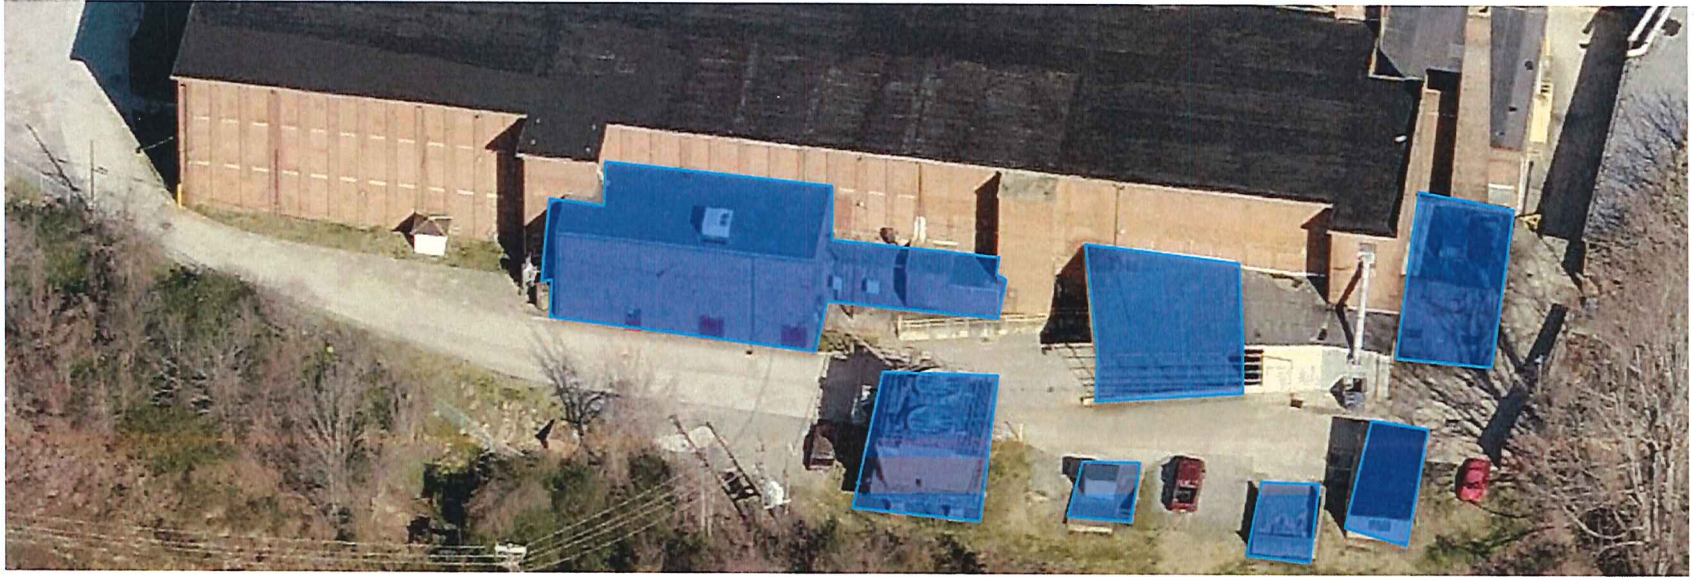
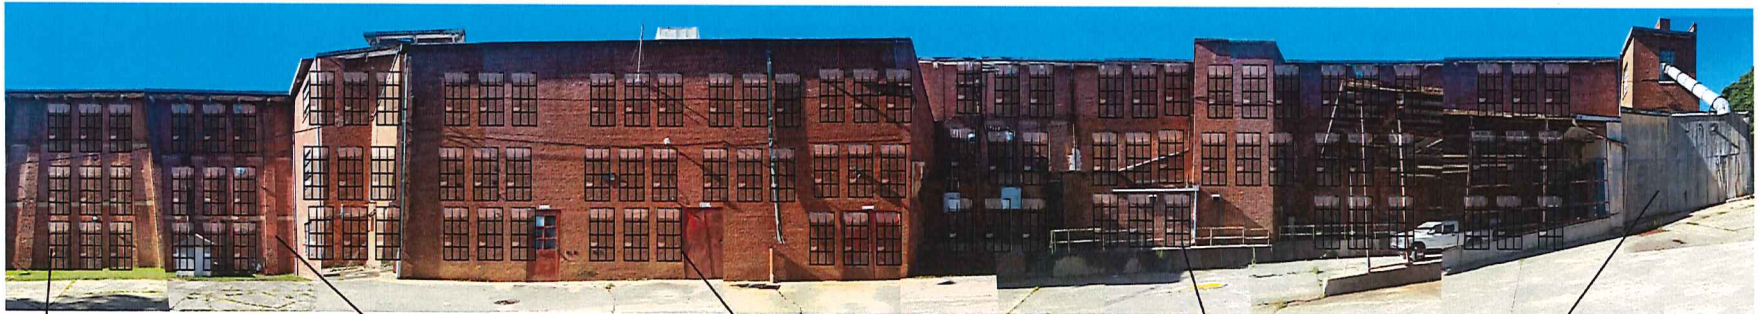
PROPOSED WINDOW LOCATIONS SHOWN. FINAL WINDOW LOCATION MAY VARY PER INPUT FROM NATIONAL PARK SERVICE.

EXISTING BRICK TO BE CLEANED AND POINTED AS PER NPS STANDARDS.

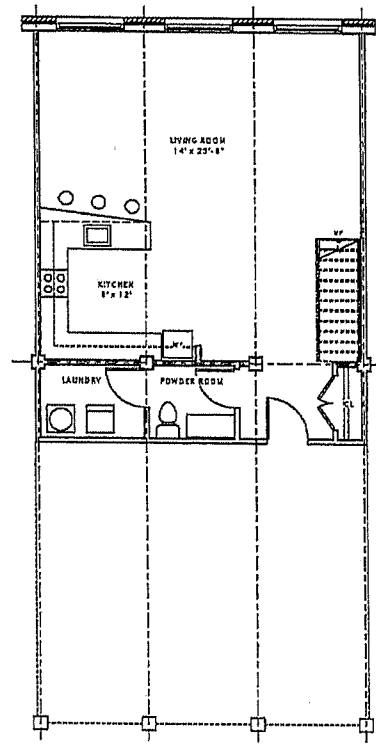
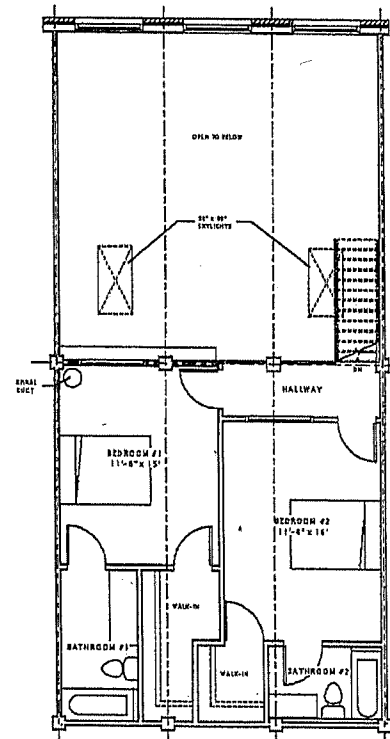
⊕ MILL LOFT - LOWER & UPPER LEVELS  
SCALE: 1/4" = 1'-0"

GROSS AREA: 749 SQ FT + 642 SQ FT = 1391 SQ FT  
RENTABLE AREA: 704 SQ FT + 618 SQ FT = 1322 SQ FT

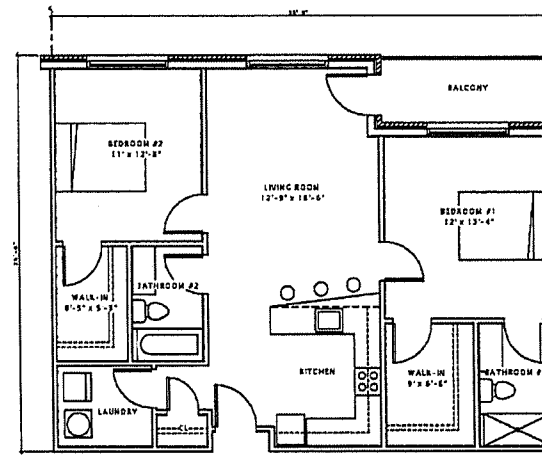
2 NEW MILL - TWO BEDROOM  
SCALE: 1/4" = 1'-0"

GROSS AREA: 1002 SQ FT  
RENTABLE AREA: 936 SQ FT

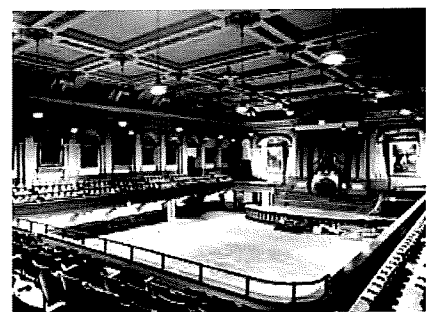
Many institutional buildings possess distinctive spaces or floor plans that are important in conveying the significance of the property. This grand hall, which occupies the entire floor of the building, could not be subdivided without destroying the integrity of the space. Photo: NPS files.

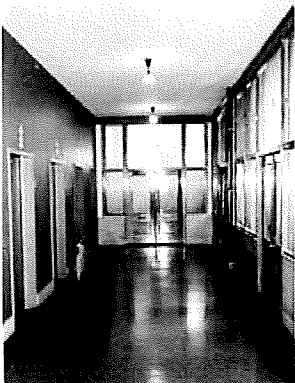
This corridor has glazed walls, oak trim, and marble wainscoting, typical of those found in the late 19th and early 20th century office buildings. Corridors such as this, displaying simple detailing, should be a priority in rehabilitation

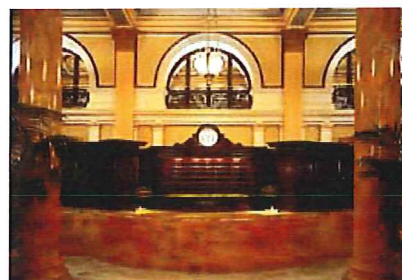
After rehabilitation, this severely deteriorated space was returned to its original elegance. Plaster was repaired and repainted; scagliola columns were restored to match marble; and missing decorative metalwork was re-installed in front of the windows. Photo: Carol M. Highsmith.

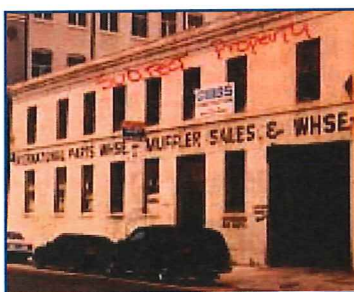
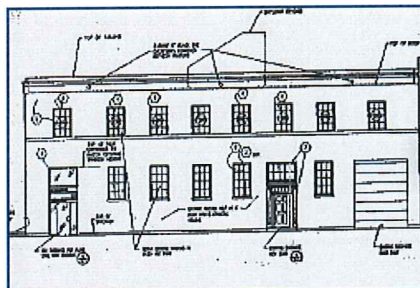
This building was constructed with a single pedestrian entrance in 1886, and a garage door was added later (left). When the building was rehabilitated for office use, an existing window was removed from the end bay and replaced with a new glazed entryway (center and right).

**Application 1 (Compatible treatment):** This two-story, eight-bay masonry structure was built in 1886 as an ice manufacturing plant. Originally constructed with only one entryway, a garage door had been added later when the building served as a warehouse. As part of the building's conversion into offices, a second pedestrian entrance was added to the street elevation during the rehabilitation to make it easier to get to some of the offices. The size of the new opening is the same as that of the existing historic entrance. But, the new entrance is almost entirely glazed, and consists of a simple butt-mounted glass door with sidelights, and a single-light transom. It is clearly a compatible, contemporary design that does not draw attention to itself. It cannot be confused with the historic entrance, and it does not change the character of the building. Thus, it meets the Standards.

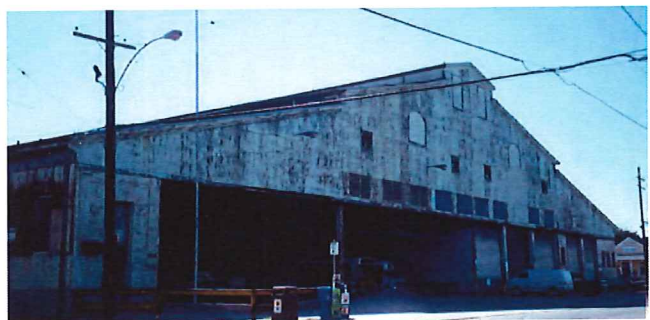
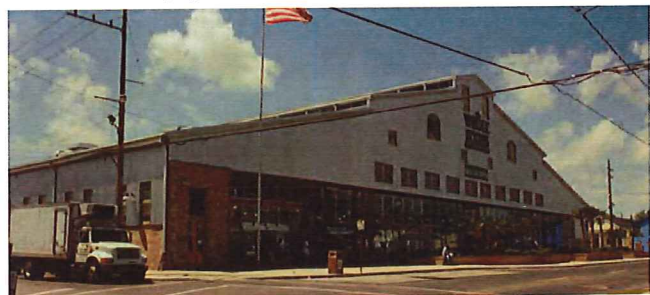
*Above: The historic bus barn before rehabilitation.  
Below: The historic bus barn after conversion to a grocery store. A butt glazed storefront was installed in the former garage bays to retain the sense of openness.*

**Application 1 (Compatible treatment):** This historic car barn was built c. 1893, originally to house streetcars and remained in use until it was closed in the 1990s when a new facility was constructed. After years of disuse, it was proposed to be converted into a grocery store. The sheer size and volume of the interior proved to be a good match for the new use. The car barn was large enough that the grocery store itself could fit into the front half of the building, leaving the rear portion available for parking. The openness and immense height of the interior with its exposed metal structural system contributes to the market's appeal and is also ideal for the parking area which, after all, was the building's original use. New corrugated metal replaced the rusted historic metal sheathing on the exterior. The large historic vehicular openings on the back allow access to the parking and also provide ventilation. The vehicular doors on the front were infilled with a butt glazed storefront system to retain the open appearance the building had historically. This project meets the Standards.

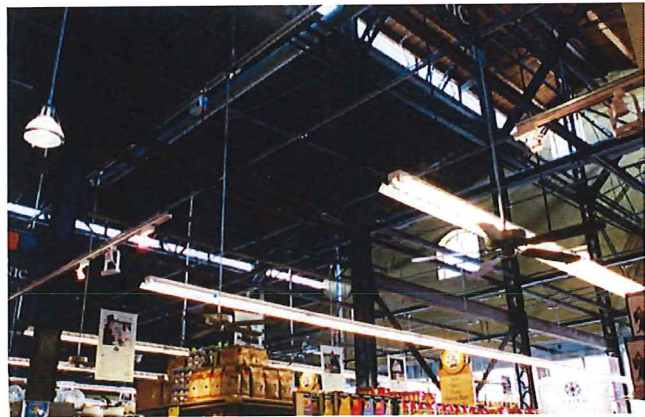
*Left and Right: The exposed trusses on the interior, both in the parking area and in the grocery store, emphasize the structure's industrial character.*

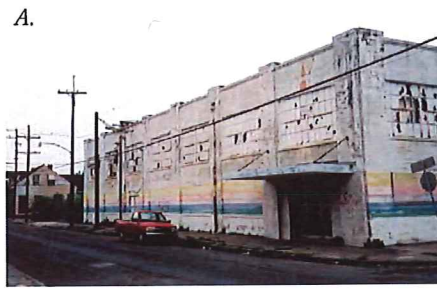
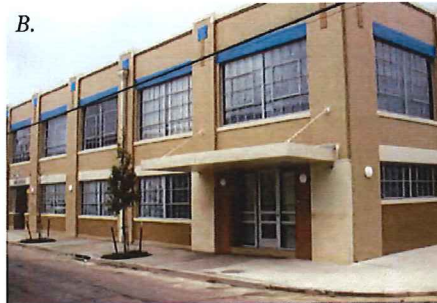
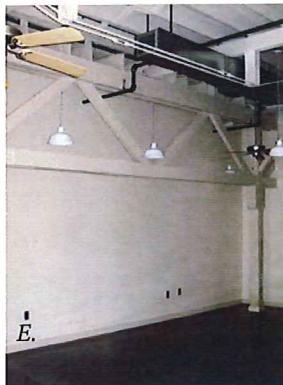
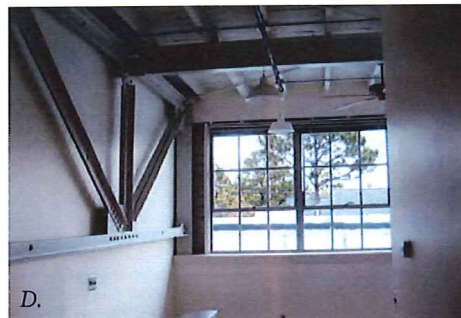
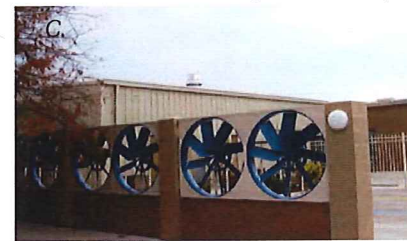
*Clockwise from top:*  
**A.** The early-twentieth century garment factory before rehabilitation.  
**B.** After rehabilitation, historic windows shine again after repair and paint removal. New windows have been installed in bricked-up openings and new matching windows have replaced historic windows too deteriorated to repair.  
**C.** Old fans have been reused decoratively as part of a fence around the parking lot.  
**D & E.** Accented by new industrial lighting fixtures, the historic character of the interior is clearly expressed in the exposed wood and steel beams and trusses, as well as in the original concrete floor.

**Application 2 (Compatible treatment):** This small brick garment factory was constructed c. 1930 with later expansions. After being vacant for many years the building was rehabilitated as low-to-moderate income residential units. The character-defining industrial metal windows were retained where possible, while those that were deteriorated beyond repair were replaced to match the existing. Bricked-up windows were reopened and matching windows were installed. The simple metal canopy over the entrance in the front was retained and the deteriorated corrugated metal siding on one elevation was replaced to match. The industrial nature of the building is also clearly evidenced on the interior in the exposed wood ceiling and metal trusses. Even the large fans that cooled the sewing area of the factory were incorporated as decorative elements in a fence around the parking lot. This project has preserved the industrial character of the structure and meets the Standards.

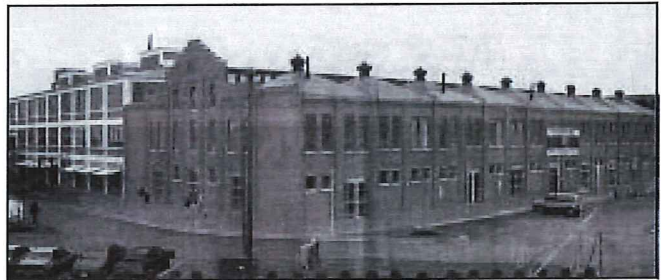
*Tin can factory following rehabilitation.*

**Application 1 (Compatible Treatment):** This 1895, three-story brick warehouse with its stepped gable façade, corrugated metal monitor roof and distinctive ventilators was originally built as a tin can manufacturing plant. The long vacant building was recently rehabilitated for use as research and office space for the world headquarters of a major manufacturing company. The creative design used in the rehabilitation for the interior underscored the building's industrial character by using materials, such as corrugated metal walls, steel beams and exposed wooden columns. Any required partitions were constructed to retain an open view of the character-defining latticed I-beams and metal trusses. The windows in the roof monitor over the center aisle were reopened and restored. The result is an open, contemporary office space that successfully retains the character of this utilitarian building.

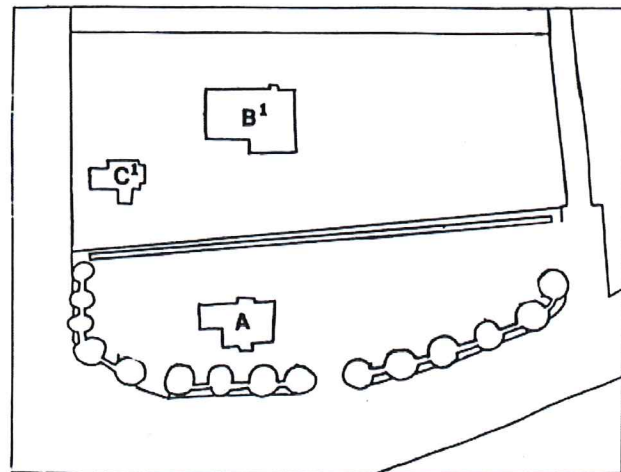
Top: Although the site was overgrown, the character of this 1900 house as a large suburban residence had survived.

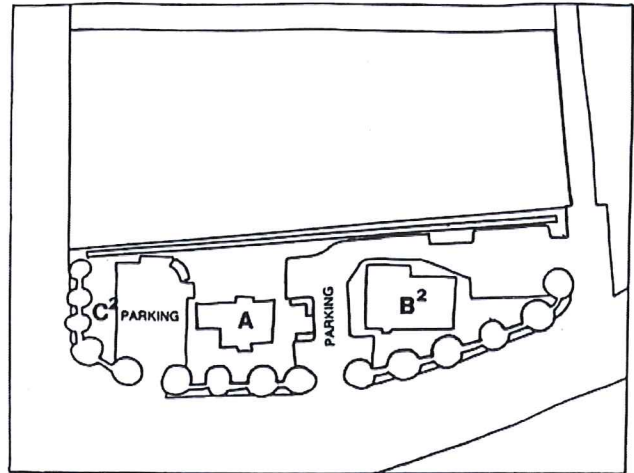
*Turned 180 degrees, the moved building (B2) faces the historic one from a distance of 60 feet.*

*Site plan after rehabilitation of buildings. The neighboring house was moved and turned around (B2) to face the 1900 building (A) across a new paved parking lot. The cottage associated with the moved house was relocated (C2) behind the 1900 building.*
