HISTORIC PRESERVATION COMMISSION MEETING AGENDA

H-15-21 (Quasi-Judicial Hearing)

STC Coleman Mill, LLC, has submitted a Certificate of Appropriateness application to renovate and repurpose the existing Coleman Mill Buildings into apartment units at 625 Main St. SW. PIN 5529-69-3574.

Stephen and Dana Rohrer have submitted a Certificate of Appropriateness application for "ex post facto" (after the fact) approval to stain the side of the rear yard fence facing the adjoining properties at 19 Franklin St and 103 Union St N and to increase the height of the rear yard fence running adjacent to Franklin St from 4.0' to 6.0' located at 113 Union St N. PIN 5620-79-8008.

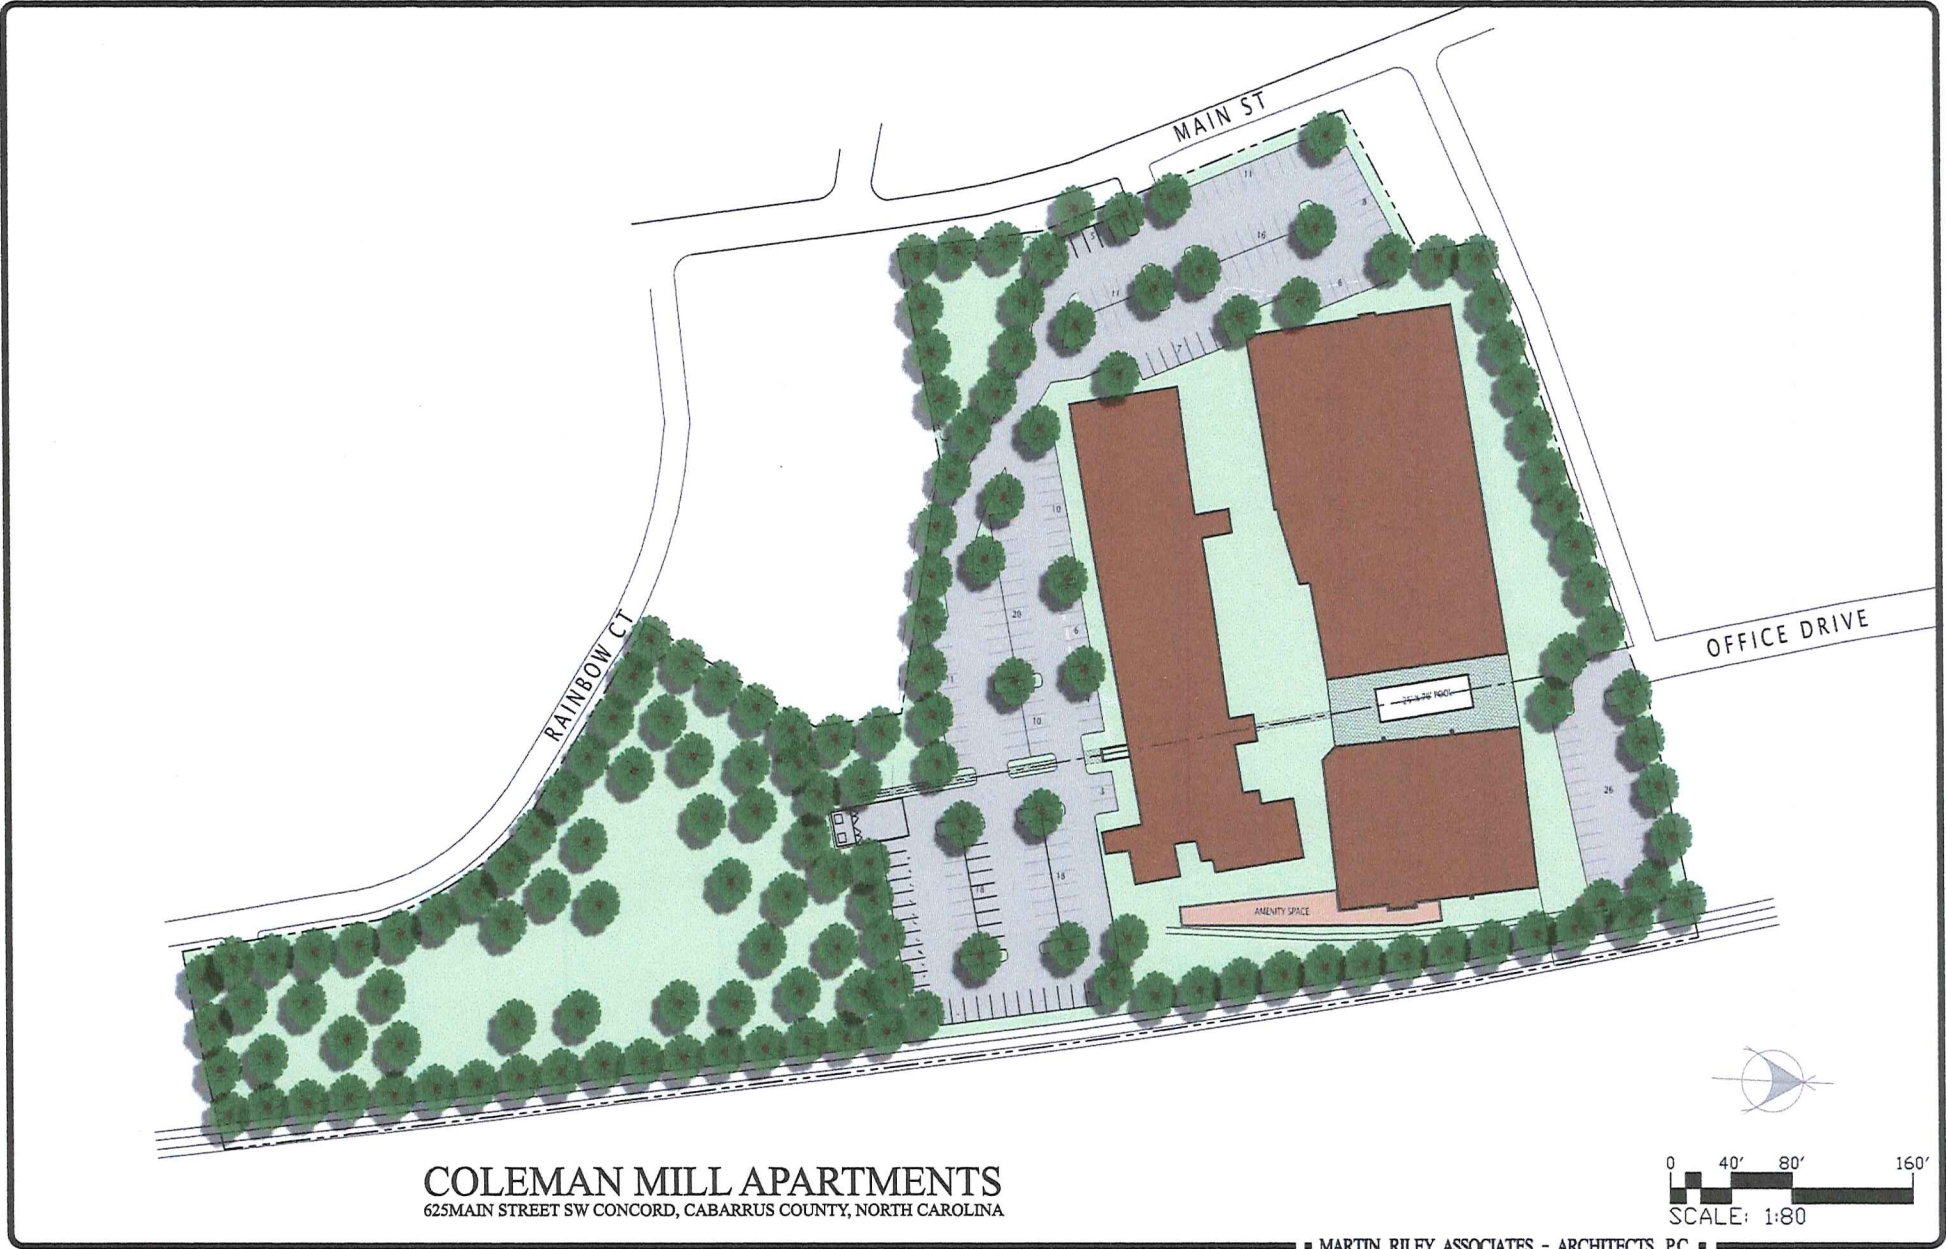
Proposed Site Plan

1. Existing brick
2. Windows replicating original windows
3. New windows to fill non-window openings acceptable to NPS
4. Metal siding matching original siding
5. Replacement roofing as necessary

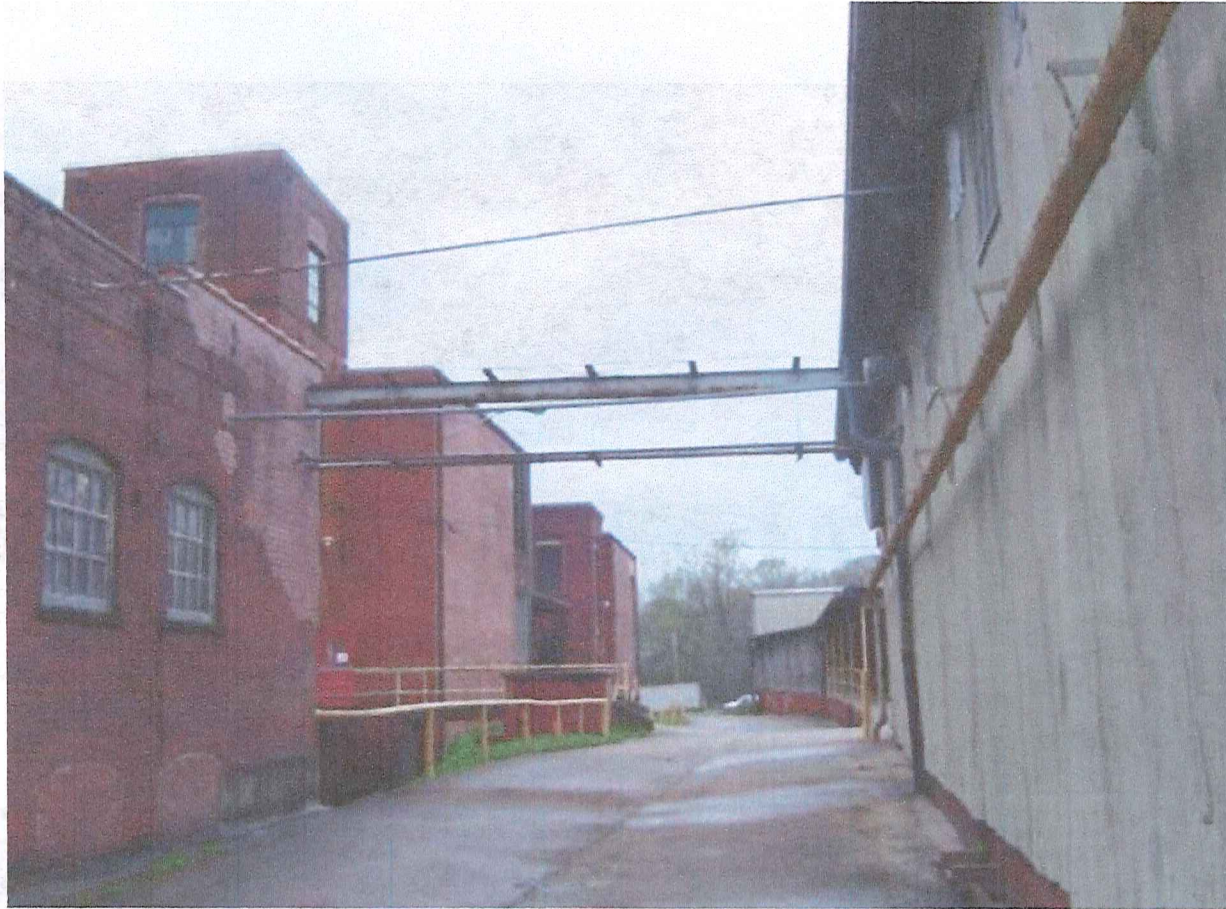
Between the East Cotton Warehouse and 1898,
1912, 1950s, 1960s Contributing Building

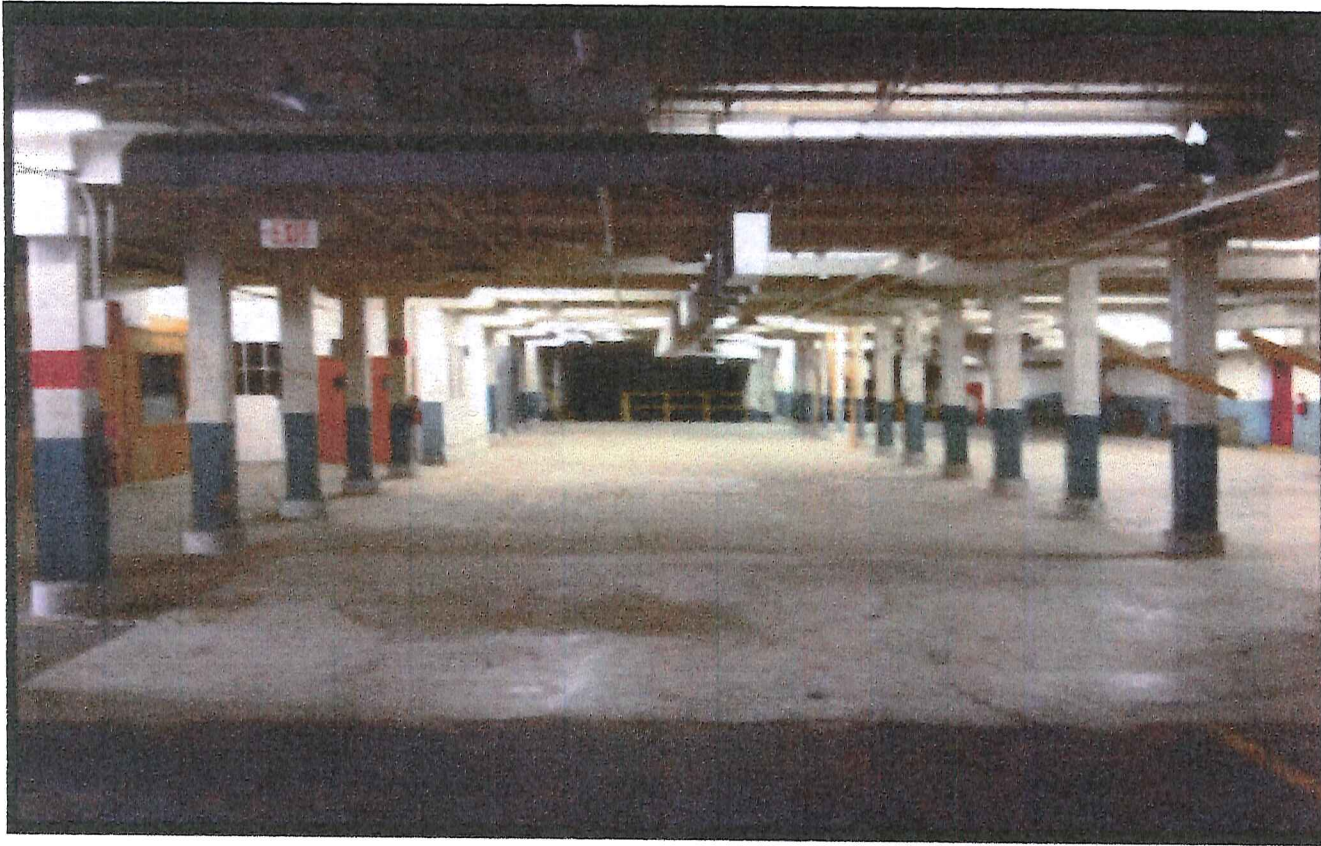
Interior--1898,1912,
1950s, 1960s
Contributing Building

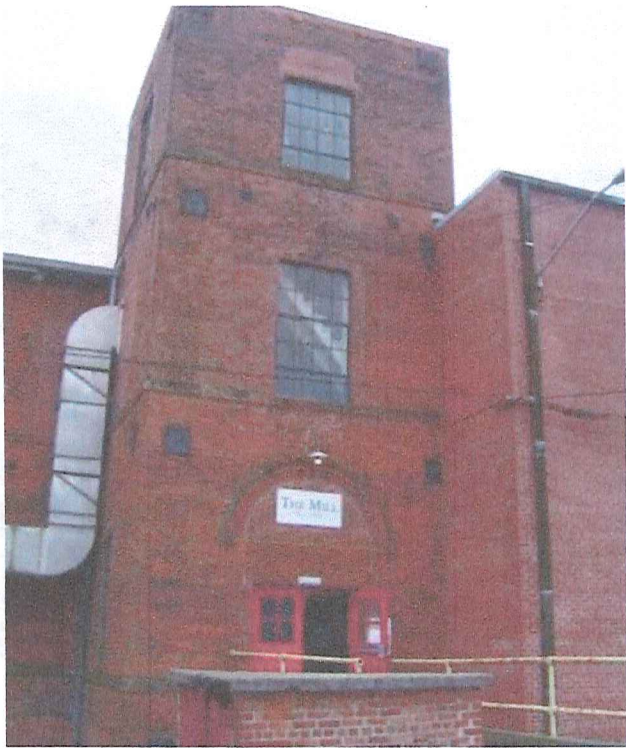
Main Mill South
Side

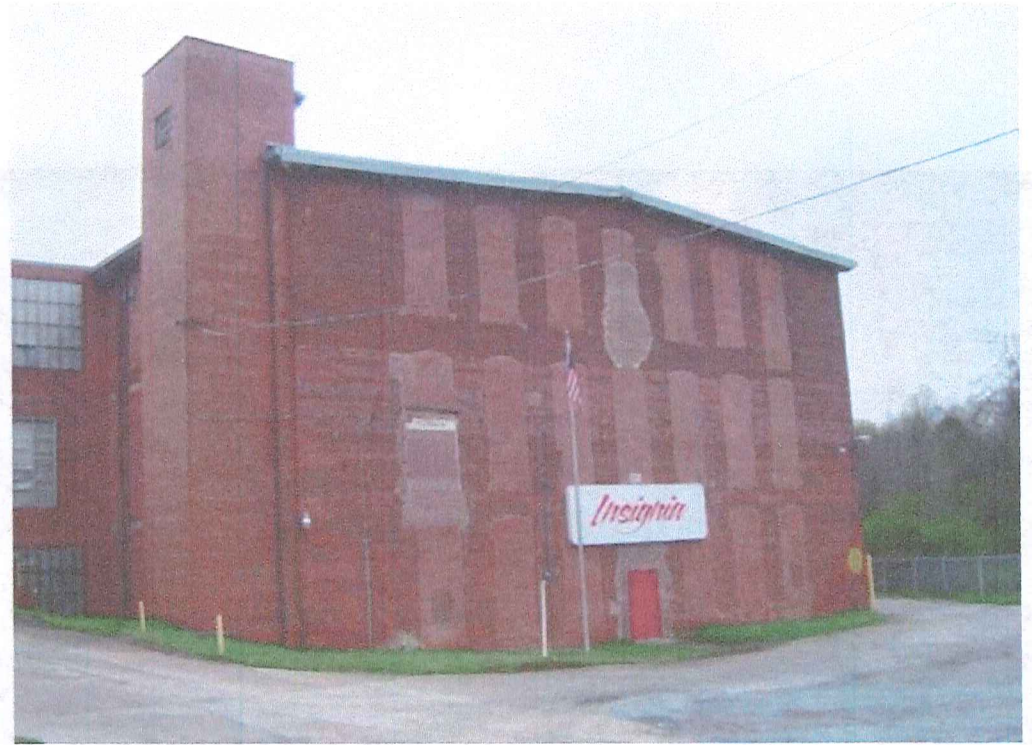
Main Mill East Facade

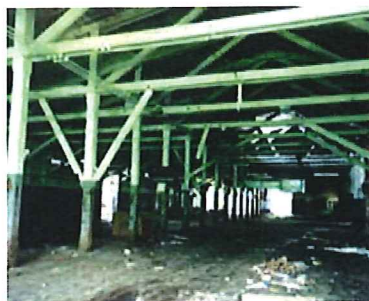
The interiors of mills and industrial buildings are frequently open, unadorned spaces with exposed structural elements. While these spaces can serve many new uses, the floor to ceiling height and exposed truss system are character-defining features that should be retained in rehabilitation. Photo: NPS files.

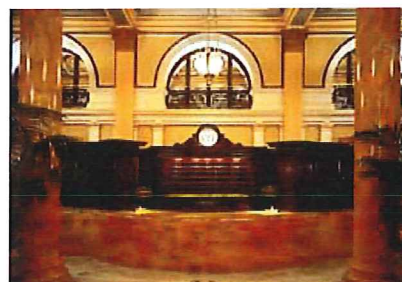
After rehabilitation, this severely deteriorated space was returned to its original elegance. Plaster was repaired and repainted; scagliola columns were restored to match marble; and missing decorative metalwork was re-installed in front of the windows. Photo: Carol M. Highsmith.

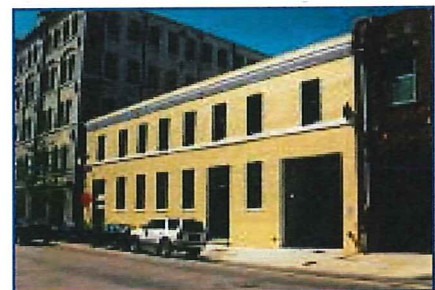
This building was constructed with a single pedestrian entrance in 1886, and a garage door was added later (left). When the building was rehabilitated for office use, an existing window was removed from the end bay and replaced with a new glazed entryway (center and right).

Application 1 (Compatible treatment): This two-story, eight-bay masonry structure was built in 1886 as an ice manufacturing plant. Originally constructed with only one entryway, a garage door had been added later when the building served as a warehouse. As part of the building's conversion into offices, a second pedestrian entrance was added to the street elevation during the rehabilitation to make it easier to get to some of the offices. The size of the new opening is the same as that of the existing historic entrance. But, the new entrance is almost entirely glazed, and consists of a simple butt-mounted glass door with sidelights, and a single-light transom. It is clearly a compatible, contemporary design that does not draw attention to itself. It cannot be confused with the historic entrance, and it does not change the character of the building. Thus, it meets the Standards.

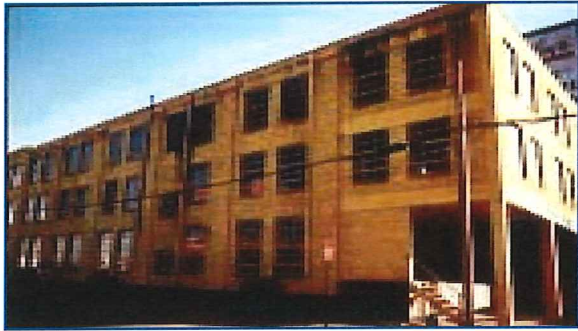
This historic warehouse had entrances on three elevations of the building prior to rehabilitation.

Application 2 (Compatible treatment): A larger, free-standing, three-story warehouse building constructed in 1922, with a 1940s addition, was to be rehabilitated into commercial and retail spaces on the first floor with residential apartments on the upper floors. The building featured a loading dock on one side and three utilitarian, non-significant entrances on various elevations. As part of the rehabilitation a new entrance was proposed to be added on a side of the building that never had an entrance. An entrance on this elevation would improve visibility and access to the new shops and businesses, and it would also help increase security for the upstairs apartments since existing entrances could be restricted for residential tenant use. Accordingly, a new glass and steel entryway which reflects the industrial character of the building and its historic metal windows was designed for this side of the building. The new entrance is compatible with the character of the historic building. It is unobtrusive and it does not noticeably impact or change the appearance of this elevation or of the warehouse building as a whole.

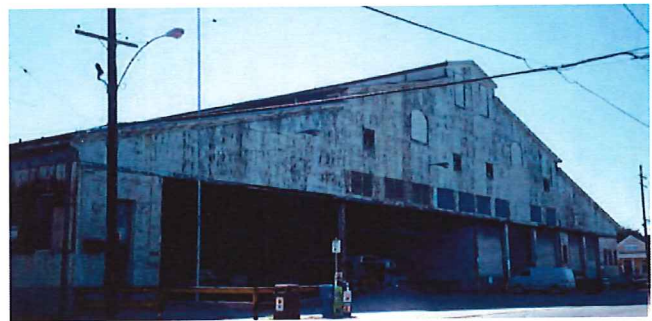
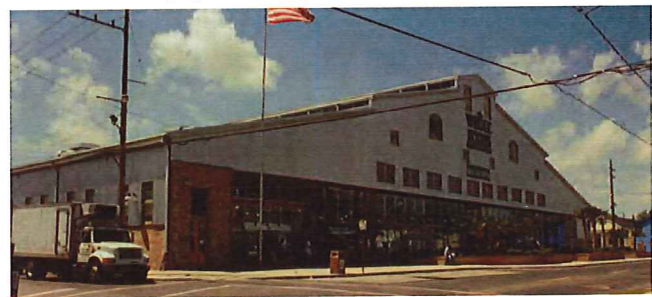
*Above: The historic bus barn before rehabilitation.
Below: The historic bus barn after conversion to a grocery store. A butt glazed storefront was installed in the former garage bays to retain the sense of openness.*

Application 1 (Compatible treatment): This historic car barn was built c. 1893, originally to house streetcars and remained in use until it was closed in the 1990s when a new facility was constructed. After years of disuse, it was proposed to be converted into a grocery store. The sheer size and volume of the interior proved to be a good match for the new use. The car barn was large enough that the grocery store itself could fit into the front half of the building, leaving the rear portion available for parking. The openness and immense height of the interior with its exposed metal structural system contributes to the market's appeal and is also ideal for the parking area which, after all, was the building's original use. New corrugated metal replaced the rusted historic metal sheathing on the exterior. The large historic vehicular openings on the back allow access to the parking and also provide ventilation. The vehicular doors on the front were infilled with a butt glazed storefront system to retain the open appearance the building had historically. This project meets the Standards.

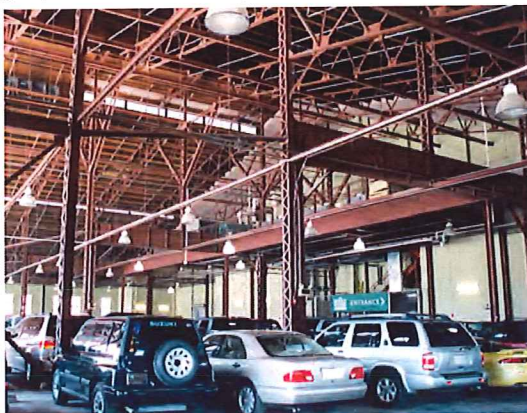
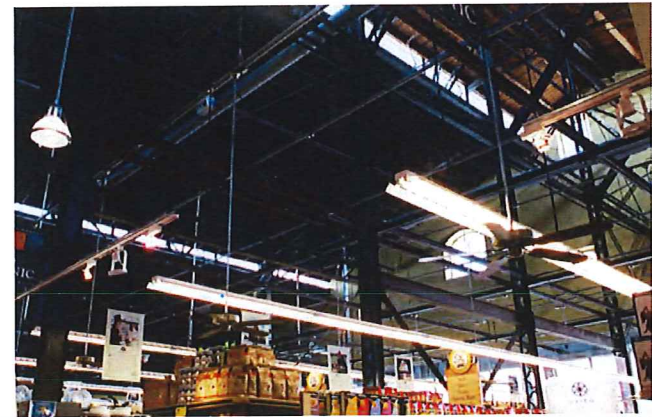
Left and Right: The exposed trusses on the interior, both in the parking area and in the grocery store, emphasize the structure's industrial character.

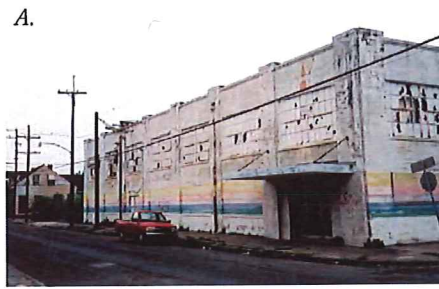
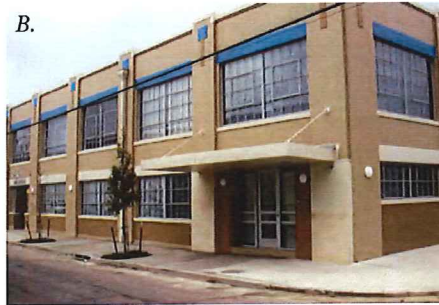
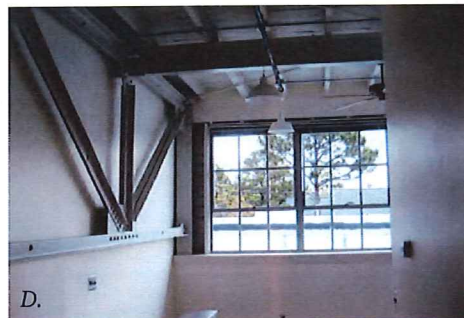
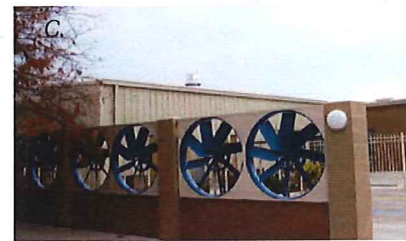
Clockwise from top:
A. The early-twentieth century garment factory before rehabilitation.
B. After rehabilitation, historic windows shine again after repair and paint removal. New windows have been installed in bricked-up openings and new matching windows have replaced historic windows too deteriorated to repair.
C. Old fans have been reused decoratively as part of a fence around the parking lot.
D & E. Accented by new industrial lighting fixtures, the historic character of the interior is clearly expressed in the exposed wood and steel beams and trusses, as well as in the original concrete floor.

Application 2 (Compatible treatment): This small brick garment factory was constructed c. 1930 with later expansions. After being vacant for many years the building was rehabilitated as low-to-moderate income residential units. The character-defining industrial metal windows were retained where possible, while those that were deteriorated beyond repair were replaced to match the existing. Bricked-up windows were reopened and matching windows were installed. The simple metal canopy over the entrance in the front was retained and the deteriorated corrugated metal siding on one elevation was replaced to match. The industrial nature of the building is also clearly evidenced on the interior in the exposed wood ceiling and metal trusses. Even the large fans that cooled the sewing area of the factory were incorporated as decorative elements in a fence around the parking lot. This project has preserved the industrial character of the structure and meets the Standards.

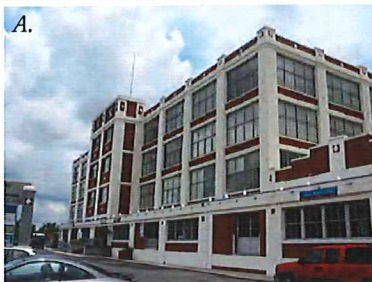
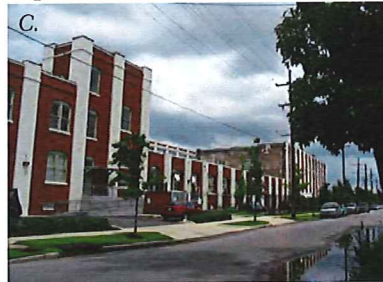
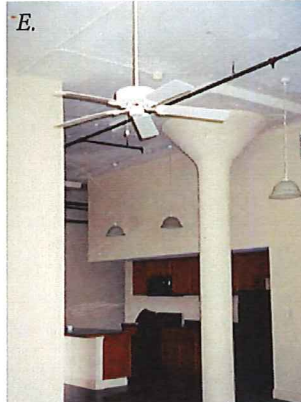
Clockwise from left:
A. After rehabilitation, this section of the factory complex includes a restaurant and shops on the first floor with apartments on the upper floors. Partially-glazed infill in the loading door openings is compatible with the character of the building.
B & C. The historic industrial bridge was retained, as were the ruins of walls that remained after a fire.
D & E. The industrial nature of the interior is evident in the mushroom-capped cast concrete columns and the fire doors that remain in several of the buildings.

Application 3 (Compatible treatment): A group of early-twentieth century factory buildings, the oldest of which dates to c. 1908, was rehabilitated into a multi-use residential, retail and commercial complex. As part of the rehabilitation, the existing windows--both wood and metal--were retained and repaired or, where necessary, replaced to match. Compatible, partially-glazed infill was installed in many of the loading dock openings on the first floor. An existing corrugated metal industrial bridge connecting two buildings was retained and the ruined walls of a fire-damaged structure were also retained as part of the complex. On the interior, mushroom-capped columns and the unfinished cast concrete ceiling were left exposed throughout. Historic metal fire doors were also kept and secured in an open position. This project, too, meets the Standards.

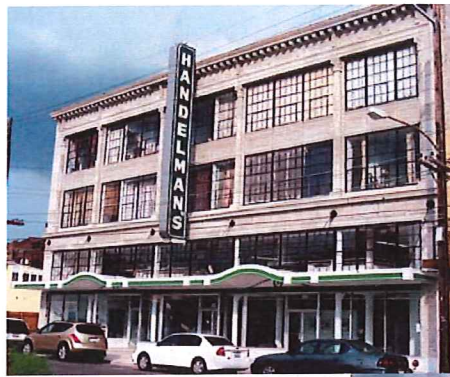
Left: This three-story building (shown after rehabilitation) was constructed in 1923 for use as a department store.

Application (Compatible treatment): This three-story building, originally constructed in 1923 as a department store with retail and warehouse space, was rehabilitated for commercial and residential use. The upper floors

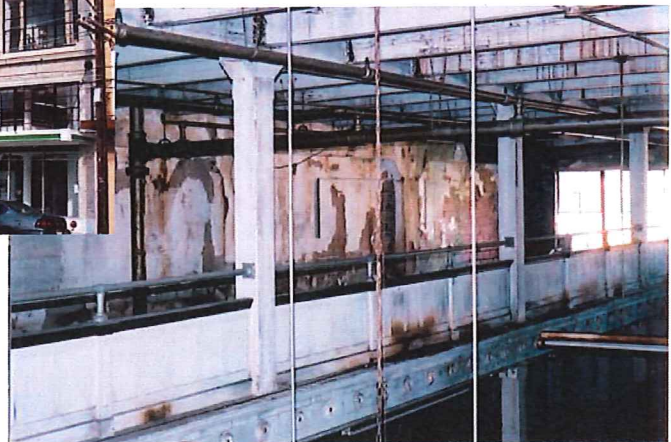
Prior to rehabilitation the one and one-half story space and mezzanine (above and below) were in poor condition after years of neglect.

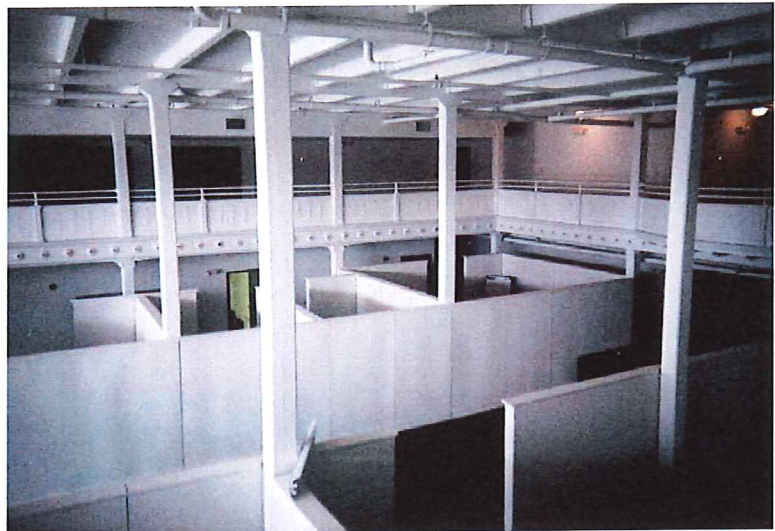
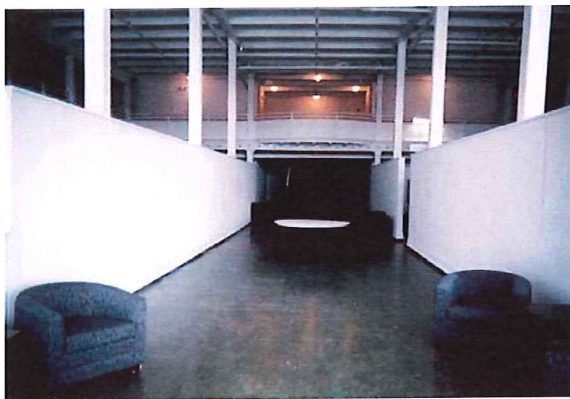
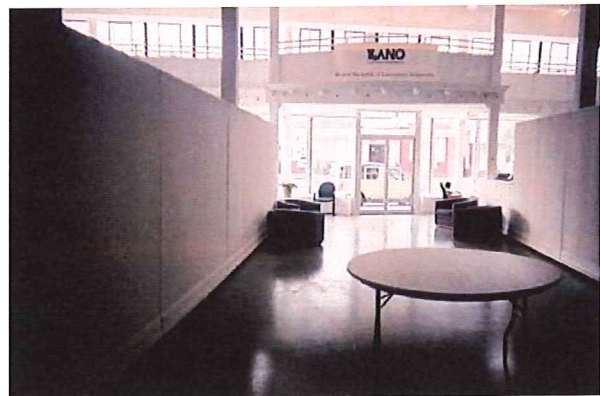
Although low-walled office cubicles were inserted on the first floor during the rehabilitation, the character-defining aspect of the space itself, as well as its principal features, the mezzanine and the grand staircase, are still clearly perceived (above and below).

In order to adapt the space to accommodate the tenant's large staff, the project architect designed simple beaded board office cubicles with low walls, and open to the ceiling. The tops of the walls of the cubicles stop well below the bottom of the mezzanine, which permits the one and one-half story space to retain its openness. The low walls provide privacy for the staff yet still allow the space to be perceived in its entirety from the first floor as well as from the mezzanine. This treatment meets the Standards.

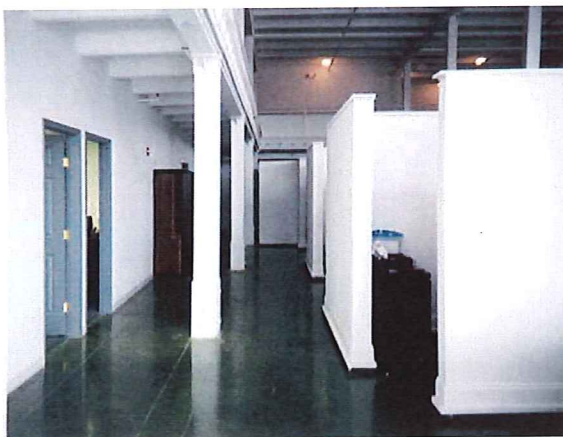
Detail. Casters on the bottom of the cubicle partitions allow them to be moved around or removed from the space.

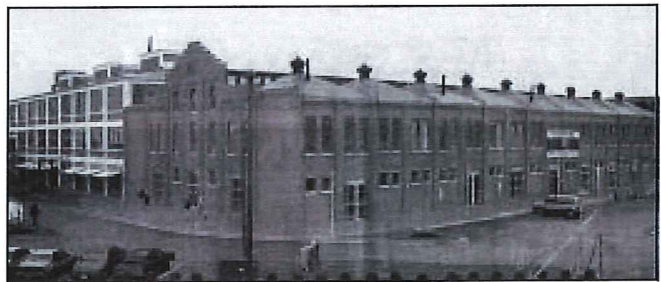
Tin can factory following rehabilitation.

Application 1 (Compatible Treatment): This 1895, three-story brick warehouse with its stepped gable façade, corrugated metal monitor roof and distinctive ventilators was originally built as a tin can manufacturing plant. The long vacant building was recently rehabilitated for use as research and office space for the world headquarters of a major manufacturing company. The creative design used in the rehabilitation for the interior underscored the building's industrial character by using materials, such as corrugated metal walls, steel beams and exposed wooden columns. Any required partitions were constructed to retain an open view of the character-defining latticed I-beams and metal trusses. The windows in the roof monitor over the center aisle were reopened and restored. The result is an open, contemporary office space that successfully retains the character of this utilitarian building.

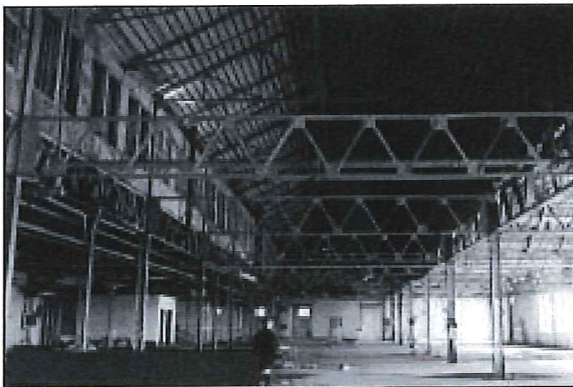
Second and third floor truss system before rehabilitation.

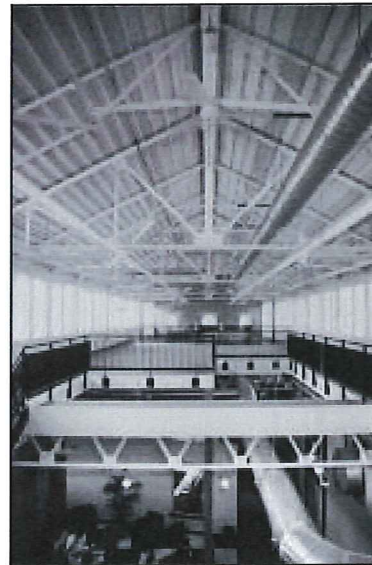
Interior following rehabilitation showing exposed latticed I-beams and metal trusses.

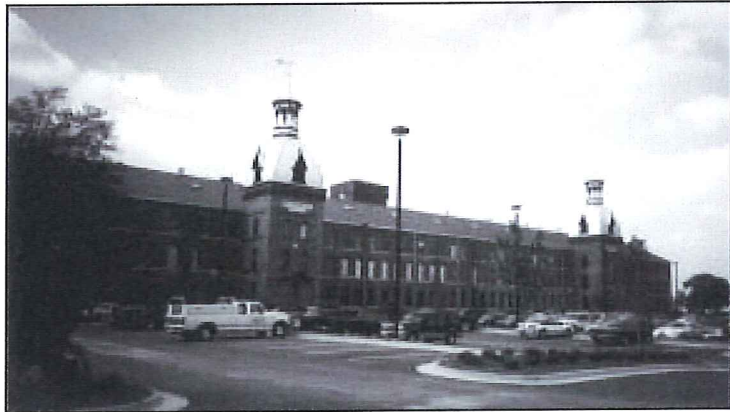
1878-1881 Textile Mill

This monumental, three-story mill building with its prominent four-story, mansard roofed stair towers is more than 400 feet in length. Constructed from 1878 to 1881, this building serves as the entry to a former flour/cotton mill complex. Recently, this mill building was rehabilitated as part of a mixed-use residential and commercial complex. While the exterior of this imposing building is highly ornamented, the interior was historically utilitarian manufacturing space characterized by exposed brick walls, wooden-chamfered posts, beams and planking, void of any decorative detail. The rehabilitation retained these character-defining features while accommodating the necessary subdivision of the large expanses of space for the new use. The large number of columns were retained by leaving some free standing in hallways and public spaces, while many remain visible engaged as part of partitions. The exposed beams, original flooring and exposed brick also preserves the industrial character of the mill's interior in the new use.

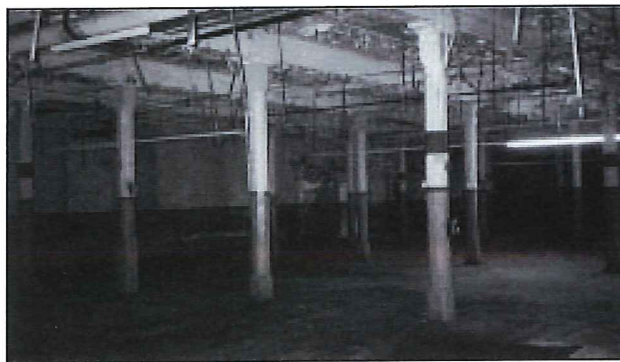
Exposed structure of the mill building prior to rehabilitation.

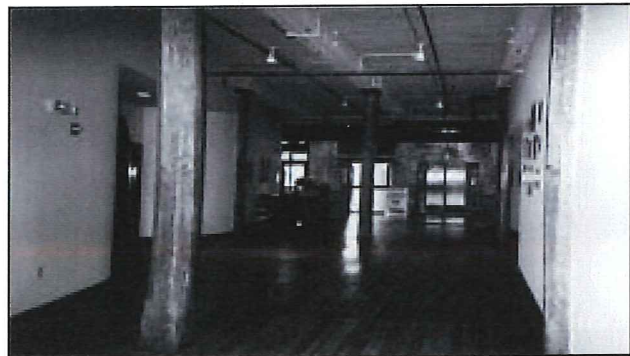
Interior after rehabilitation retains the exposed structure and finishes characteristic of the mill building with subdivision of the space for the new use.

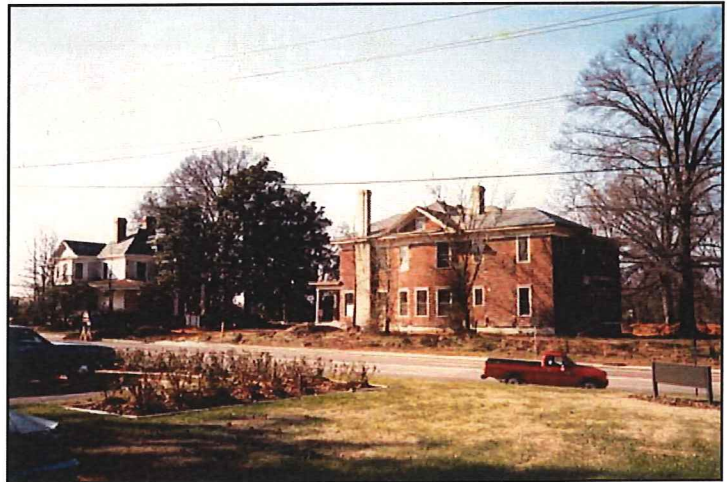
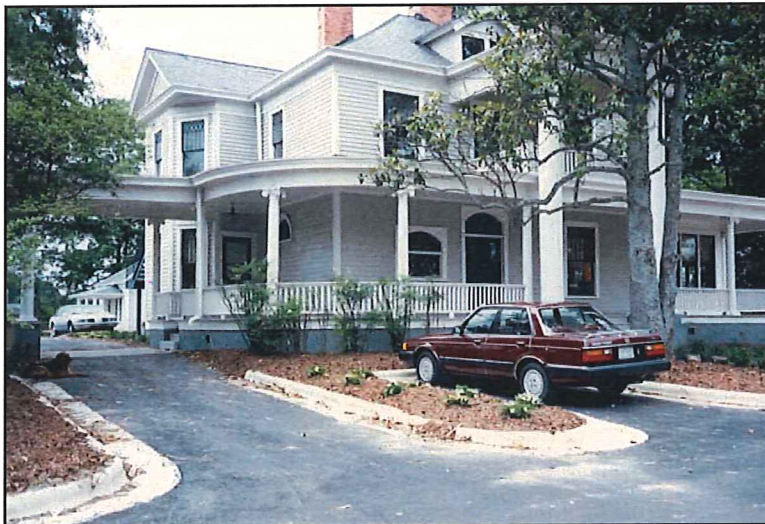
The new parking lot completes the drastic alteration of the setting. The second relocated structure (C2) can be seen through the porte-cochere at left.

To convert the site into an office condominium complex, the owner moved a house from an adjacent lot with a similar setback and orientation, and set it in the front yard of the National Register-listed property. The moved building was turned to face the 1900 building, and a new parking lot was placed between the two structures. A smaller building from the adjacent property was also moved and sited at the rear of the 1900 building.

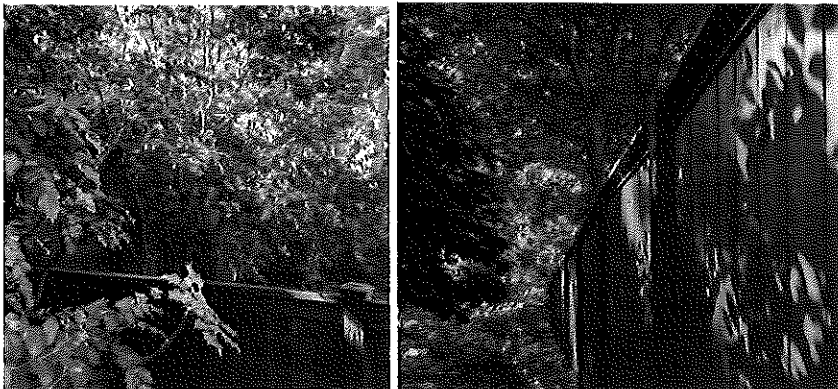
Fence on 19 Franklin Ave side

The fence was stained to match the trim of the home, particularly the wooden, original historic columns on the front porch and balcony, along with the double front doors and storm doors of the home (following Handbook guidelines). The stain was color matched to Minwax Red Oak 215 wood stain, which coincides with the same home trim stain. Oil based stains provide a long lasting protection compared to paint, which can appear dirty quicker, crack and peel from sunlight and water, and create rot by locking in moisture. Stained fencing also gives a more natural backdrop to this historic property, not to take attention away from the historic home itself.

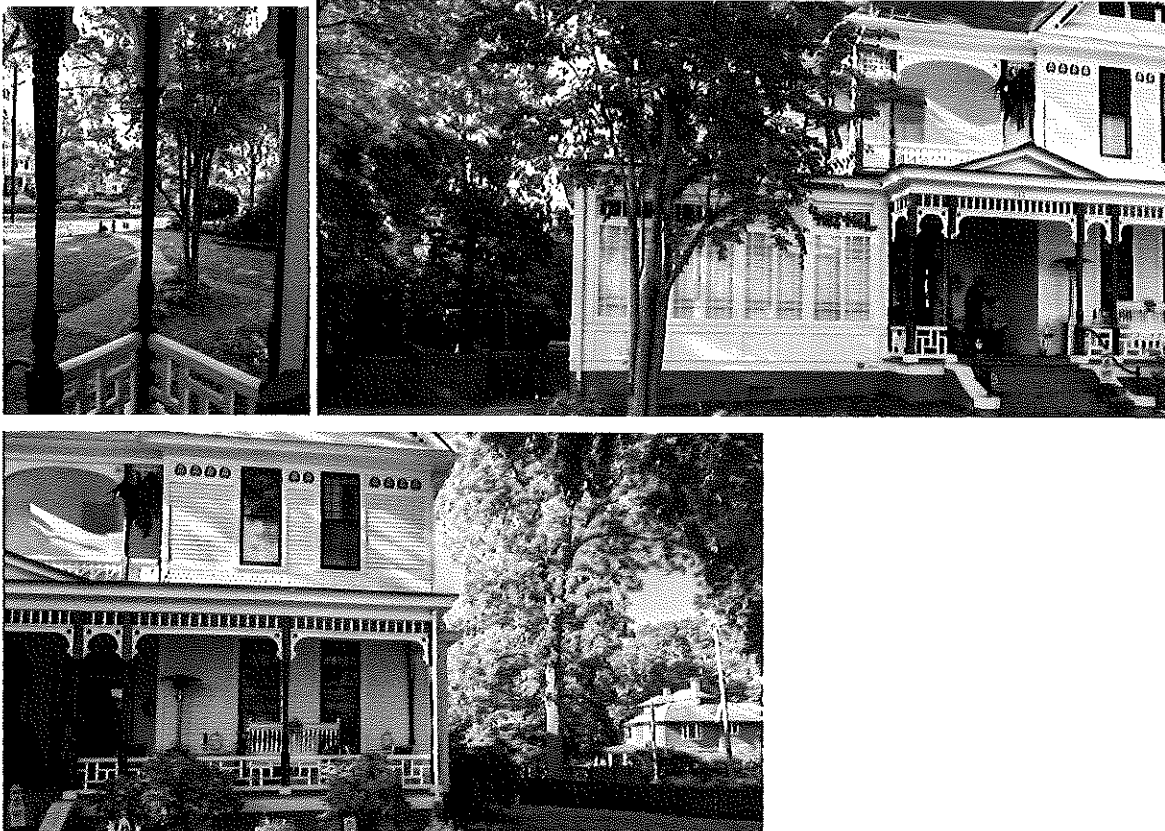
Addendum 1: Home Trim and Fencing stained to match
