HISTORIC PRESERVATION COMMISSION MEETING AGENDA

Wednesday, November 8, 2023 at 6:00 PM

H-23-23 (Quasi-Judicial Hearing)

Forest Hill United Methodist Church has submitted a Certificate of Appropriateness application for the removal and replacement of 8 trees and the installation of new landscaping at the north parking lot at the corner of Union St N and Buffalo St NW at 265 Union St N. PIN 5621-60-3553.

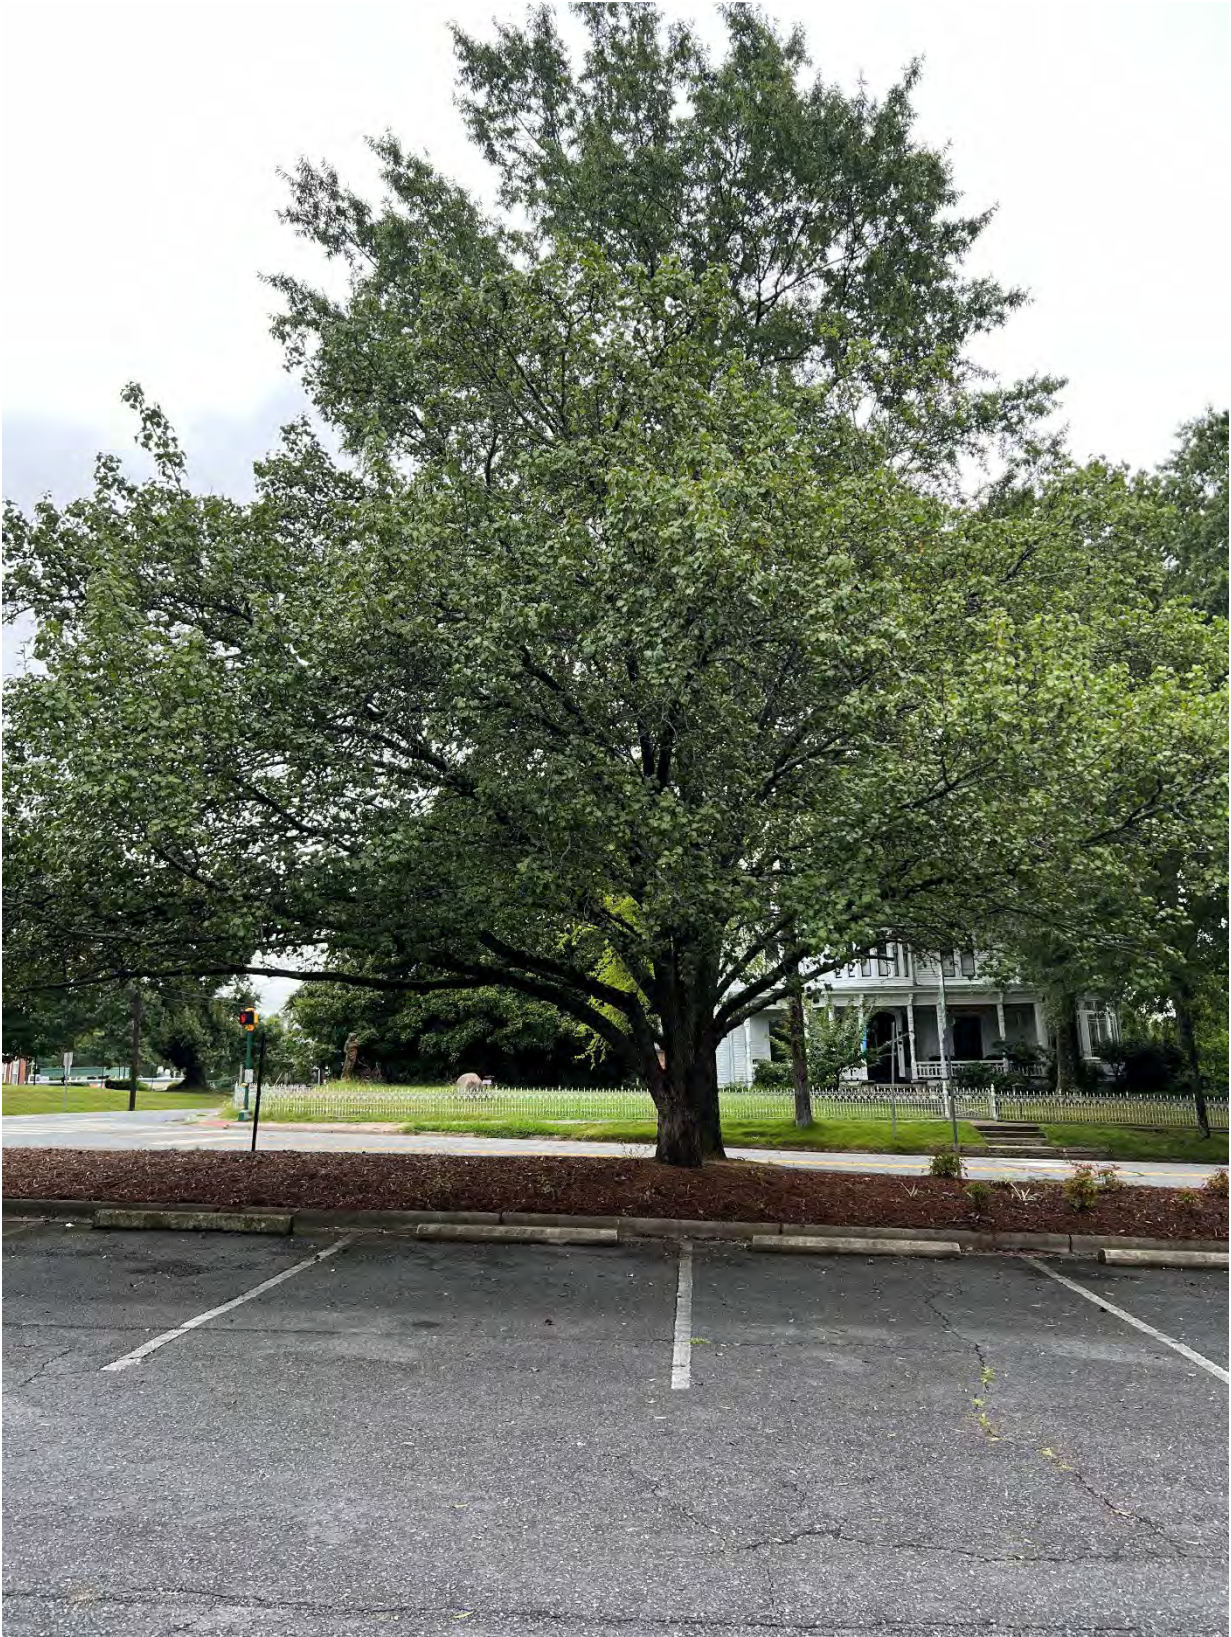
Pear 4

This mature pear tree has weak branch unions as is typical of the species.

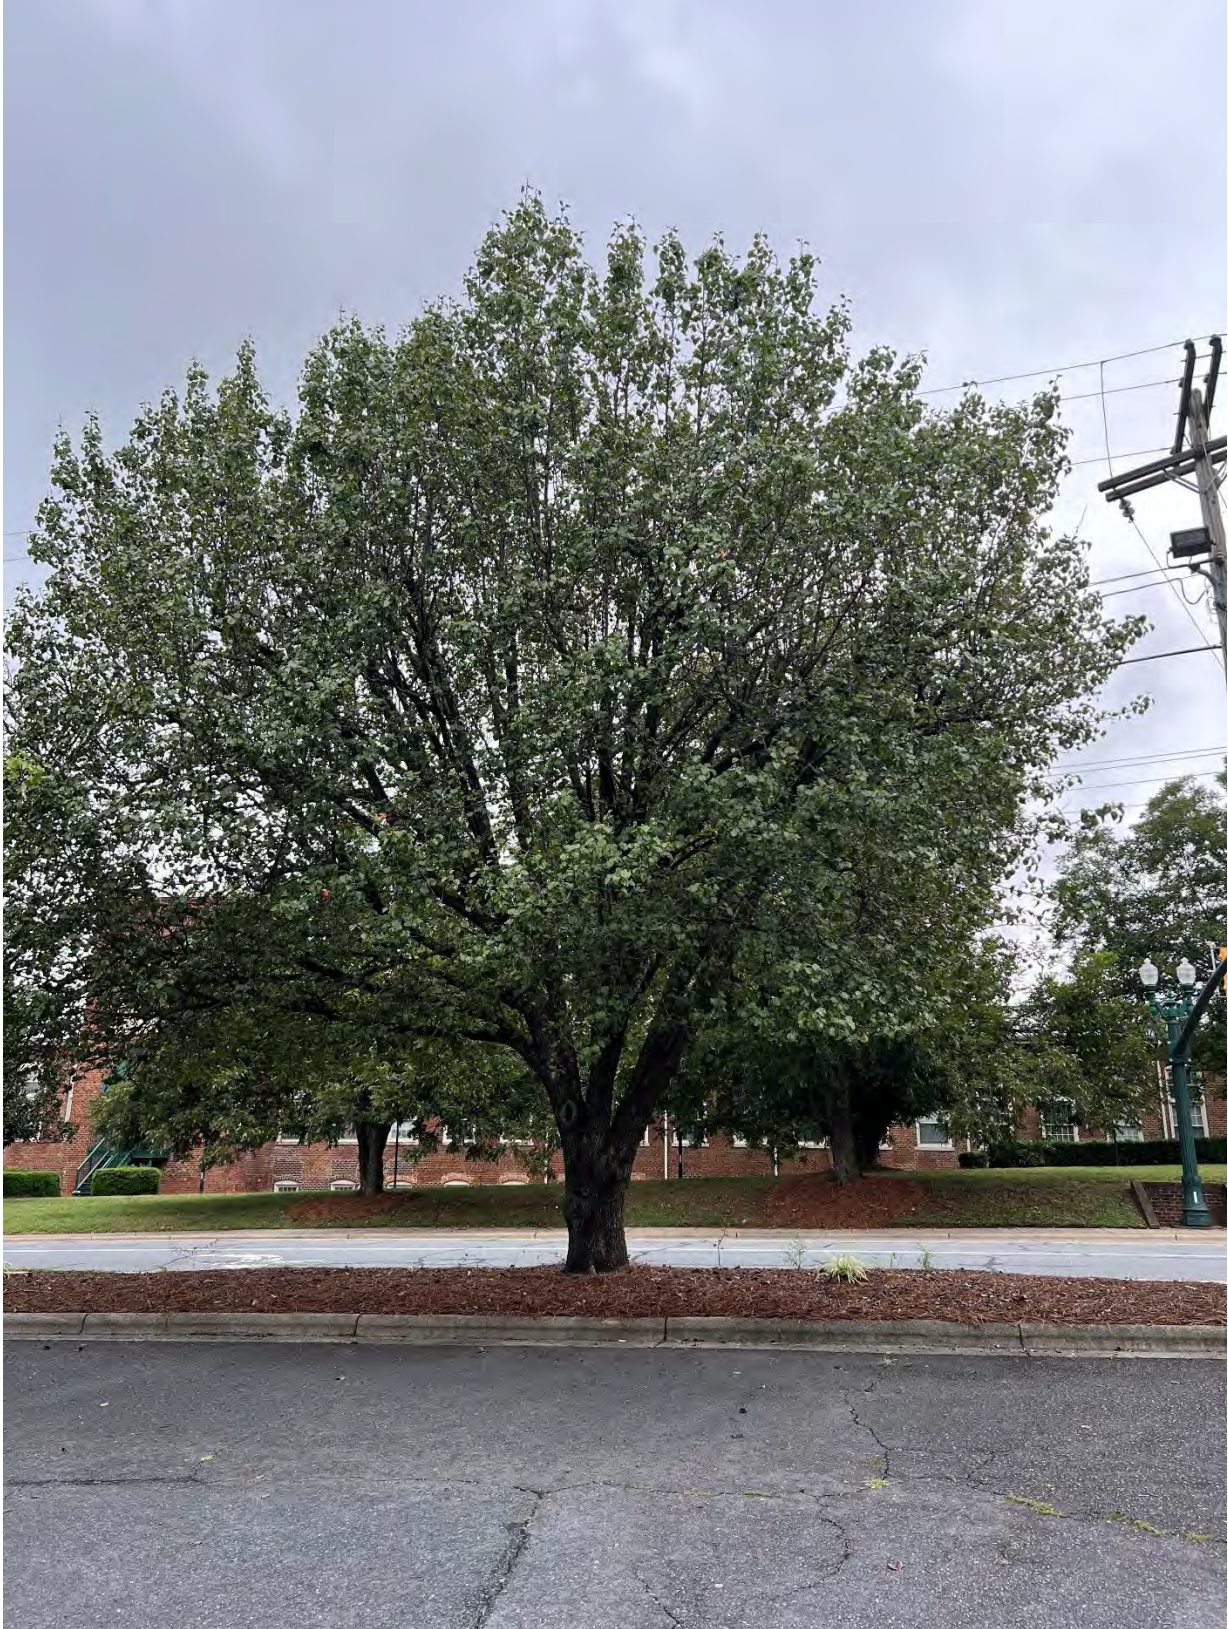
Pear 5

This mature pear tree has weak branch unions as is typical of the species.

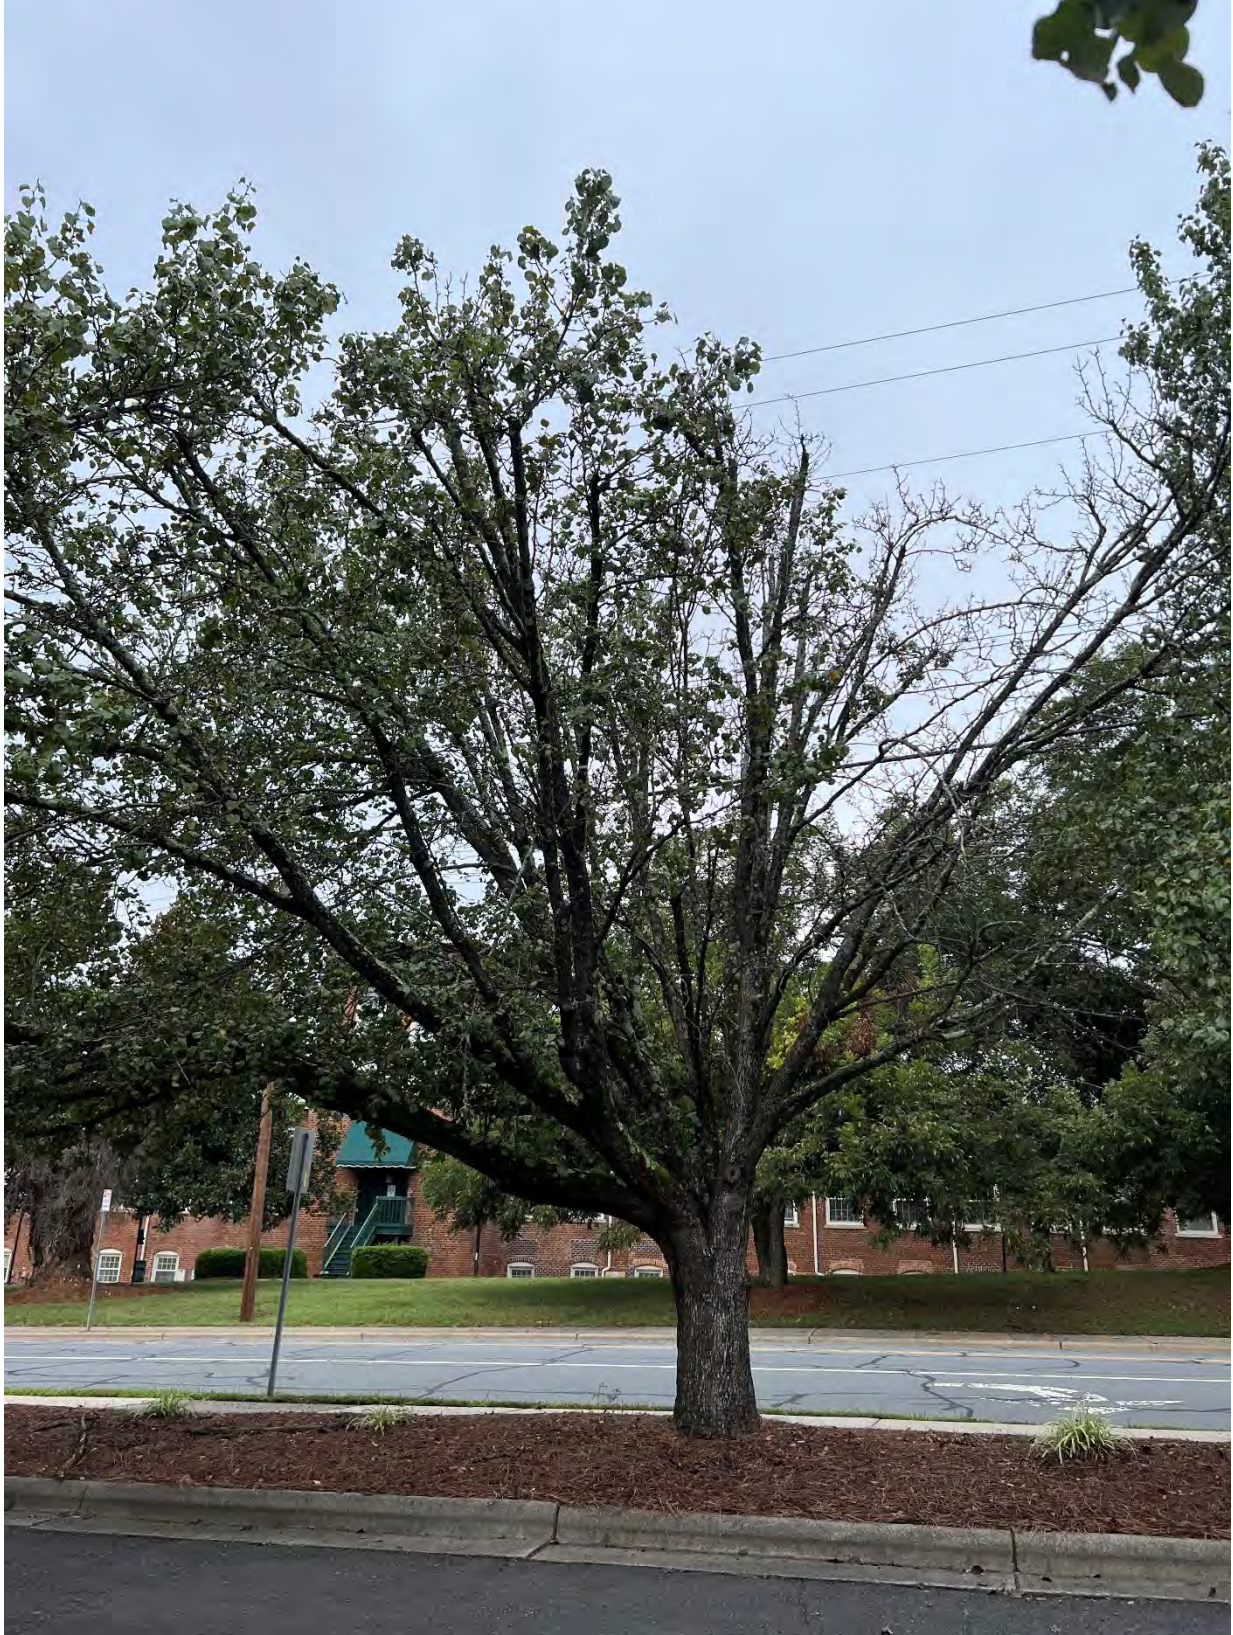
Pear 6

This mature pear tree has weak branch unions as is typical of the species. This is dieback on several upper branches.

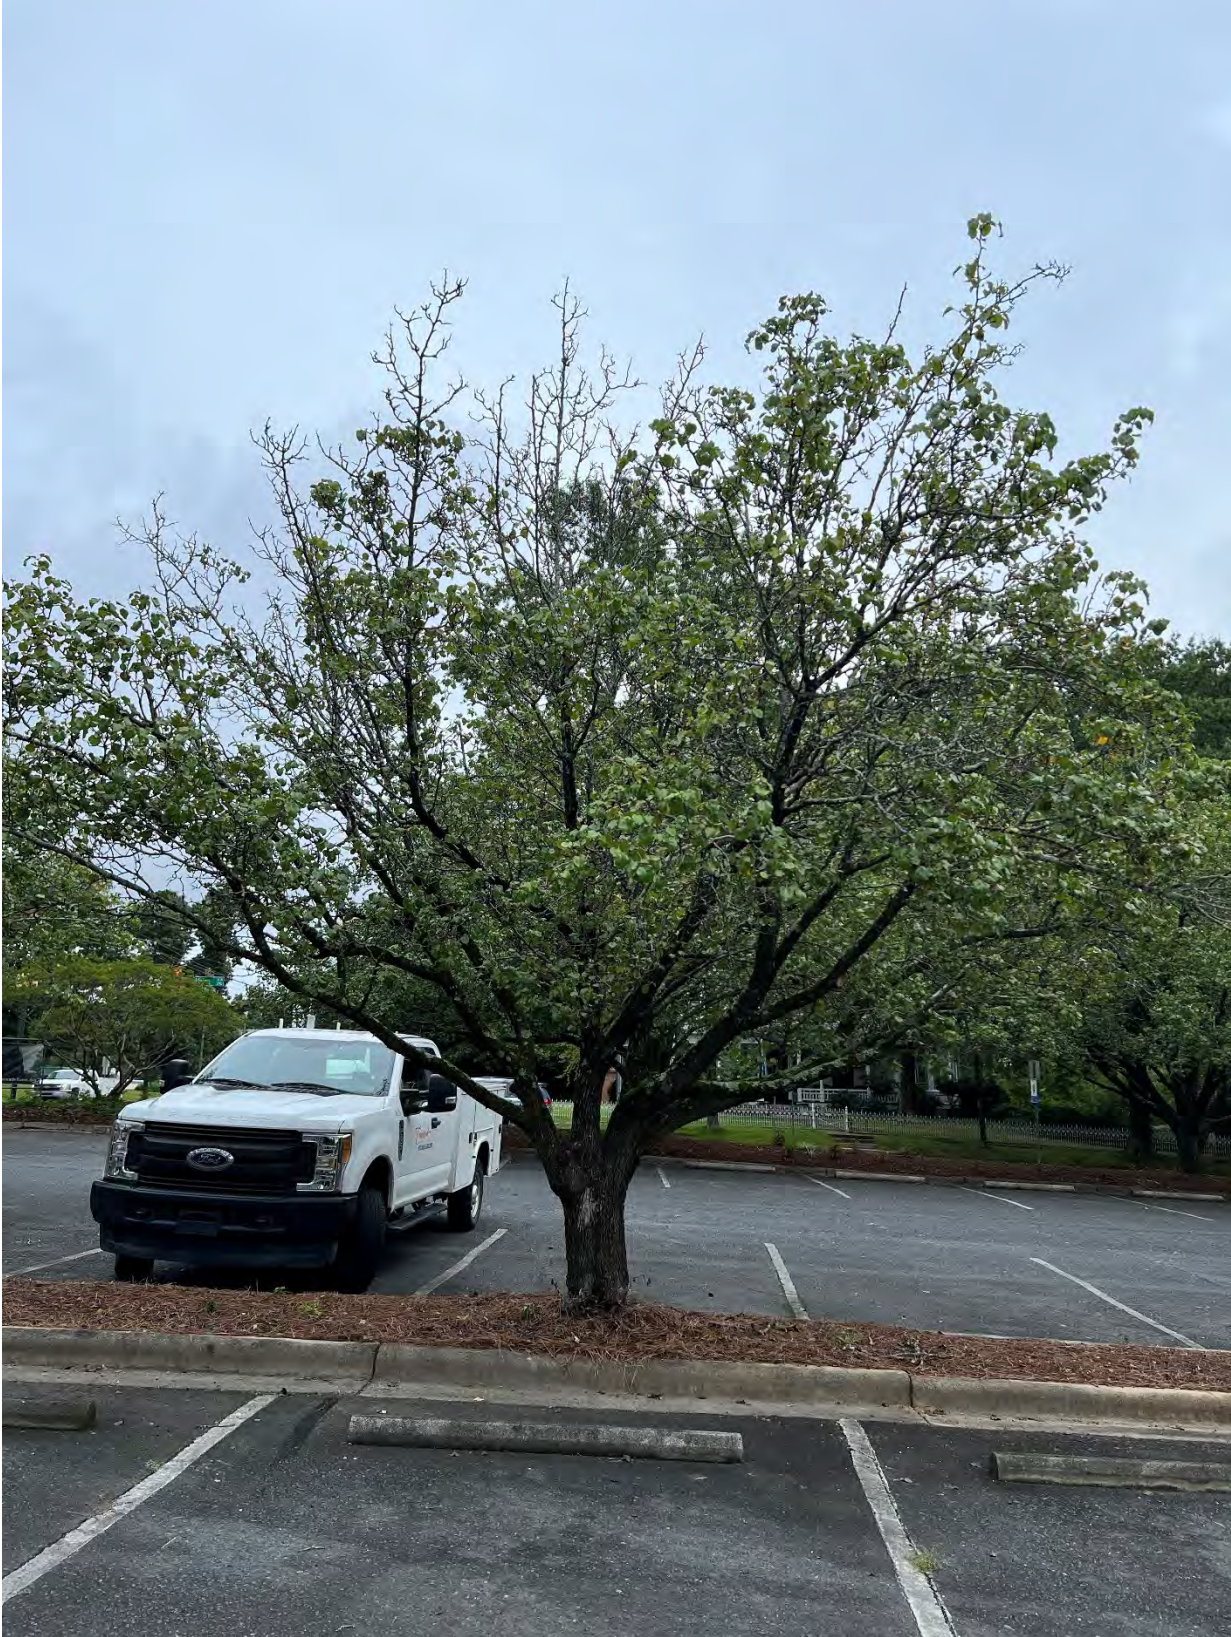
Pear 9

This mature pear tree has weak branch unions as is typical of the species. This is dieback on several upper branches.

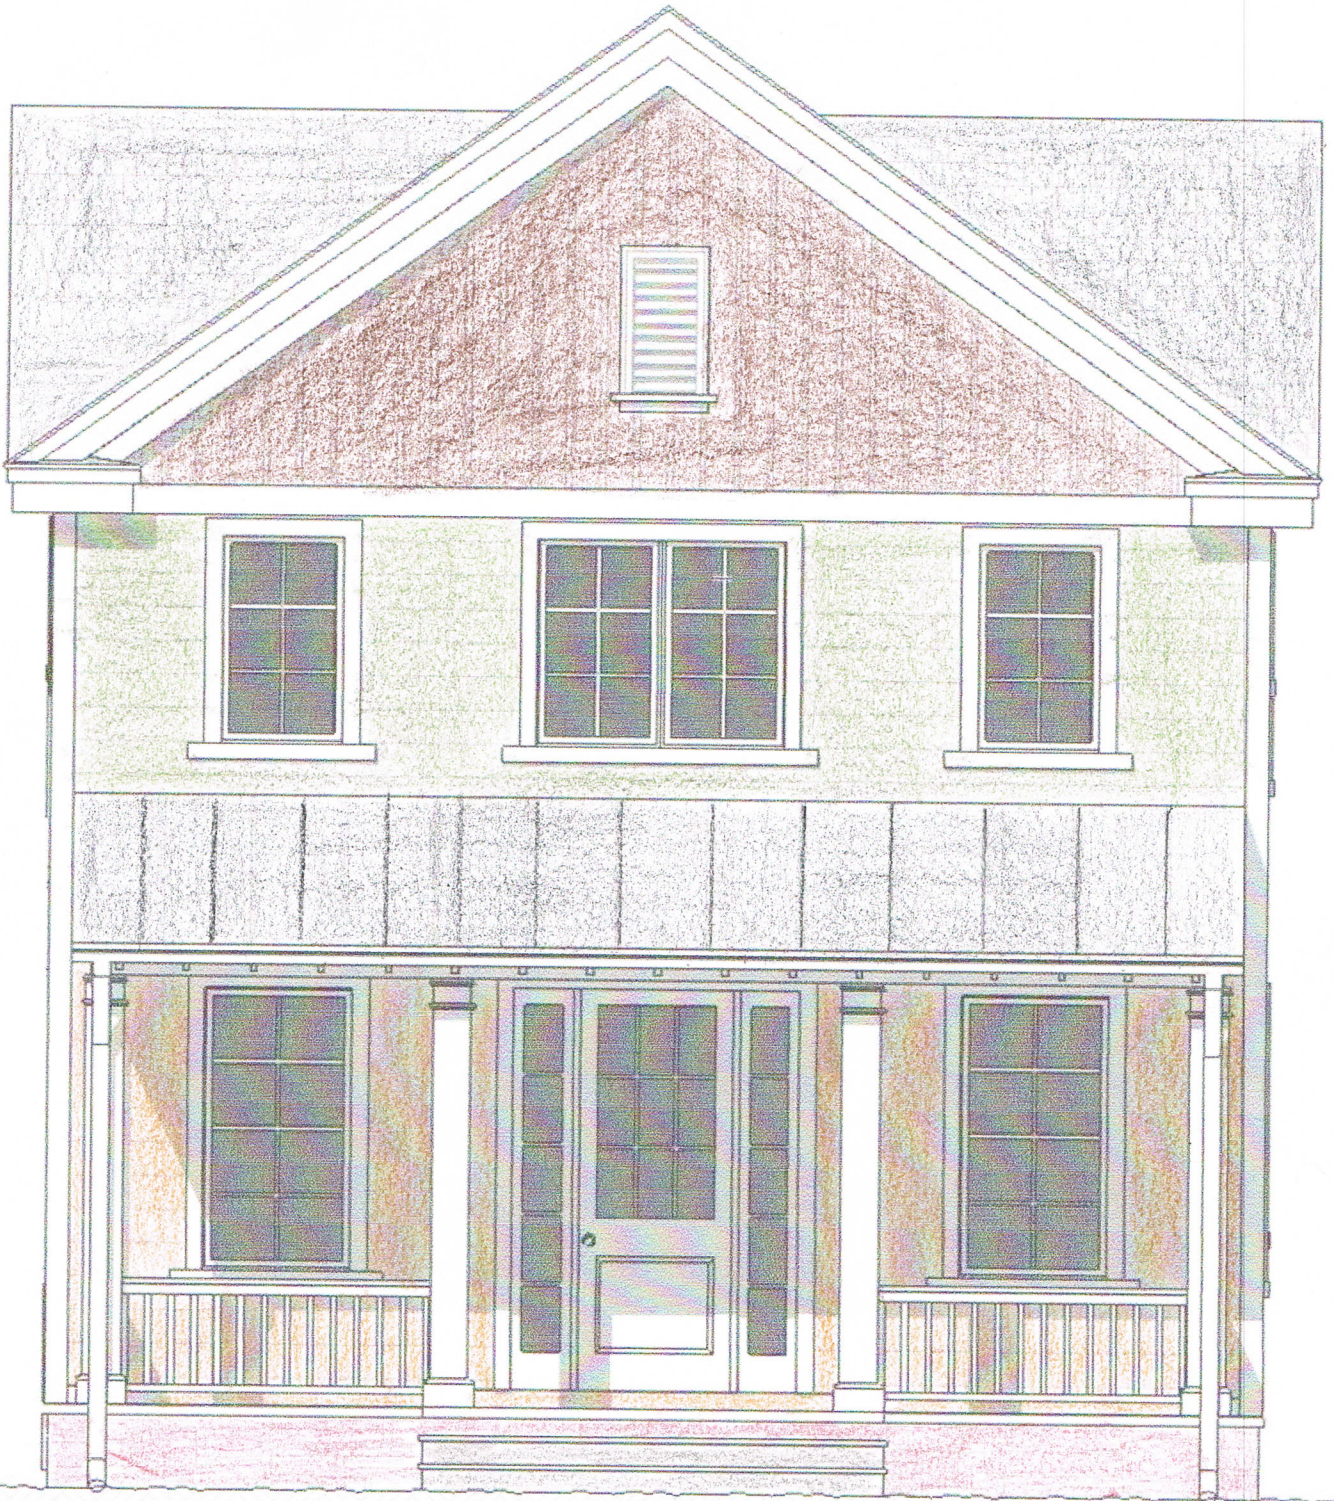
FRONT ELEVATION

GARAGE
HEIGHT
15'

6' HIGH
PRIVACY WALL

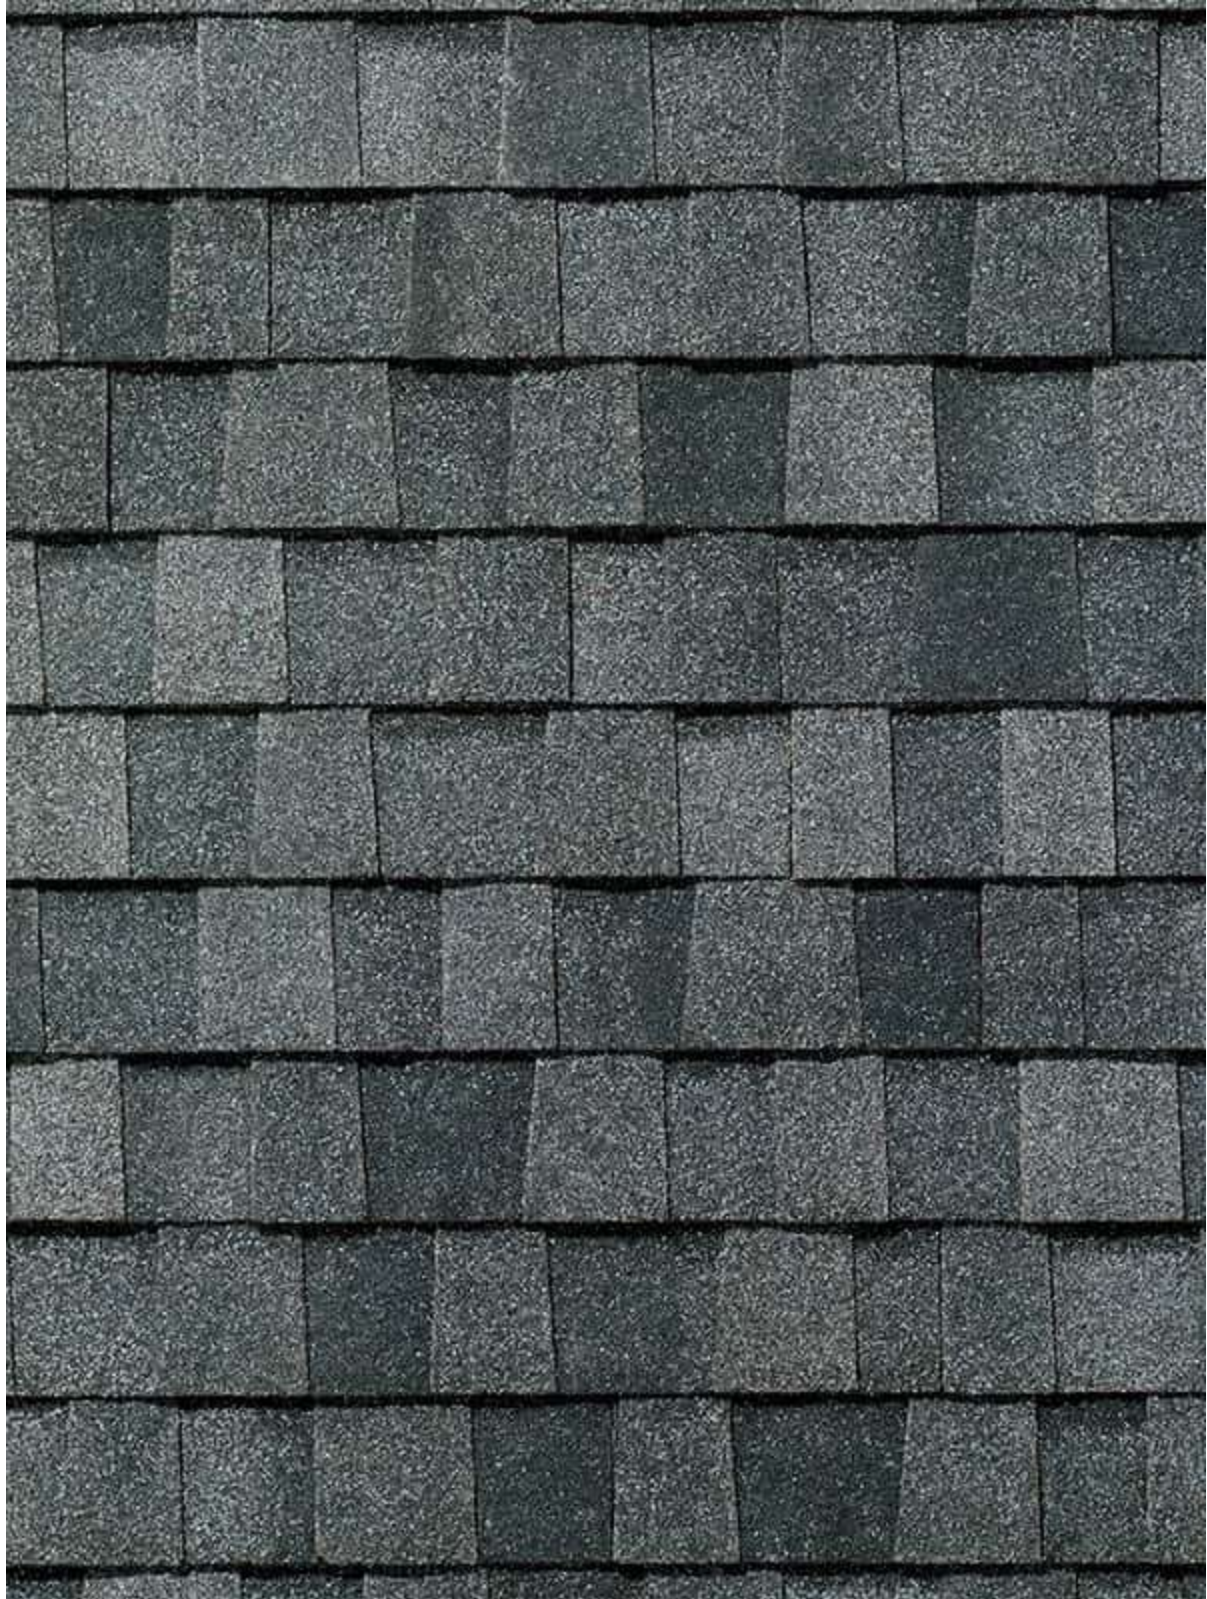
TRIANGLE BRICK CO - CAMDEN

- A - TRIANGLE BRICK - CAMDEN - BRICK
- B - JAMES HARDIE - AUTUMN TAN - LAP SIDING
- C - JAMES HARDIE - HEATHERED MOSS - LAP SIDING
- D - JAMES HARDIE - CHESTNUT BROWN - LAP SIDING
- E - TAMKO - VIRGINIA SLATE - SHINGLES
- F - ALL EXTERIOR TRIM, SOFFIT, COLUMNS - JAMES HARDIE - SAILCLOTH.

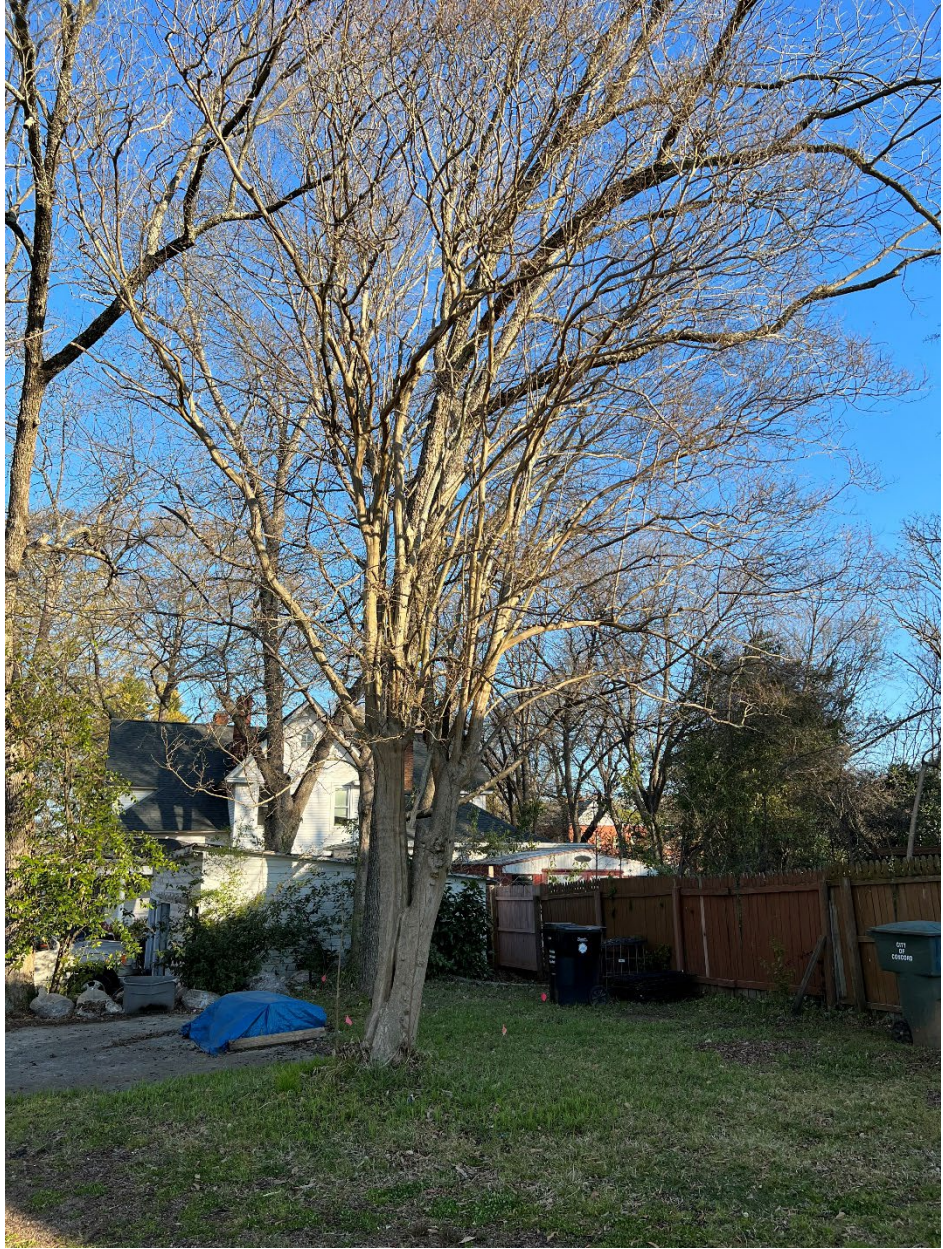
This tree has some dead branches in the crown. This is typical of old myrtles that were topped in the past.

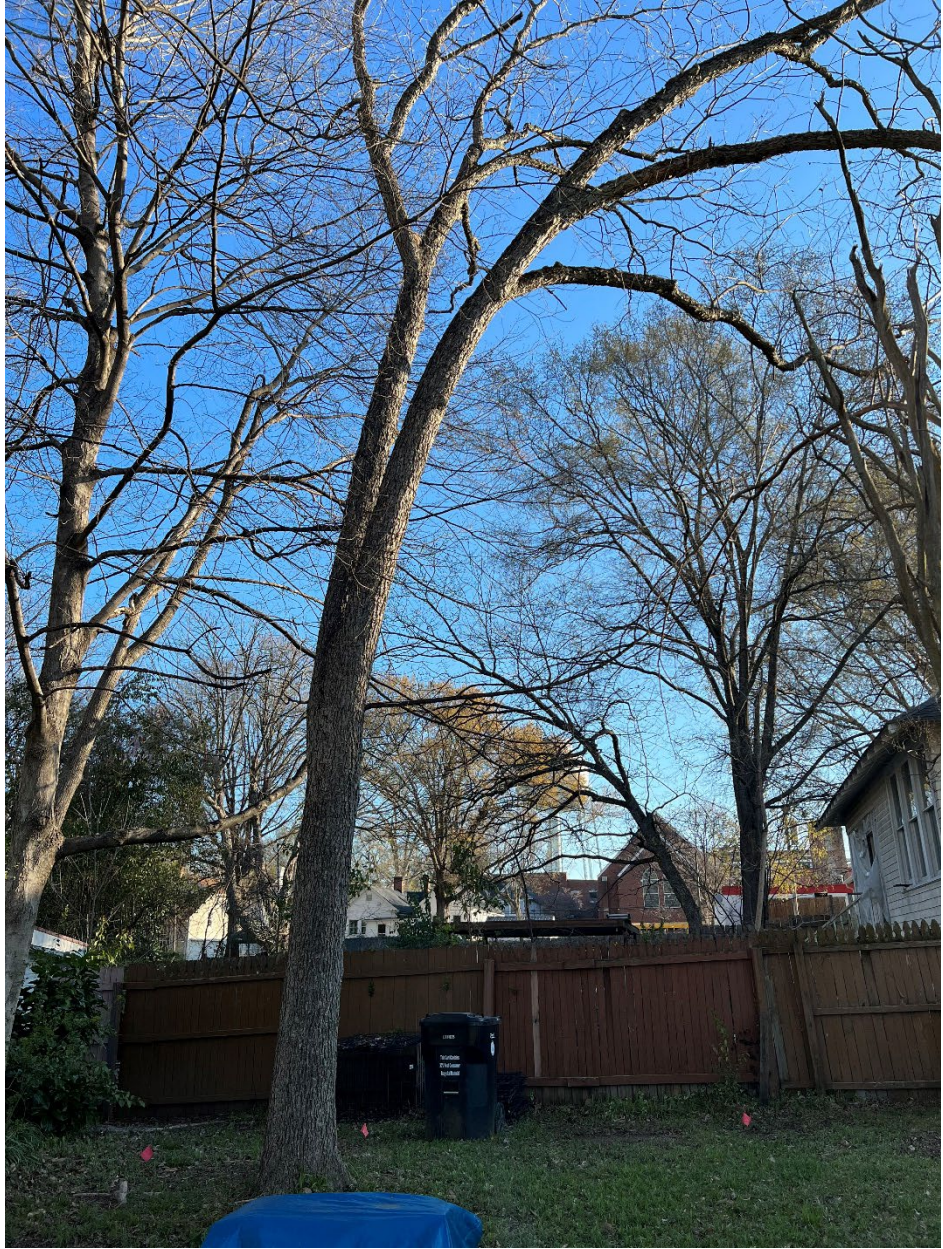
This tree has no structural defects or concerns above the normal for a healthy tree of this tree species.

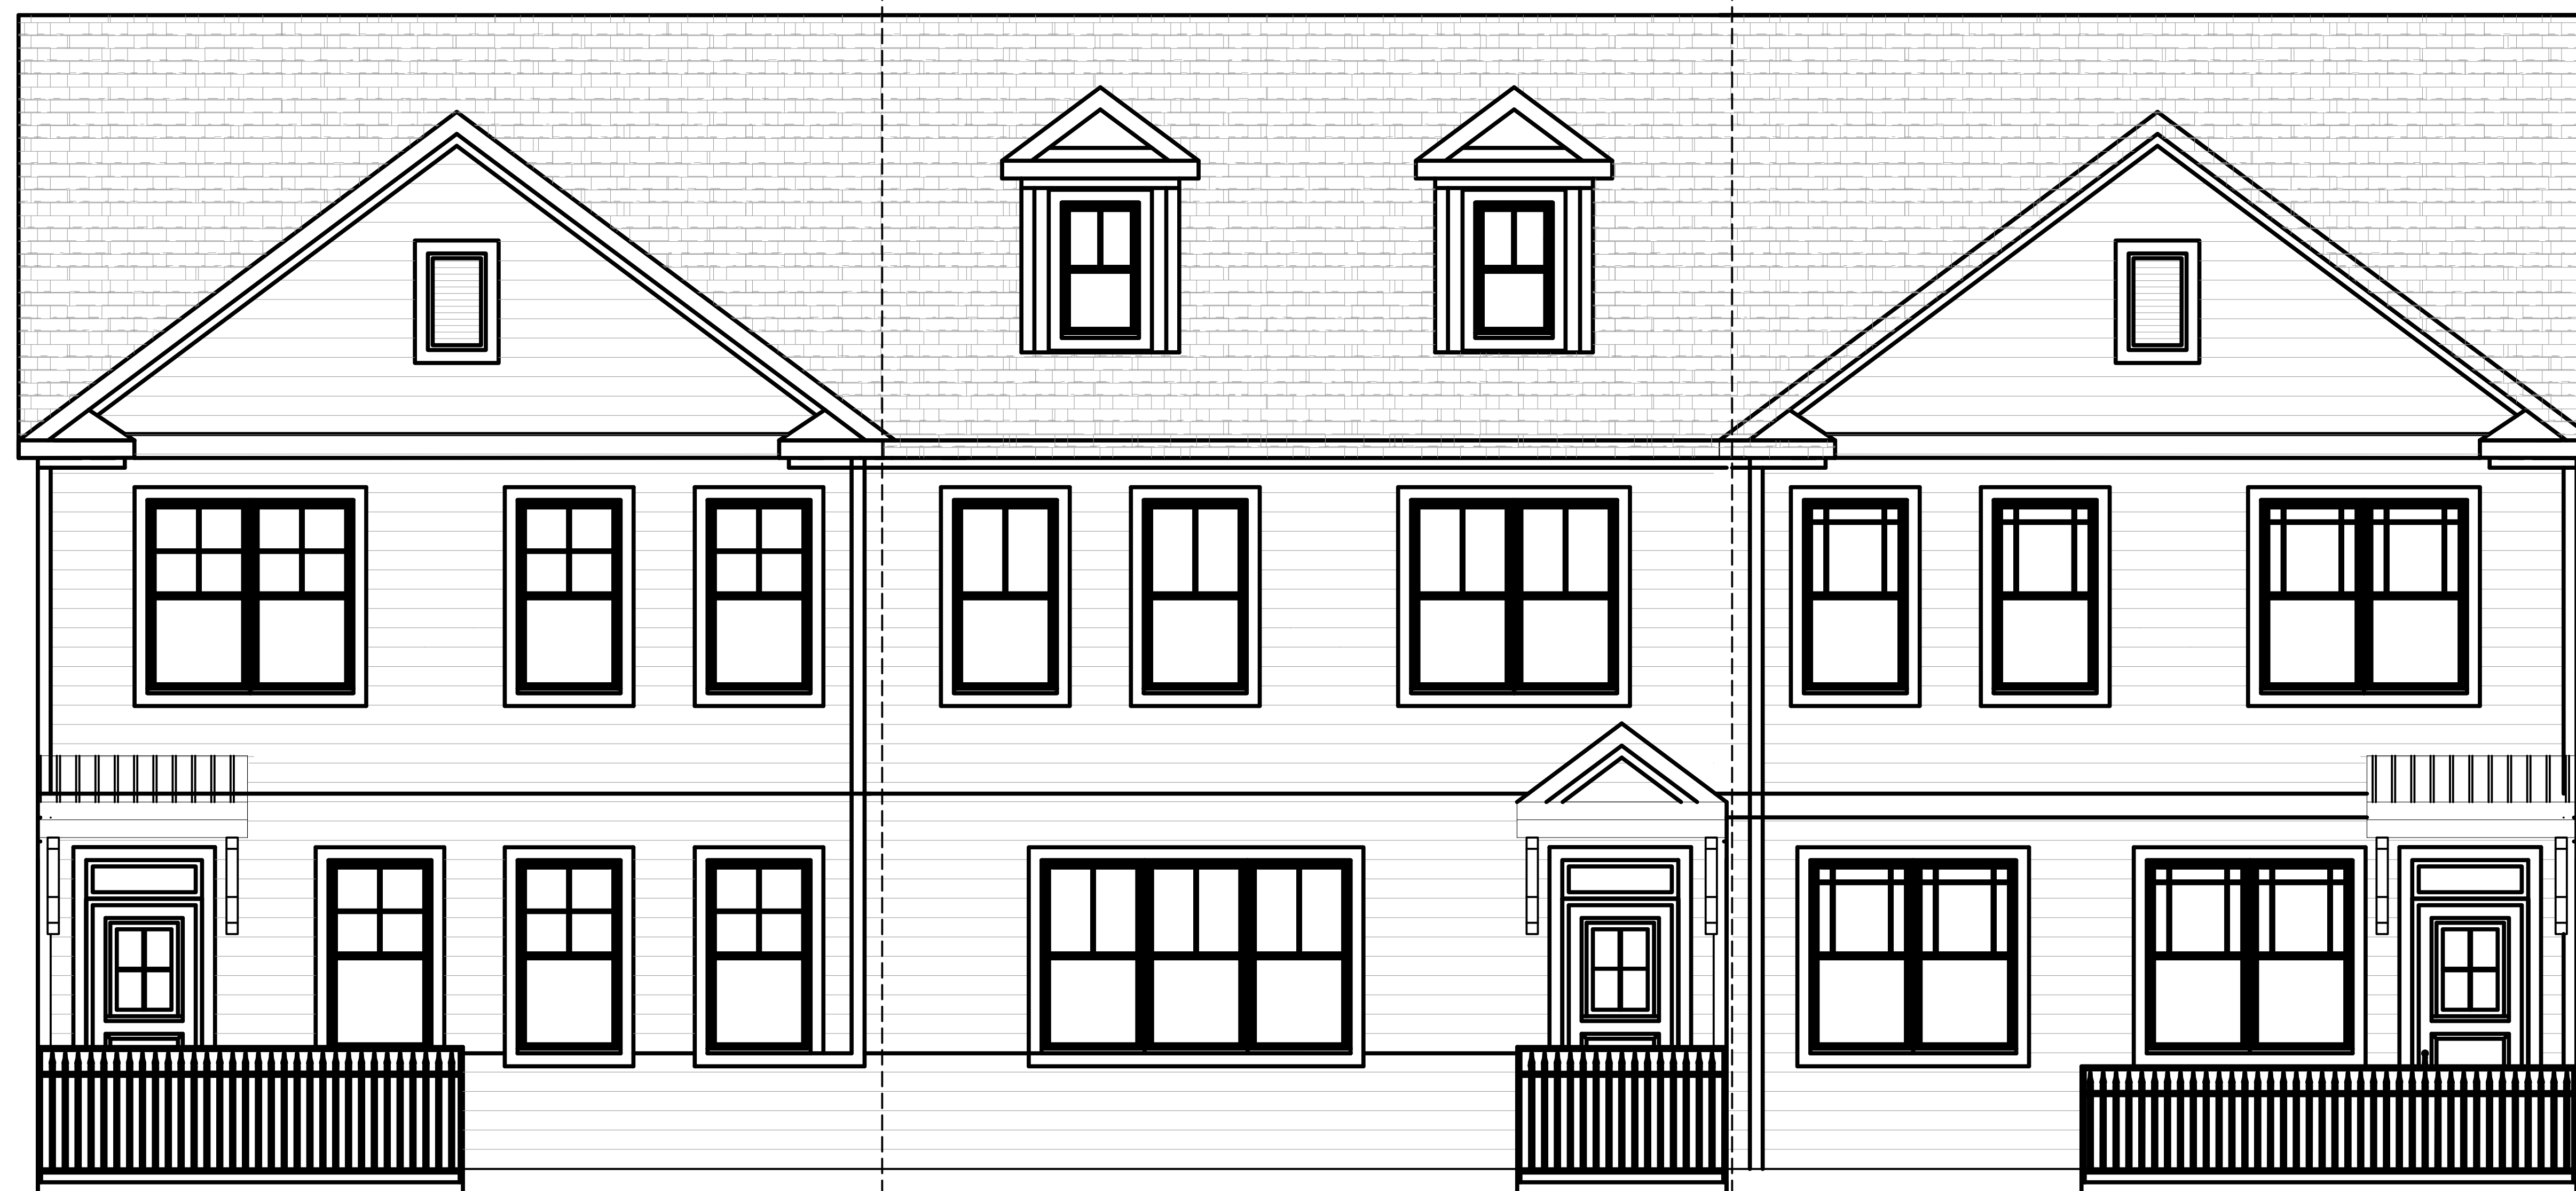
FRONT ELEVATION

R 302.2.5 & 302.2.6-TOWNHOUSE EAVE PROTECTION
 IN TOWNHOUSE CONSTRUCTION (WITH 3 OR MORE ATTACHED DWELLINGS) PROJECTIONS EXTENDING INTO THE FIRE SEPARATION DISTANCE SHALL HAVE NOT LESS THAN 1 HOUR FIRE RESISTIVE CONSTRUCTION ON THE UNDERSIDE. SOFFIT MATERIAL BEYOND THE FIRE SEPARATION DISTANCE SHALL BE SECURELY ATTACHED TO FRAMING MEMBERS AND SHALL BE CONSTRUCTED USING EITHER NON-COMBUSTIBLE SOFFIT MATERIAL, FIRE RETARDANT TREATED SOFFIT MATERIAL, VINYL SOFFIT INSTALLED OVER 3/4" WOOD SHEATHING OR 5/8" GYPSUM BOARD. VENTING REQUIREMENTS SHALL BE PROVIDED IN BOTH SOFFIT AND UNDERLAYMENTS. VENTS SHALL BE EITHER NOMINAL 2" CONTINUOUS OR EQ. INTERMITTENT AND SHALL NOT EXCEED THE MIN. NET FREE AIR REQUIREMENTS ESTABLISHED IN SECTION R206.2 BY MORE THAN 50%
 VENTS IN THE SOFFIT ARE NOT ALLOWED WITHIN 4' OF FIRE WALLS OR PROPERTY LINES

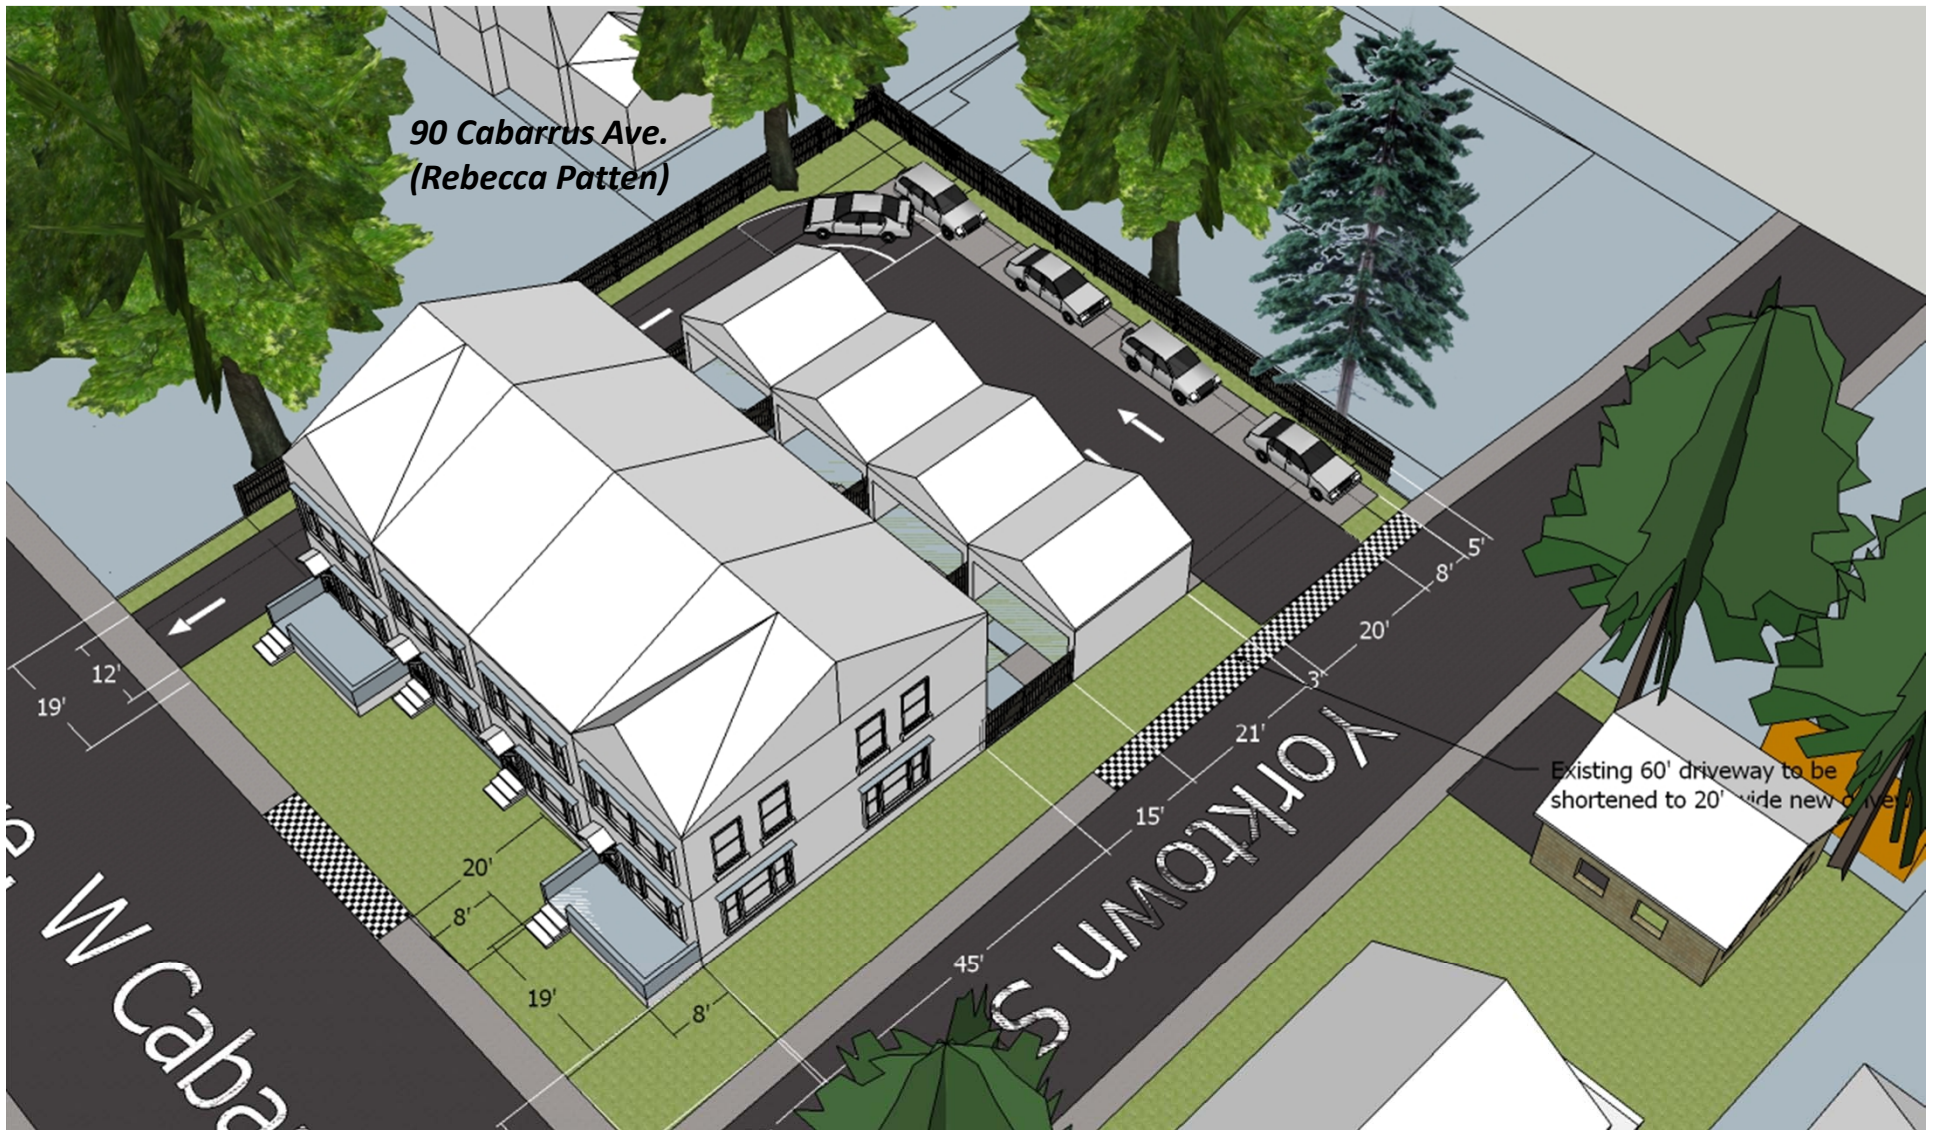
All models are for height/massing purposes only, not detailed architecture. Historic Preservation Commission will review detailed architecture (i.e. materials, roof pitch/style, etc.)

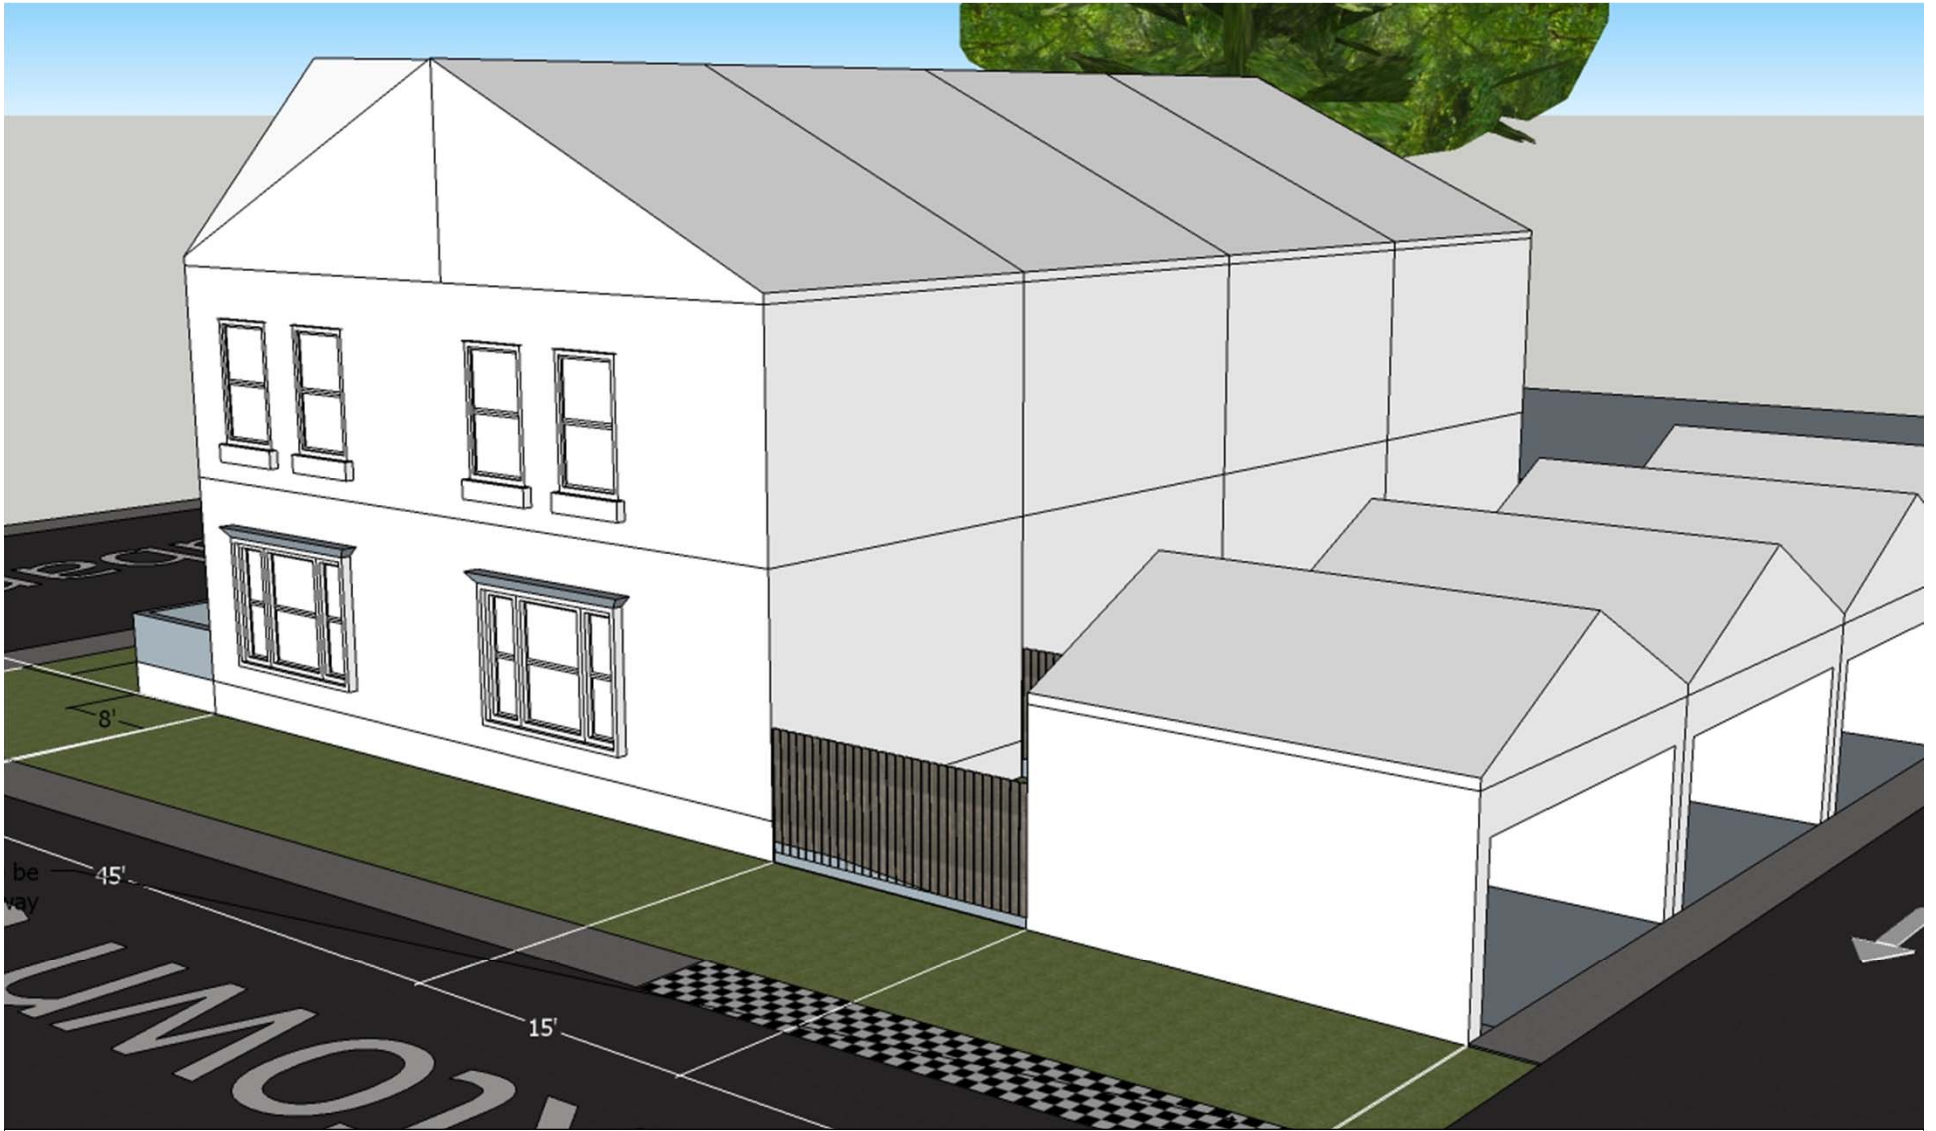
All models are for height/massing purposes only, not detailed architecture. Historic Preservation Commission will review detailed architecture (i.e. materials, roof pitch/style, etc.)
