HISTORIC PRESERVATION COMMISSION MEETING AGENDA

Wednesday, November 8, 2023 at 6:00 PM

H-23-23 (Quasi-Judicial Hearing)

Forest Hill United Methodist Church has submitted a Certificate of Appropriateness application for the removal and replacement of 8 trees and the installation of new landscaping at the north parking lot at the corner of Union St N and Buffalo St NW at 265 Union St N. PIN 5621-60-3553.

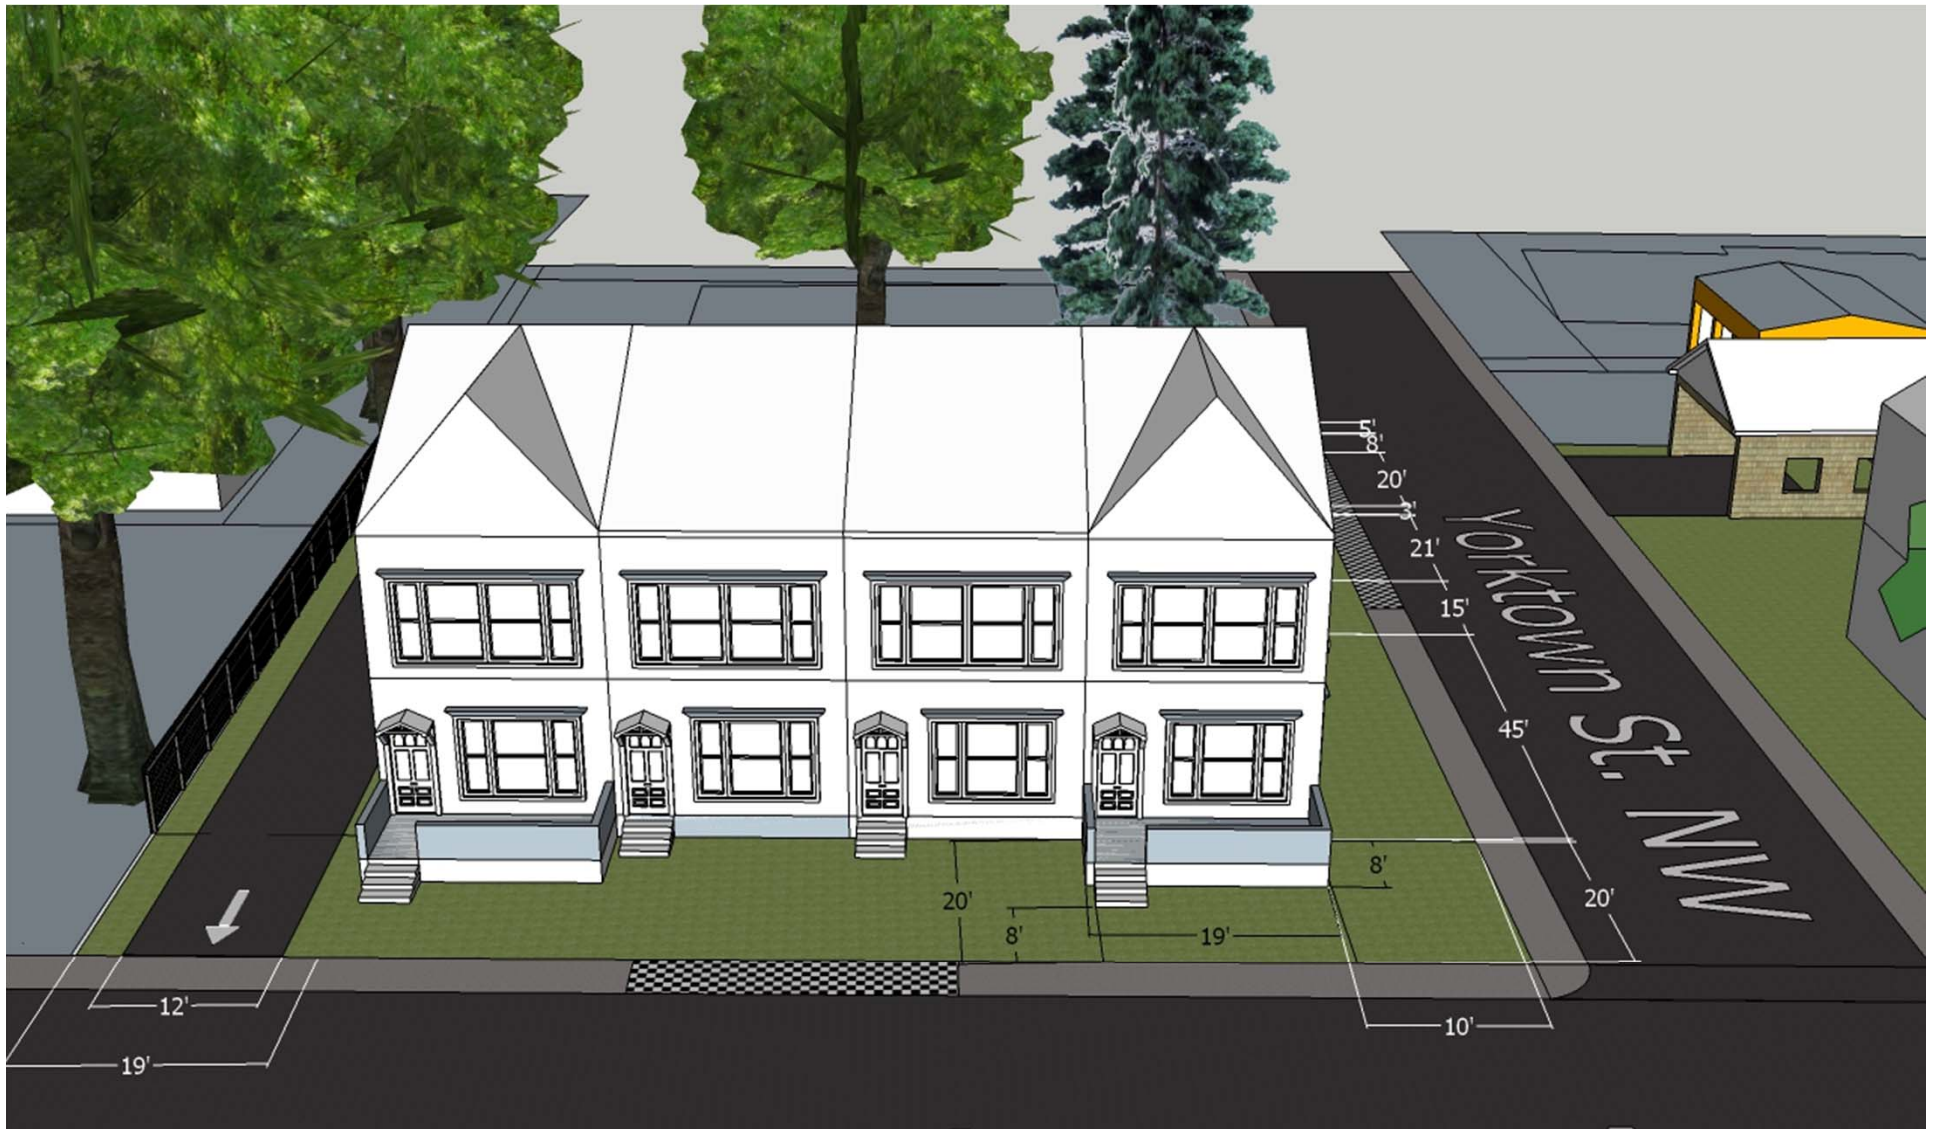
All models are for height/massing purposes only, not detailed architecture. Historic Preservation Commission will review detailed architecture (i.e. materials, roof pitch/style, etc.)
