**DATE:** February 12<sup>th</sup>, 2020

<u>Certificate of Appropriateness Request:</u>	H-03-20
<u>Applicant:</u>	Philip Curley
<u>Location of subject property:</u>	24 Franklin Ave. NW
<u>Staff Report prepared by:</u>	Kristen Boyd-Sullivan, Sr. Planner

# TREE RISK ASSESSMENT FORM

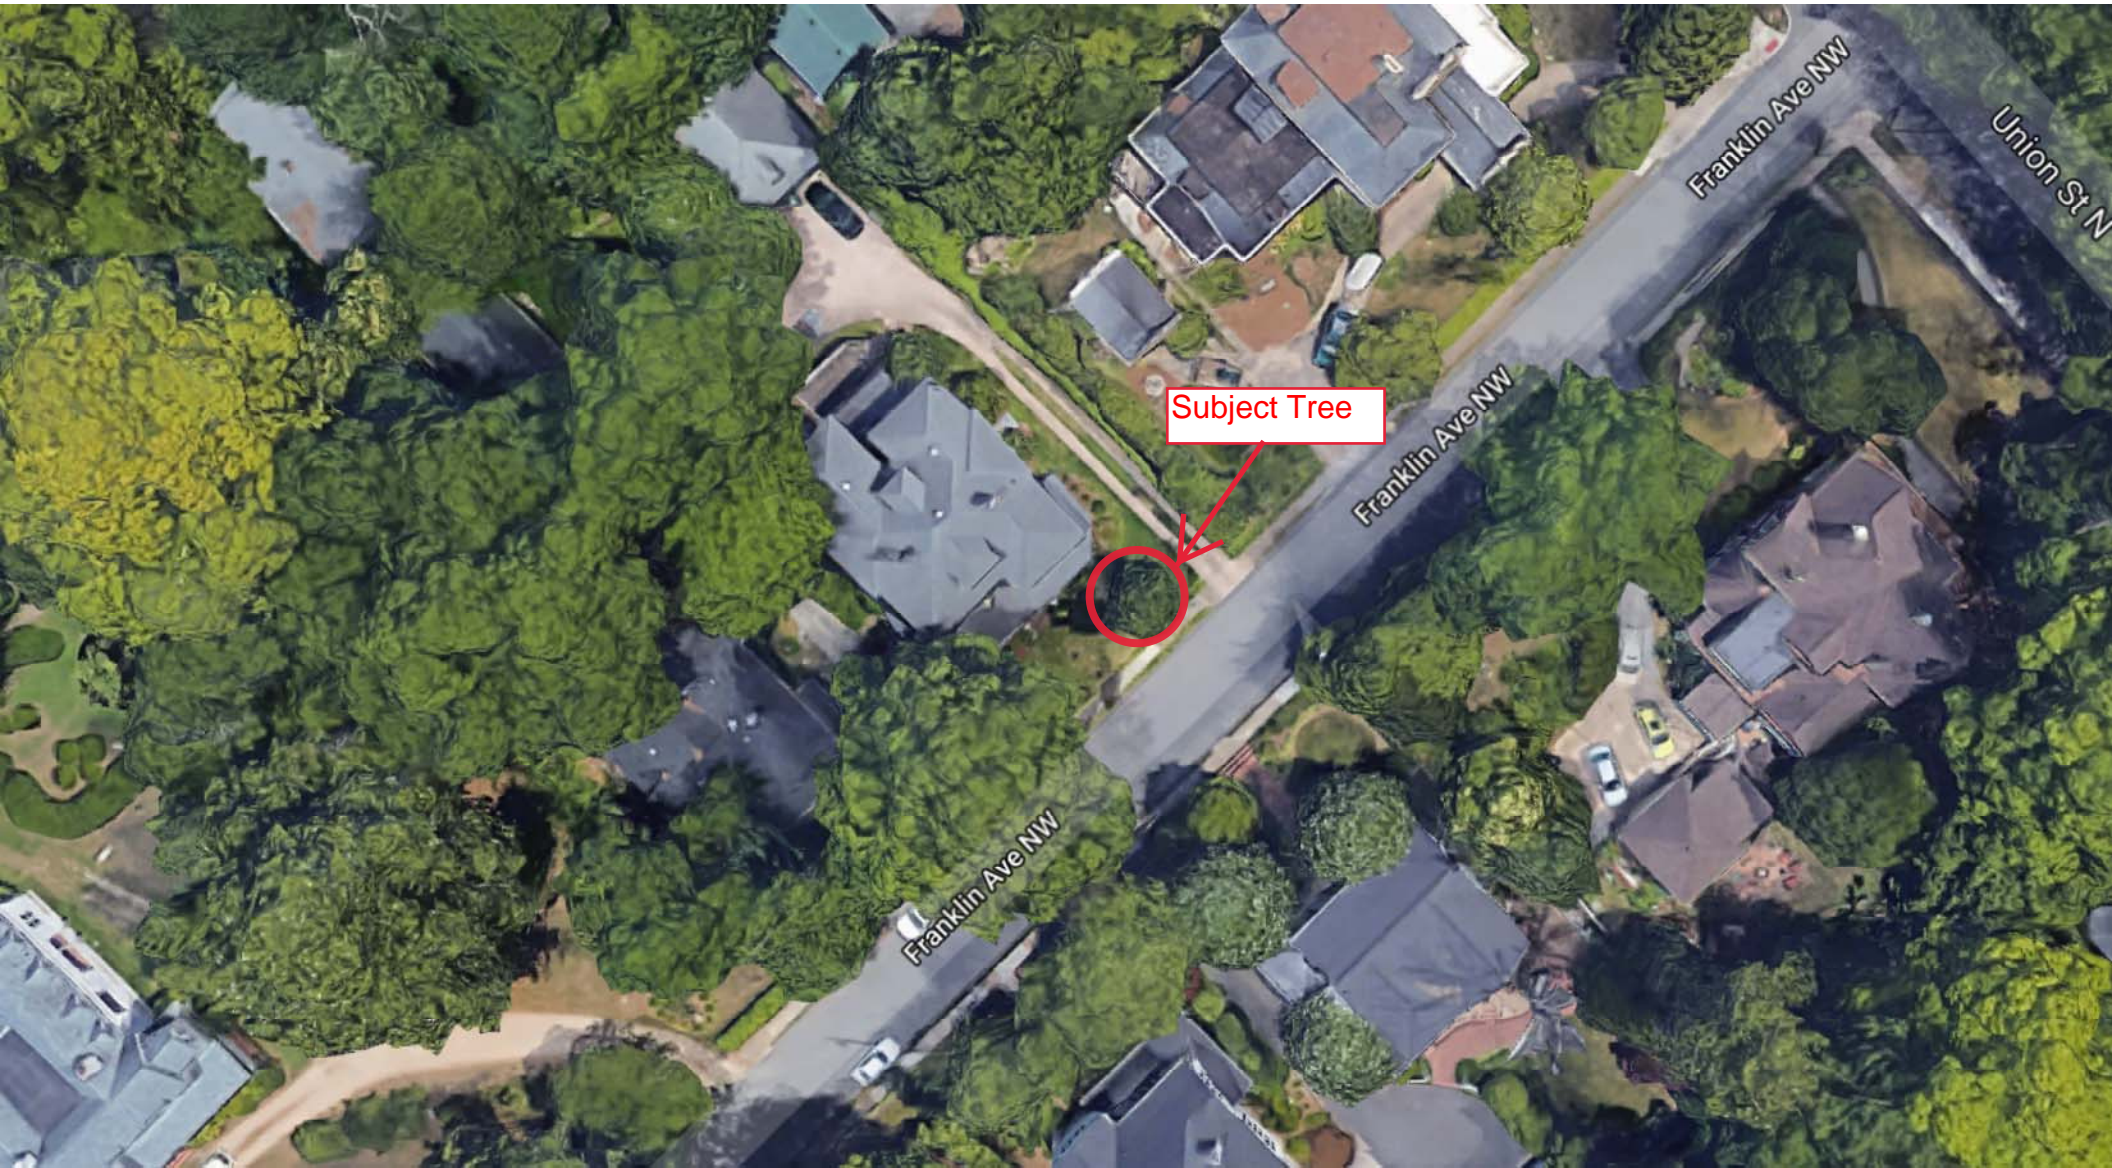
EXHIBIT C

Half of this tree has broken leaving an unbalanced crown that is exposed to new wind load stress. The remaining trunk has a vertical crack in the center that reduces the structural integrity of the first five feet of trunk. I recommend this tree be removed. This location would be appropriate for another similar sized tree.

Remove tree  When replaced, a similar sized tree species would be appropriate in same location
