DATE: June 14, 2023

SUBJECT:
Certificate of Appropriateness Request: H-06-23
Applicant: Chad VanKeuren
Location of Subject Property: 120 Union St N
PINs: 5620-79-1486
Staff Report Prepared by: Jeff Ellis, Planner

TREE RISK ASSESSMENT FORM

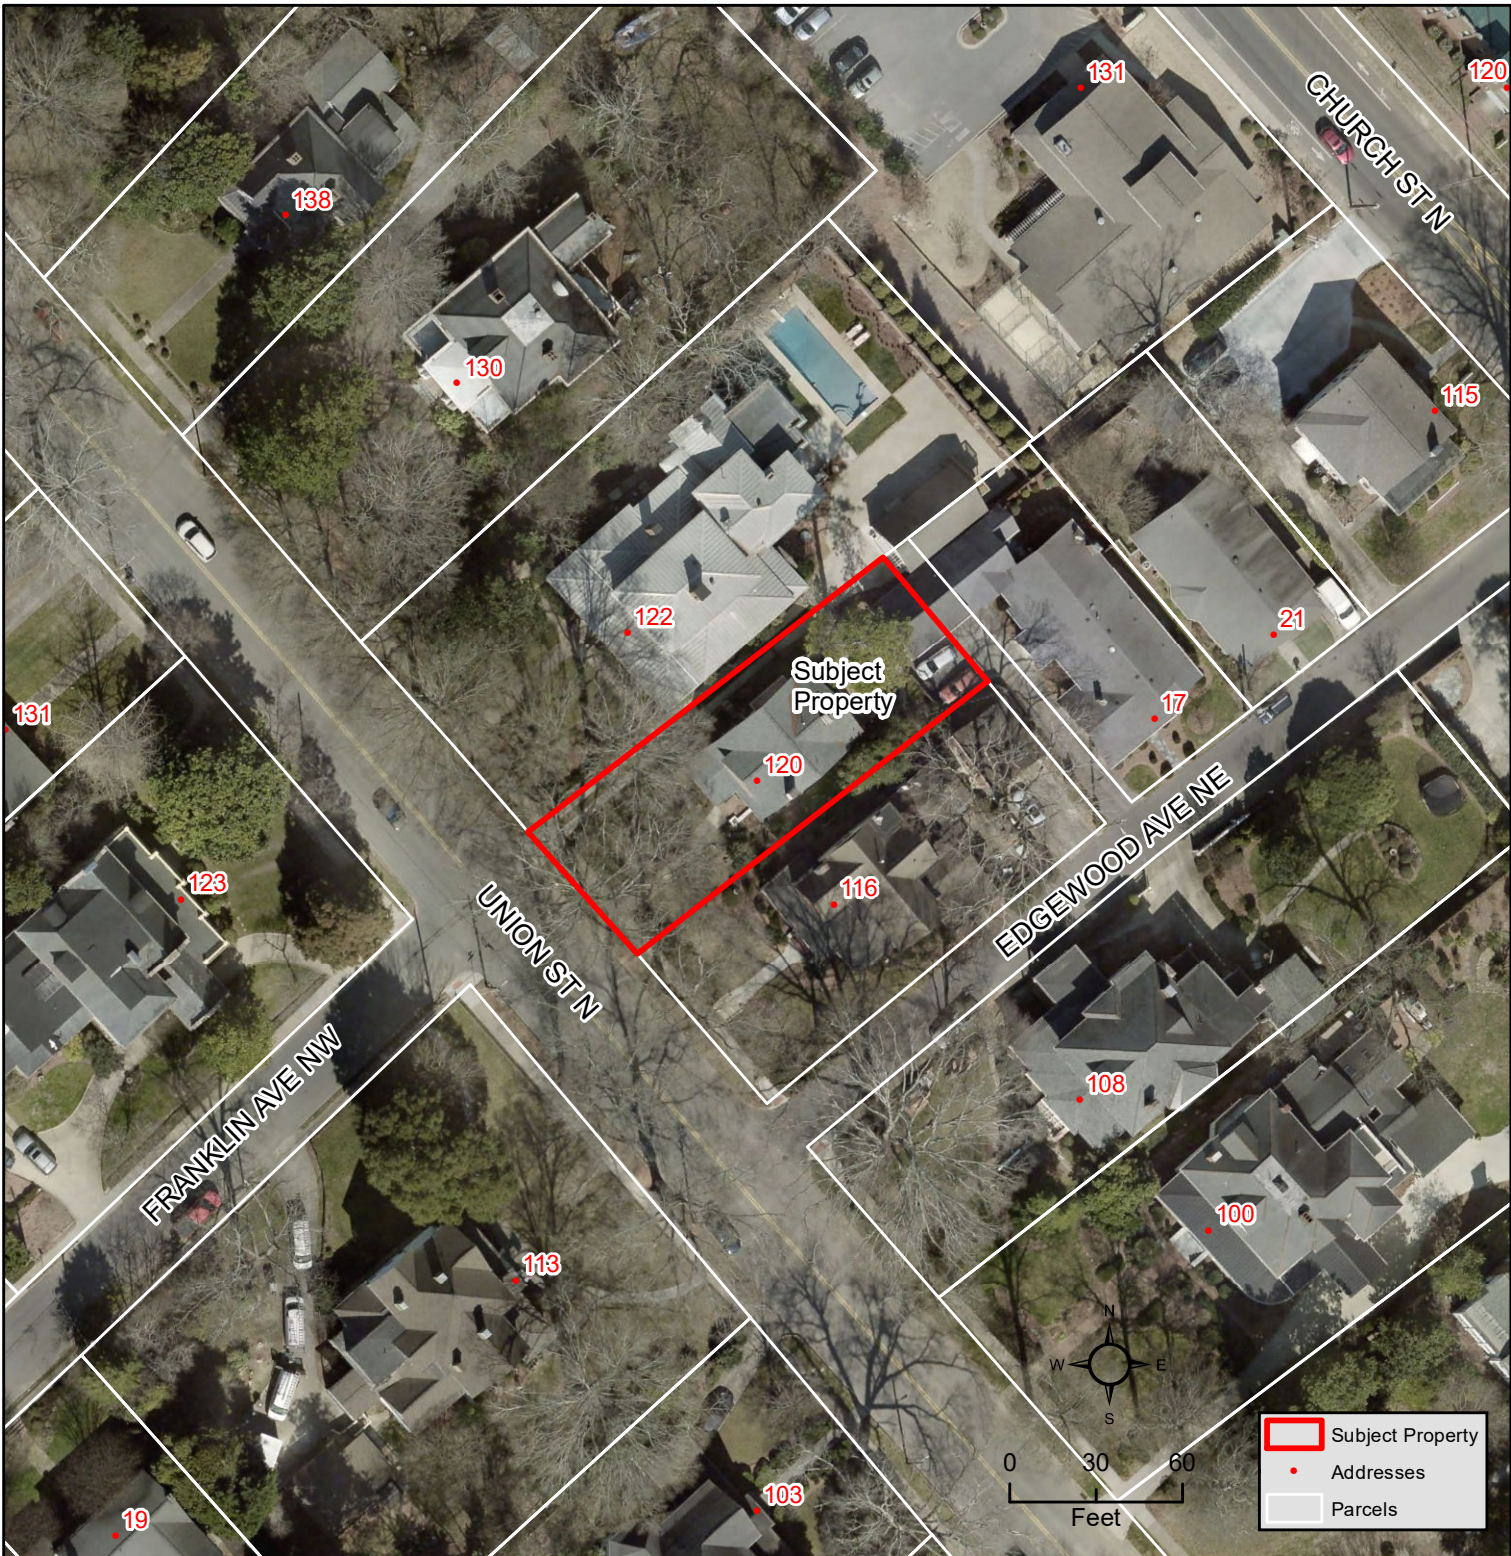
On March 7, 2023, Chad VanKueren applied for a Certificate of Appropriateness under Concord Development Ordinance (CDO) §9.8 to remove one (1) Burford Holly tree located on the right side of the home (front of house perspective). (Exhibit E).

According to the Tree Risk Assessment Form (Exhibit D), the subject tree was inspected and evaluated by Bill Leake, City Arborist, on November 22, 2022. Bill notes the subject tree has no structural defects, and that it is in close proximity to the applicant’s home.
