<u>Certificate of Appropriateness Request:</u>	H-13-19
<u>Applicant:</u>	Trenton and Courtney Whalen
<u>Location of subject property:</u>	449 Union St. S
<u>Staff Report prepared by:</u>	Scott Sherrill, Sr. Planner

BACKGROUND:

1. Interior kitchen renovation with new exterior door to rear deck in lieu of current window. Replace kitchen windows (not seen from street)
2. Remove failing wooden deck on rear of the home (not seen from the street) and replace with construction of new covered porch extending to rear corner of the home.
3. Remove cedar shake siding on rear of the home (not original to the home) and replace with Hardiplank siding painted in the same color as current trim on the home.
4. New addition of a rear entry porch in similar style to side sunroom entry porch
5. Remove all windows and doors (several broken) of rear mudroom and replace with new windows and French doors in similar style to current windows.

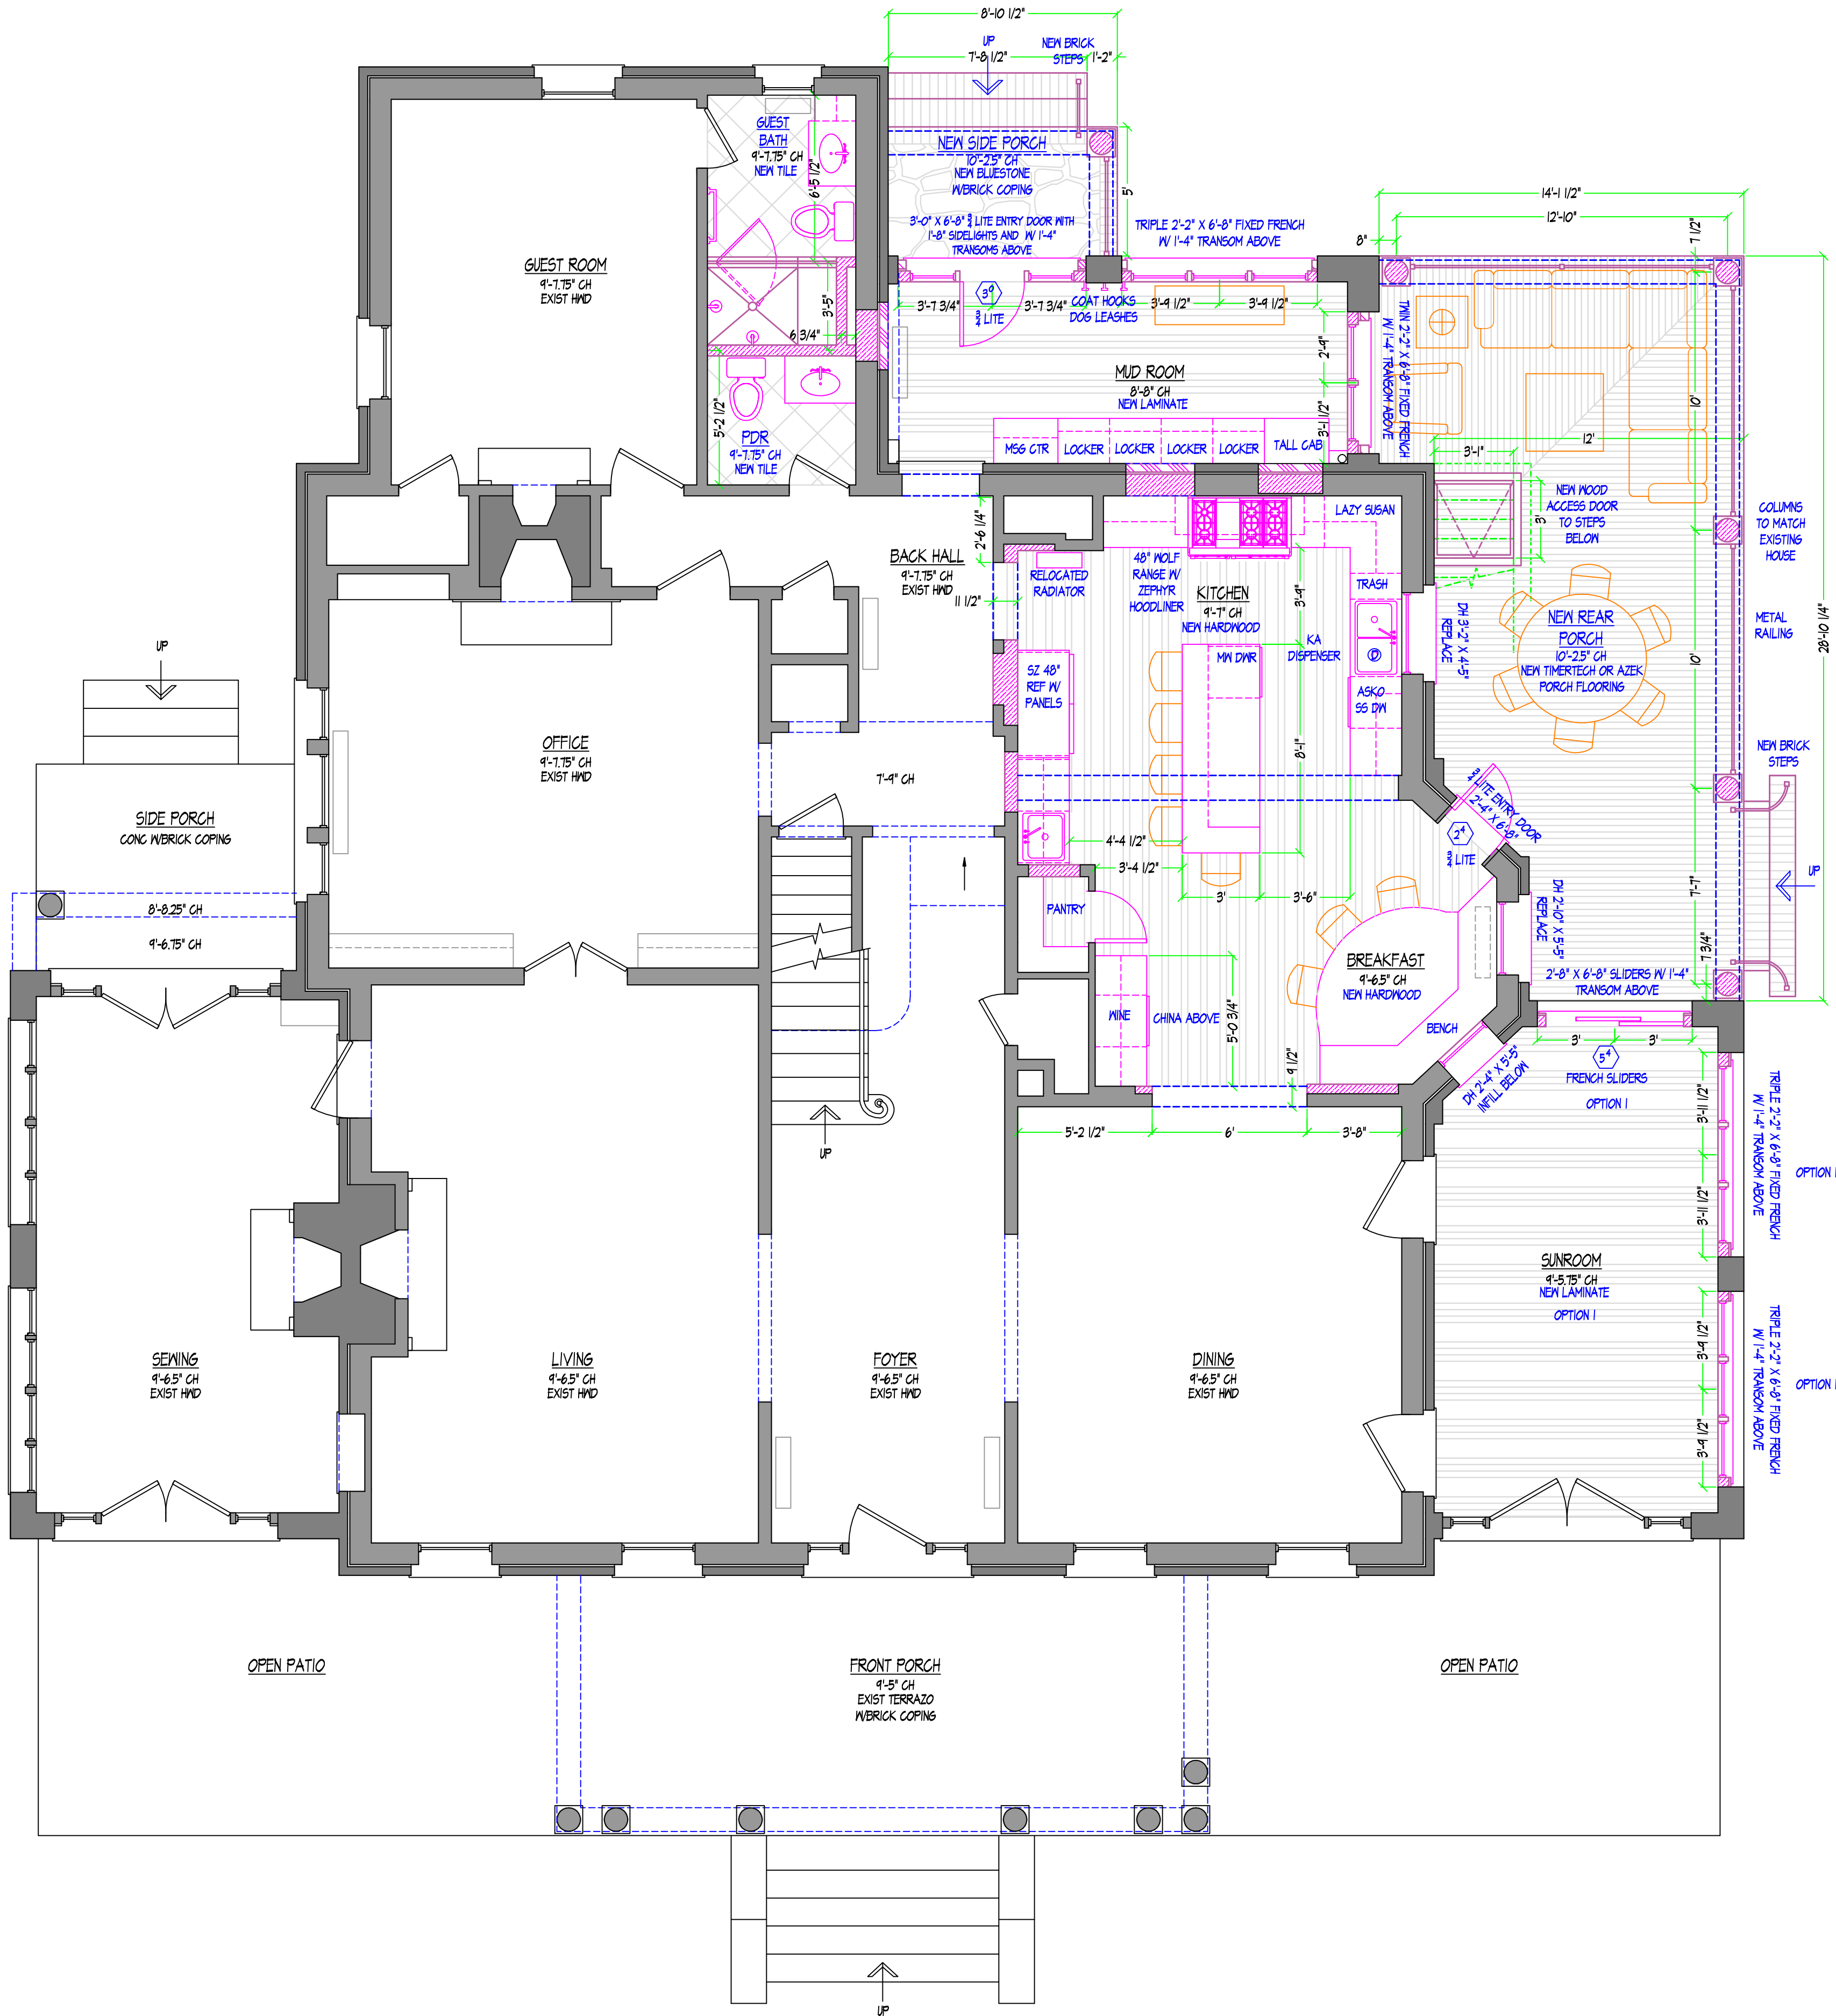
SHEET
A=1

NEW CONSTRUCTION FIRST FLOOR	All dimensions to be verified by general contractor and sub-contractors prior to construction, fabrication and installation
---------------------------------	-----------------------------------------------------------------------------------------------------------------------------

WHALEN RESIDENCE
FIRST FLOOR

The applicant further proposes to remove the failing wooden deck, and construct in its place a covered porch off the kitchen, extending to the rear corner of the home. The addition will feature a continuation of the roofline from the sunroom using metal roofing, composite tongue and groove flooring for porch. The new porch and porch stairs would also feature metal railings, and a new brick foundation to match the existing house.

The applicant proposes to add a new covered porch at the rear entry of the mudroom. The roofline and columns will be constructed in a similar style and materials to the existing entry porch at the right rear sunroom. The addition will not extend past the footprint of the existing home.

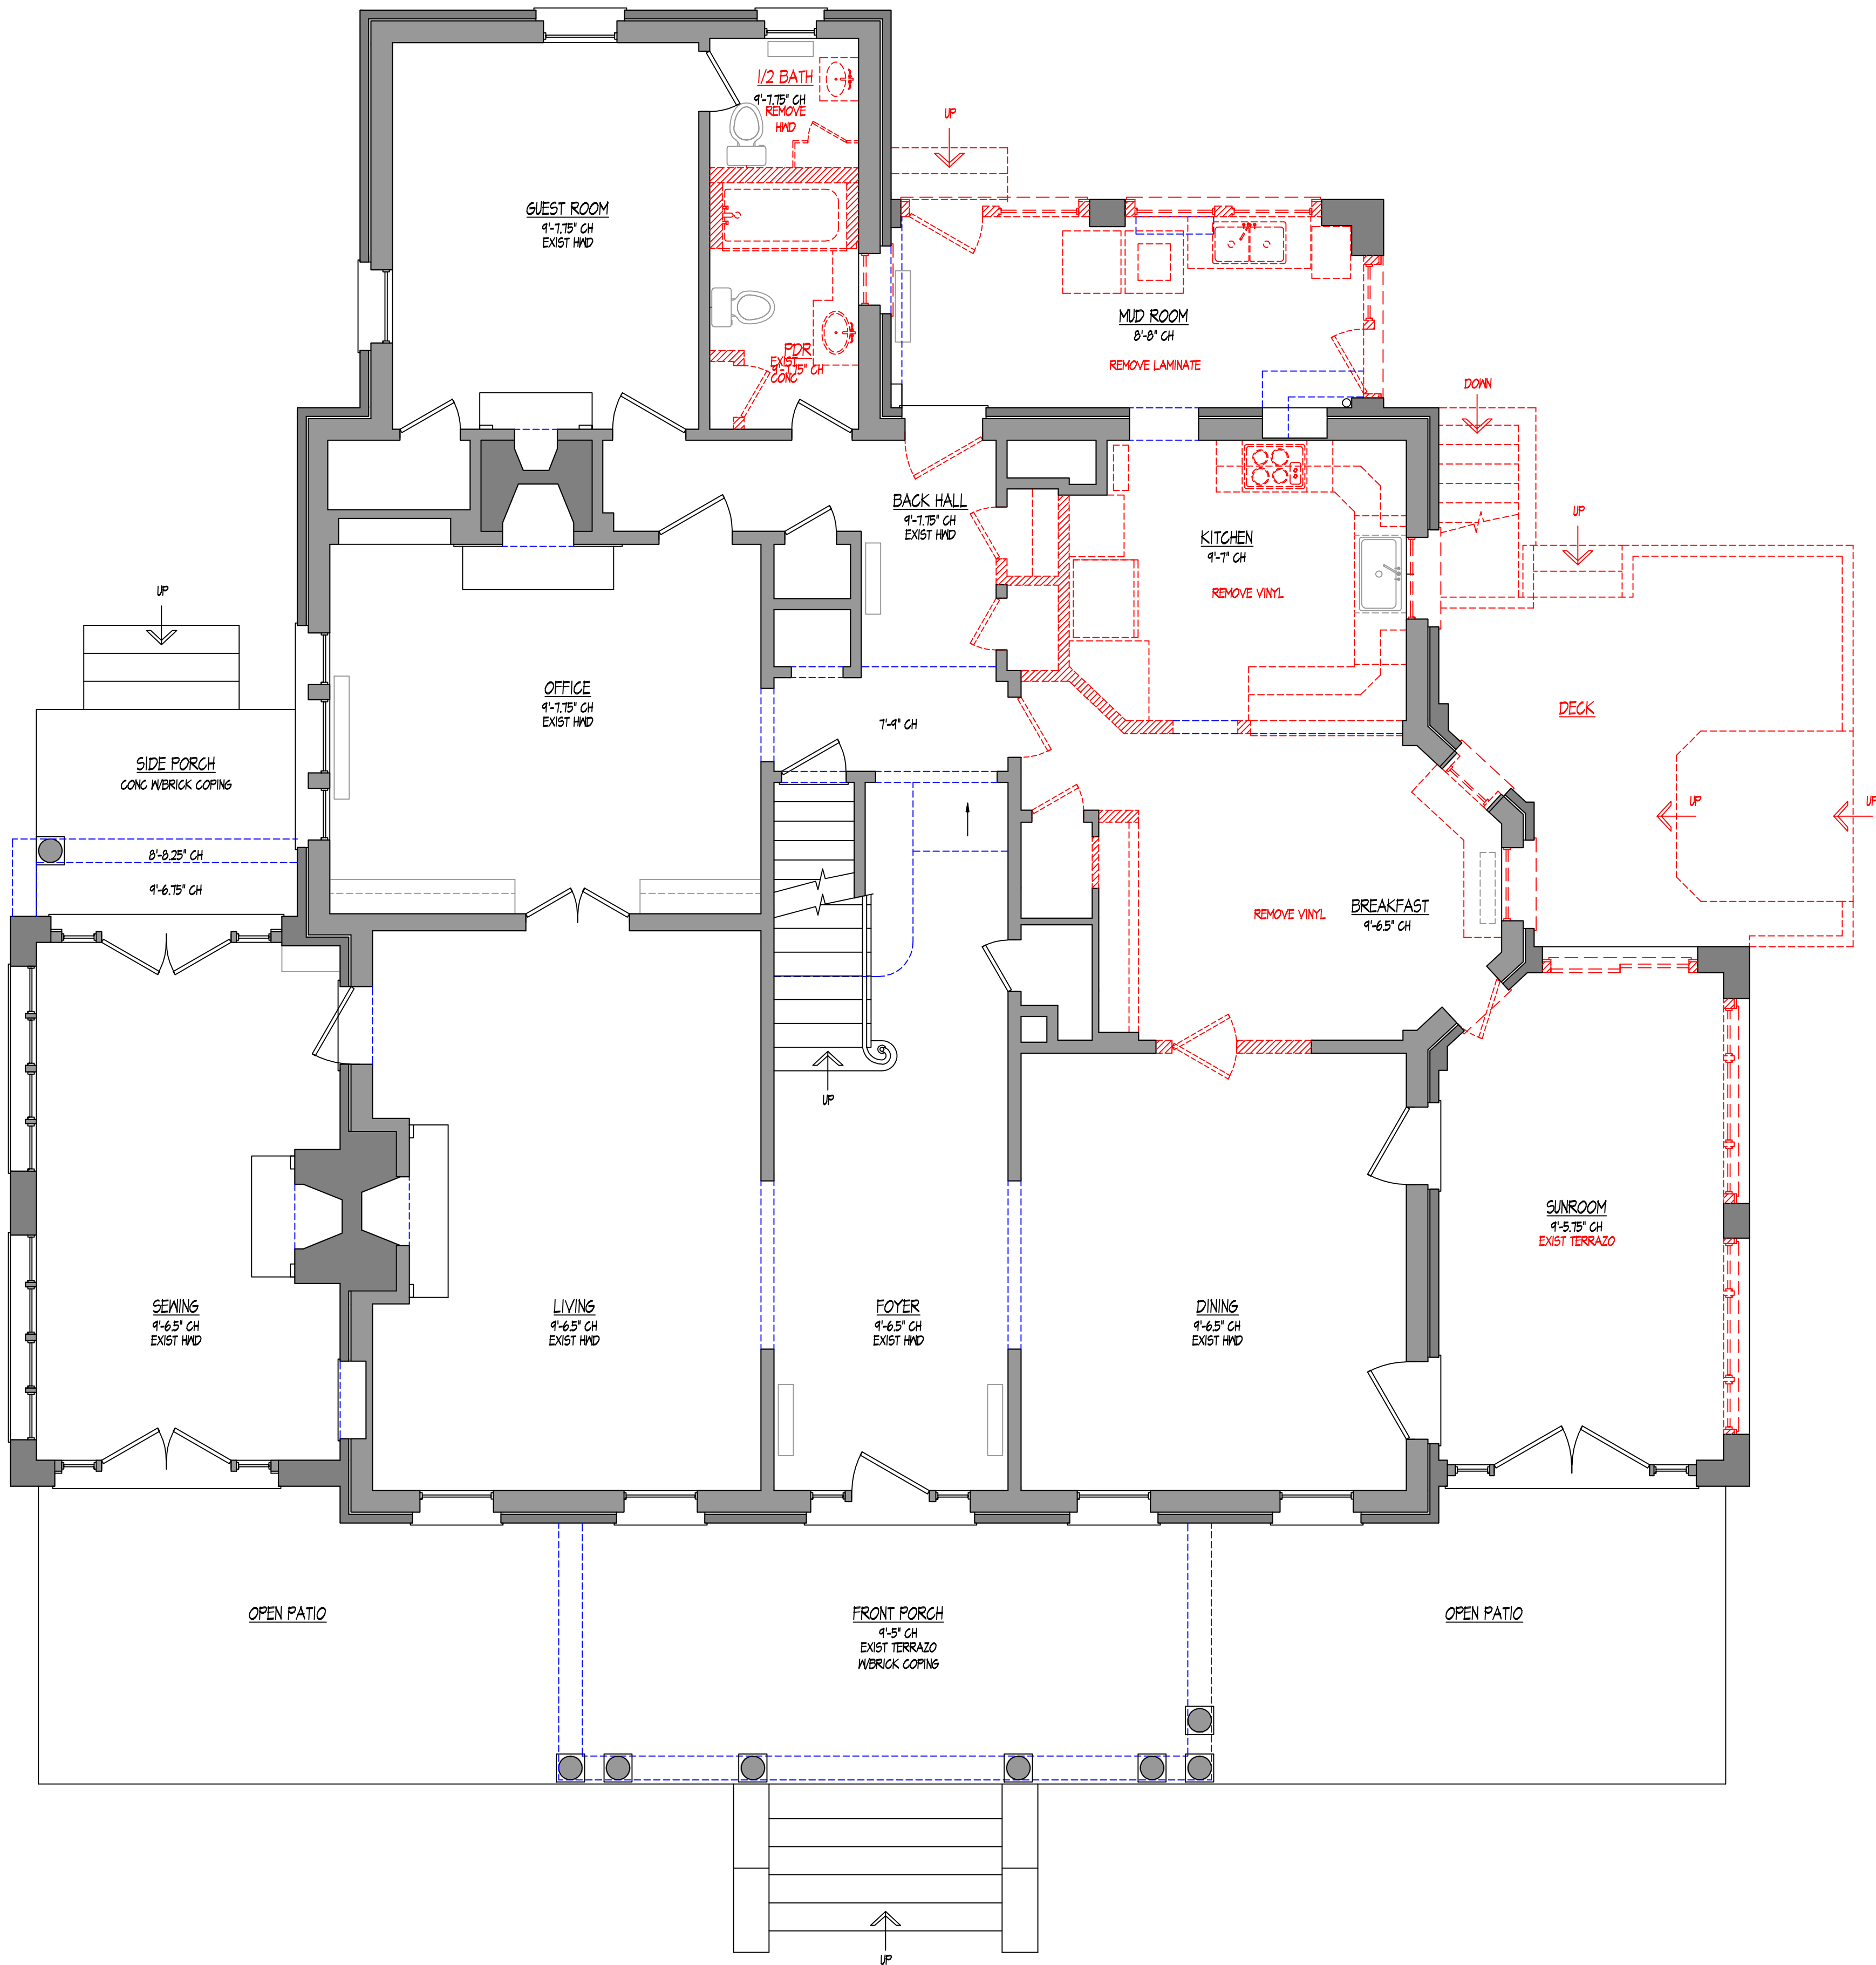
REVISION	DEMOLITION FIRST FLOOR	
	All dimensions to be verified by general contractor and sub-contractors prior to construction, fabrication and installation	
SHEET	D-1	
OF PROJECT	119

WHALEN RESIDENCE
FIRST FLOOR

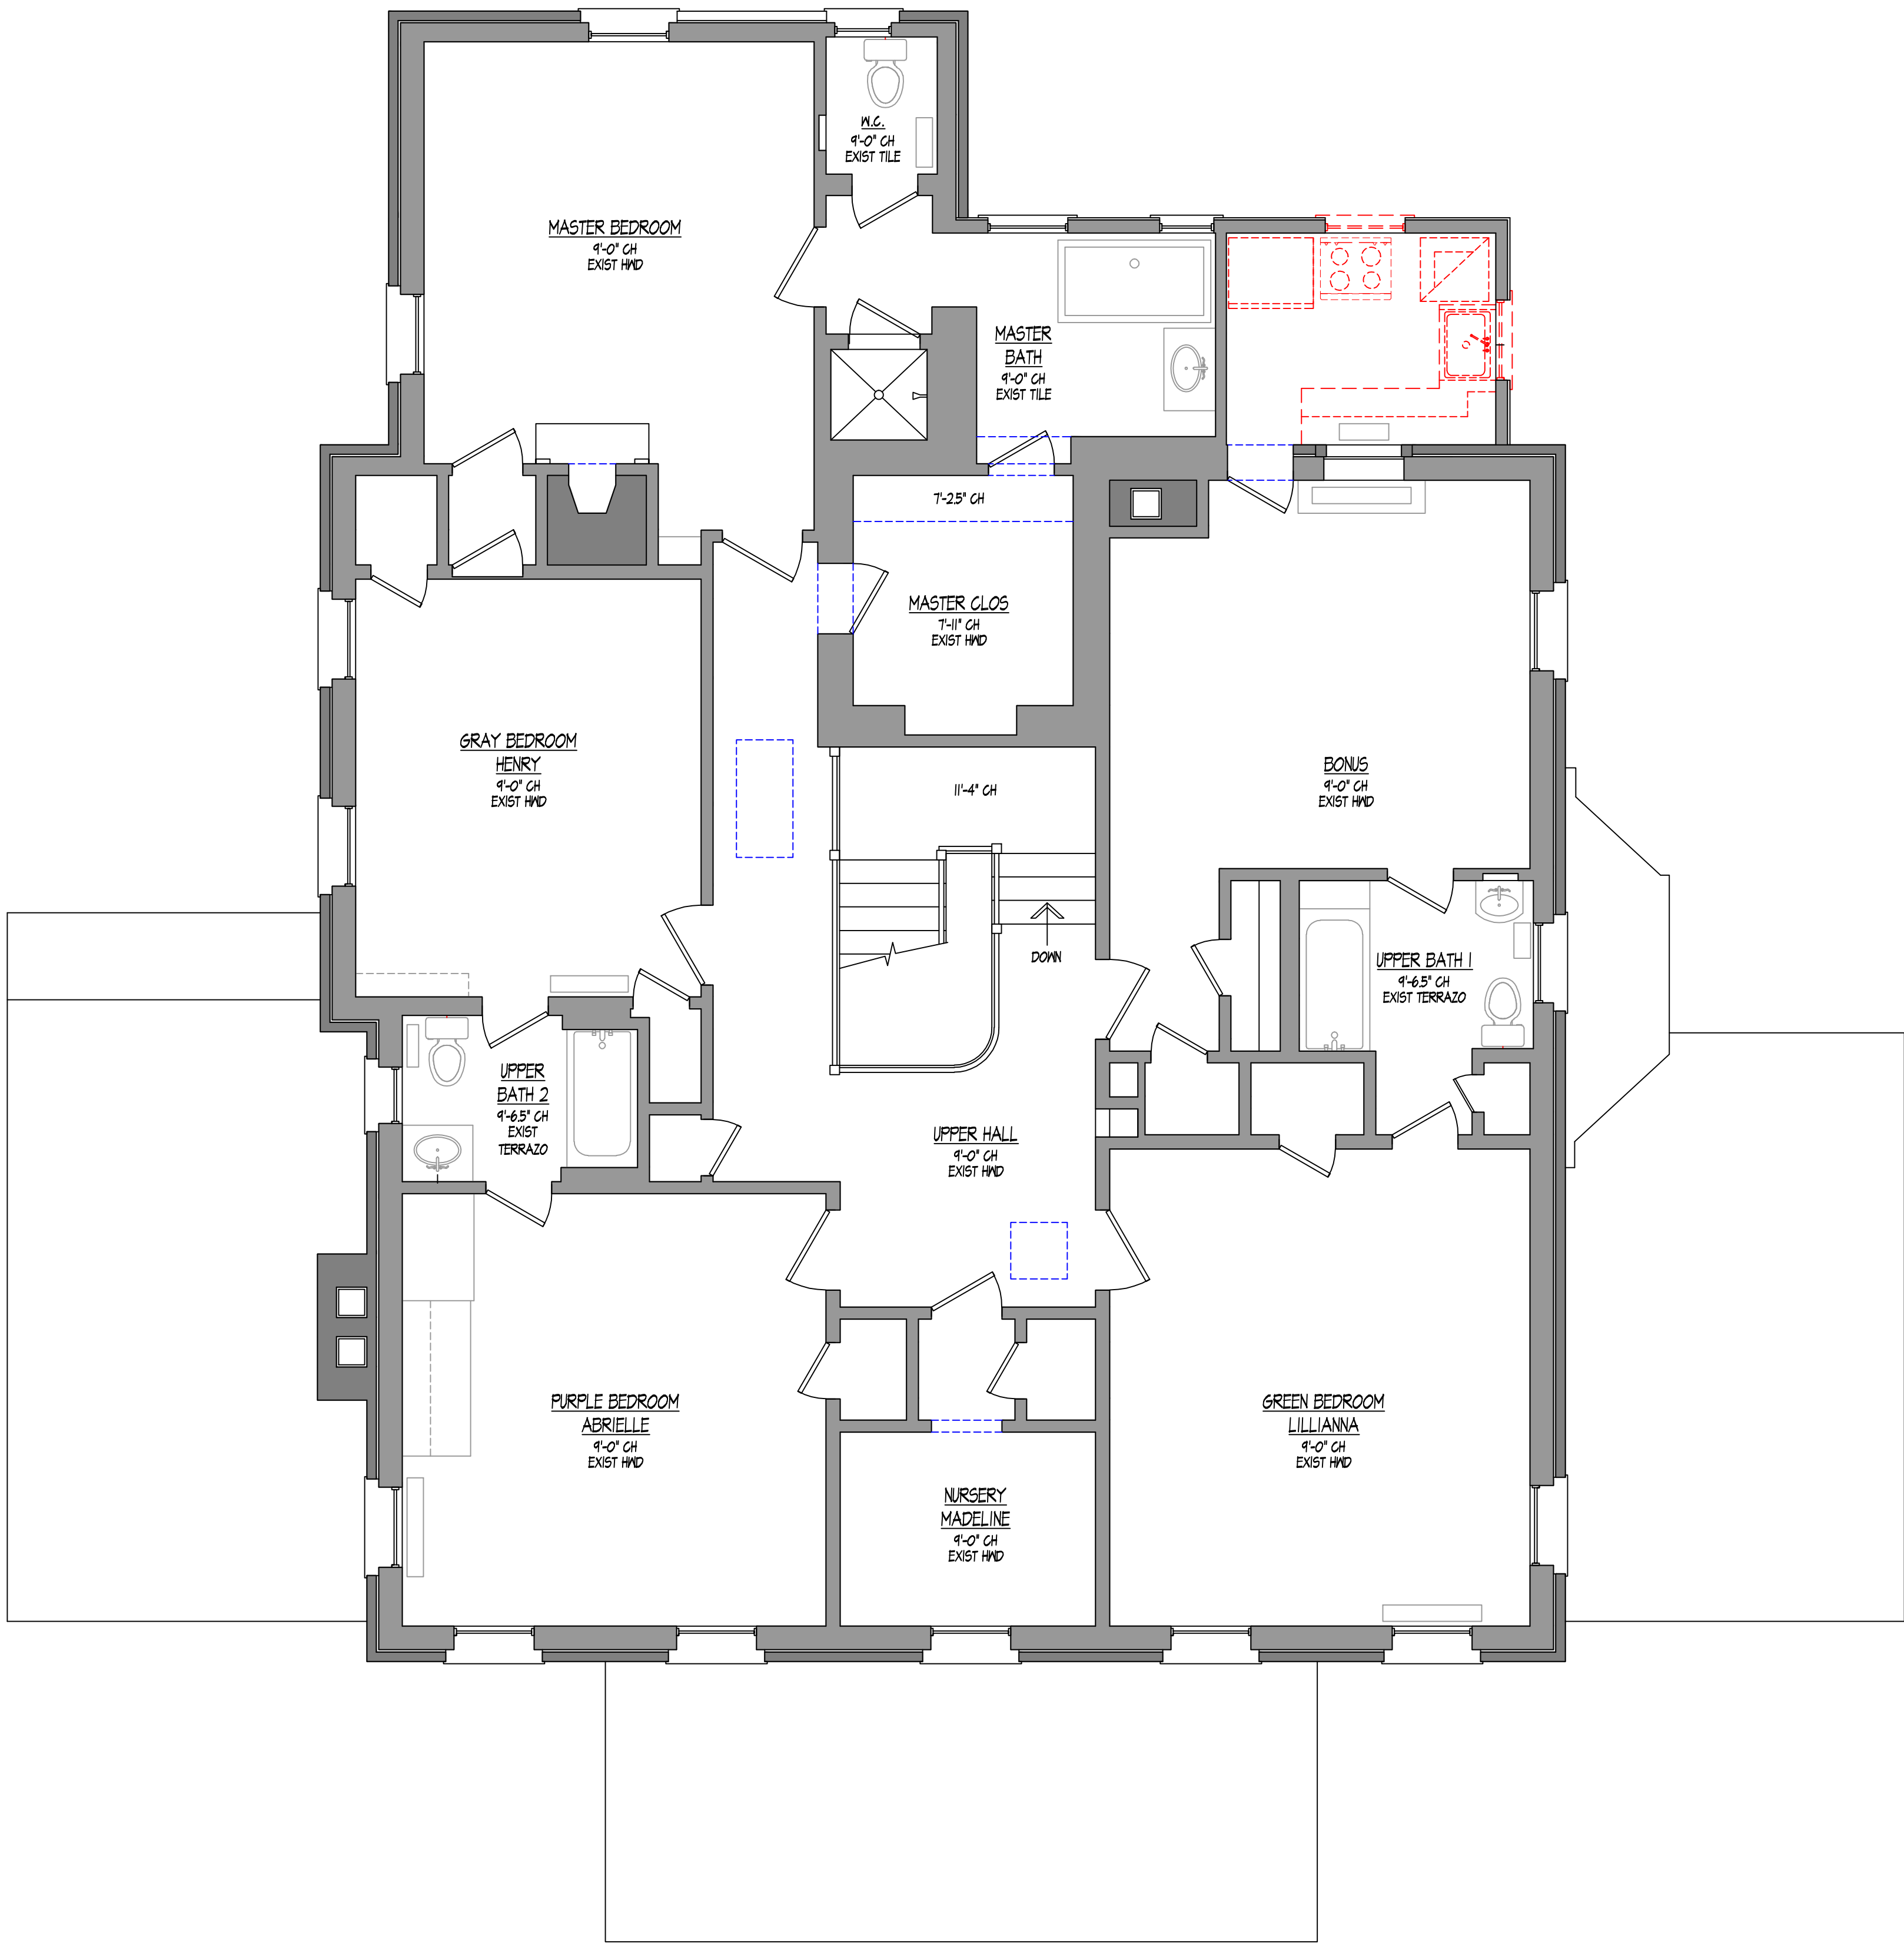
D=2

DEMOLITION
SECOND FLOOR

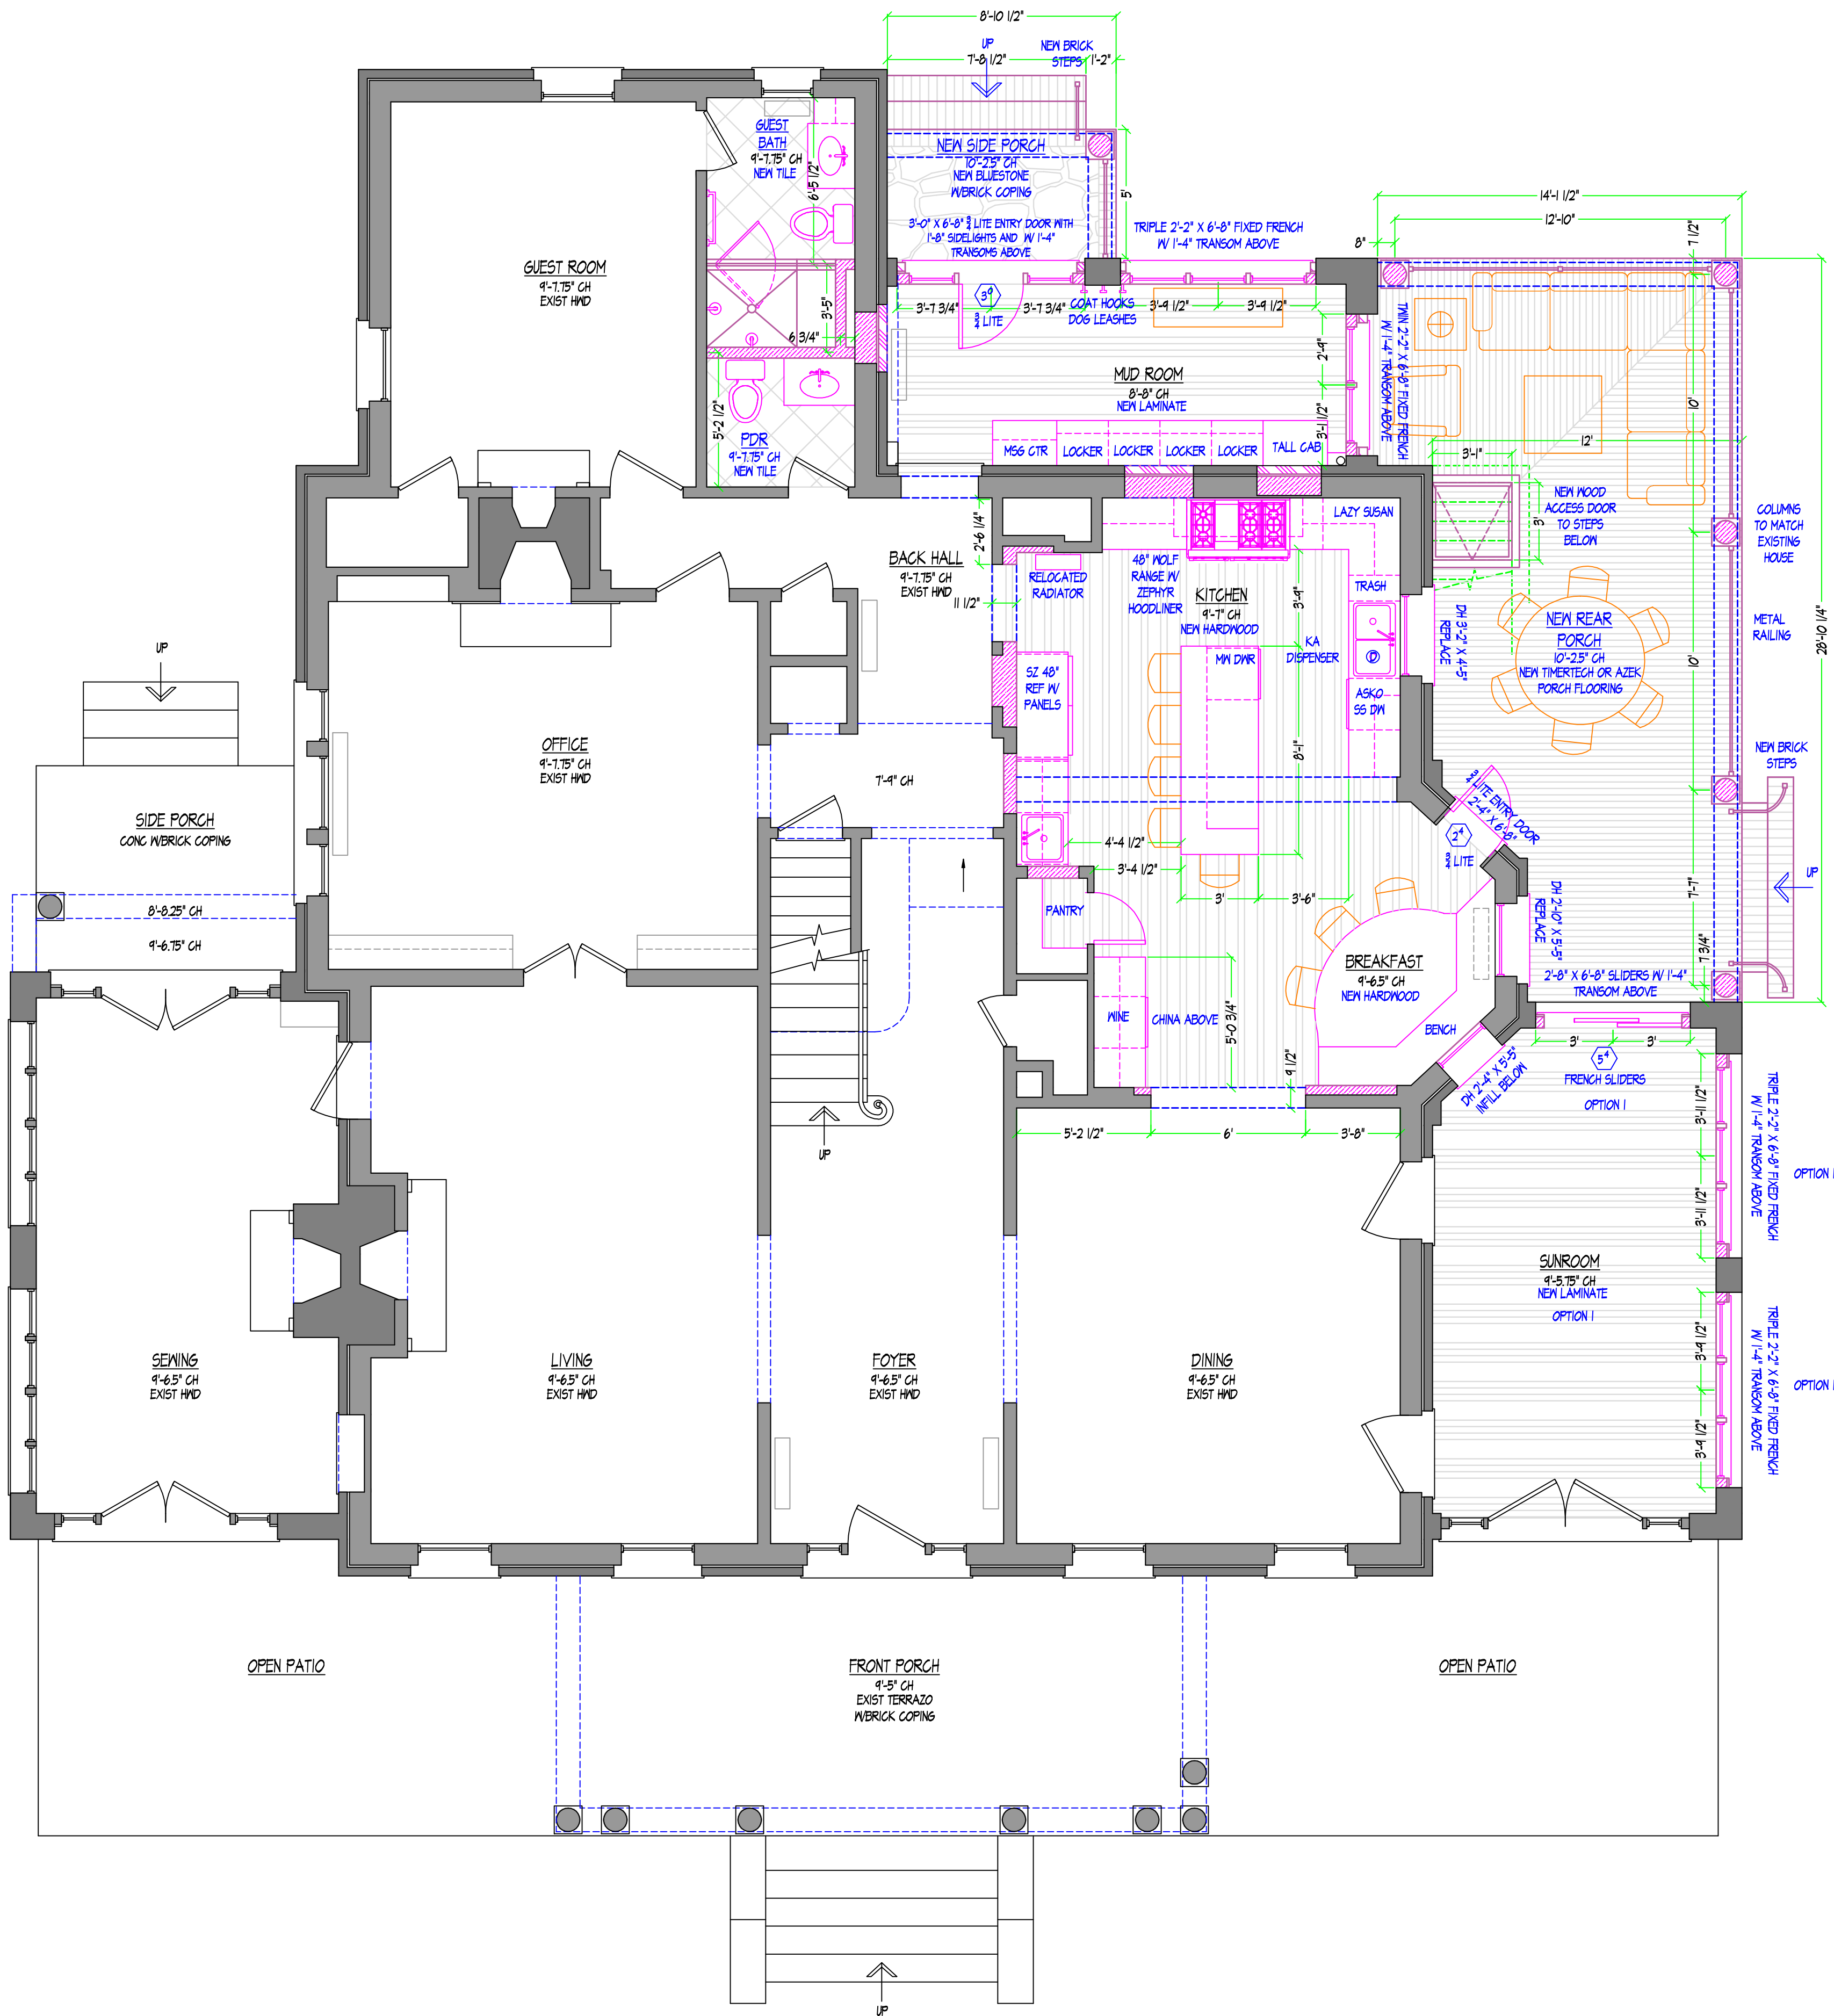
REVISION	SHEET A=1
NEW CONSTRUCTION FIRST FLOOR	OF PROJECT 119
All dimensions to be verified by general contractor and sub-contractors prior to construction, fabrication and installation

WHALEN RESIDENCE
FIRST FLOOR

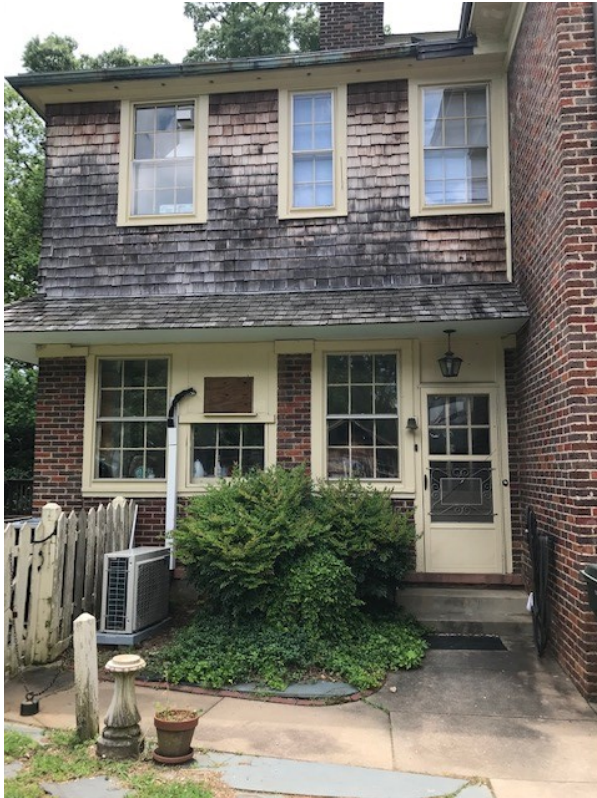
Rear entry mudroom

The applicant proposes to remove windows and doors to existing mudroom and replace one door to yard with windows, replace the rear entry door from the driveway with French style door with sidelights. The replacement windows are proposed to be aluminum clad double hung in similar style to current windows. The existing windows are wood with aluminum storm windows.

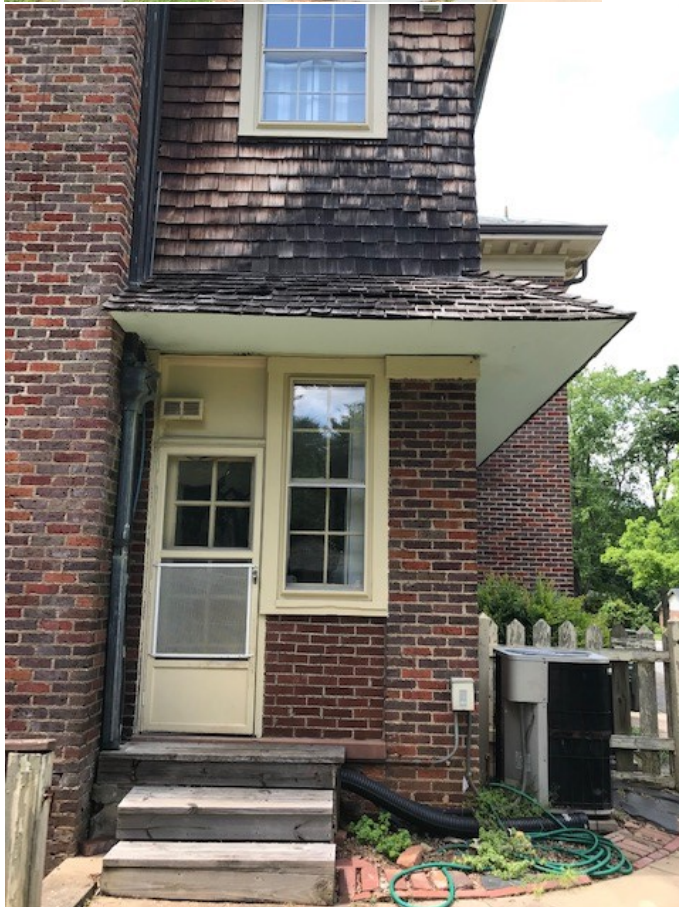
Left side rear mudroom

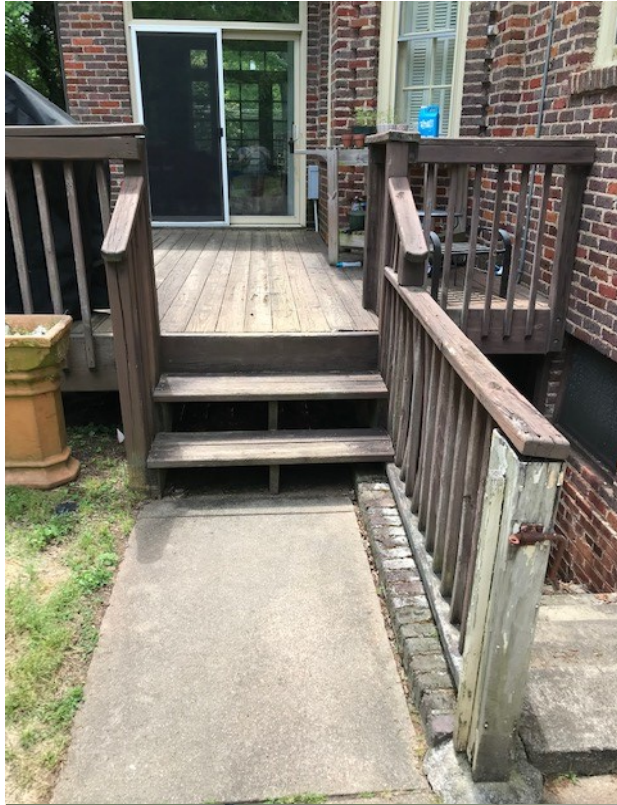
Failing deck off rear of sunroom

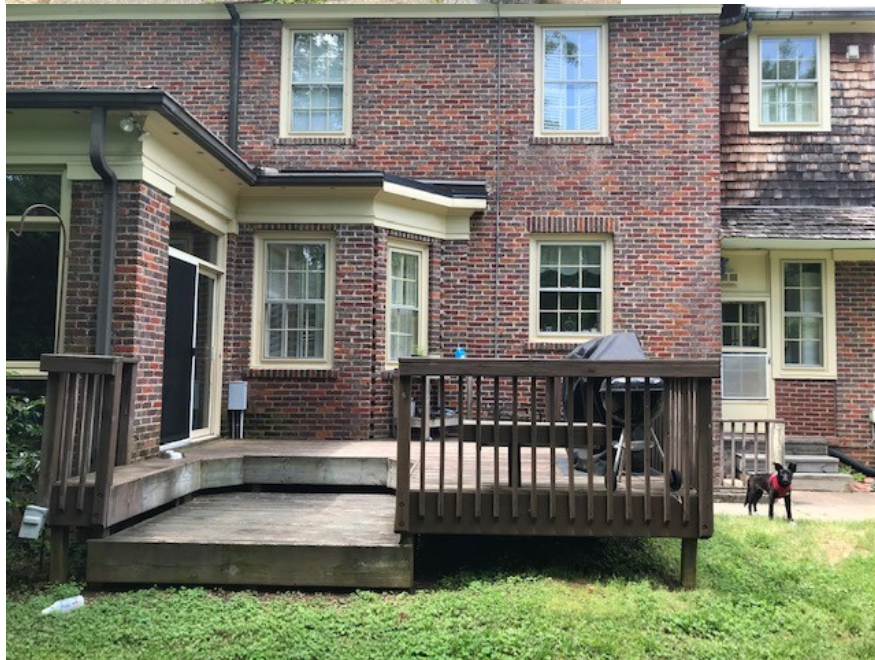
Left side elevation

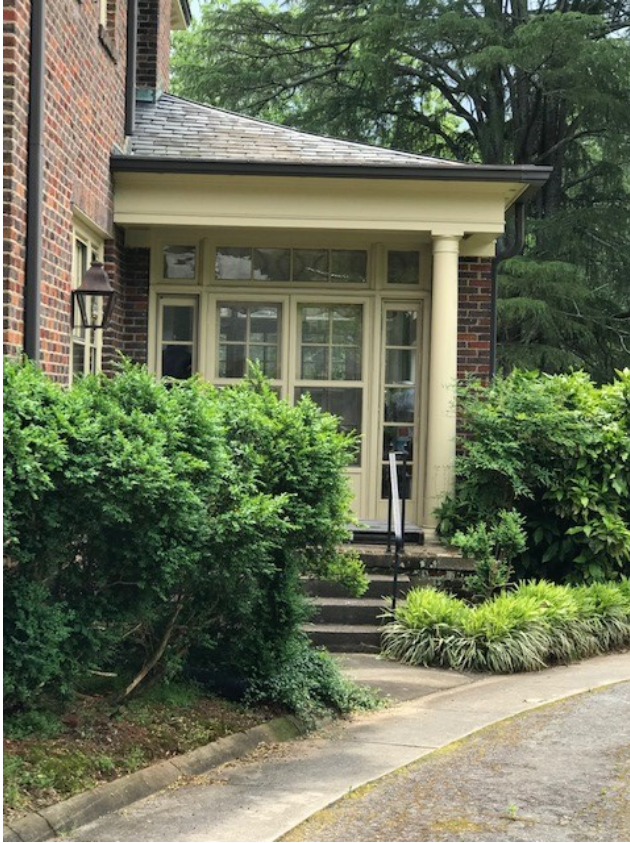
Right rear sunroom porch
entry. Proposed rear
mudroom porch construction
will be constructed in a
similar style
