# HISTORIC PRESERVATION COMMISSION MEETING AGENDA

Wednesday, June 14, 2023 at 6:00 PM

### **H-07-23 (Quasi-Judicial Hearing)**

**Cary Gluf** has submitted a Certificate of Appropriateness application for modifications including, but not limited to, partial demolition, a second story addition, addition of porches/deck, and modification to the driveway at 391 Union St S. PIN 5630-24-0612.

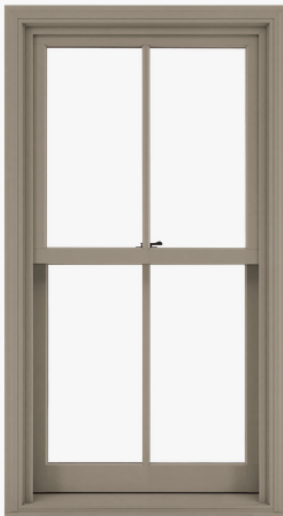
### Proposed Window Details

Multiple sizes, as described above, will be used. These all wood windows will match the materials of the main house windows. None of the new windows are replacing any original, historically significant windows. The new windows are designed to be compatible with the existing house, and per the Historic handbook, will be discernable from the original windows. The 5/8" SDL mullion detail will be used.

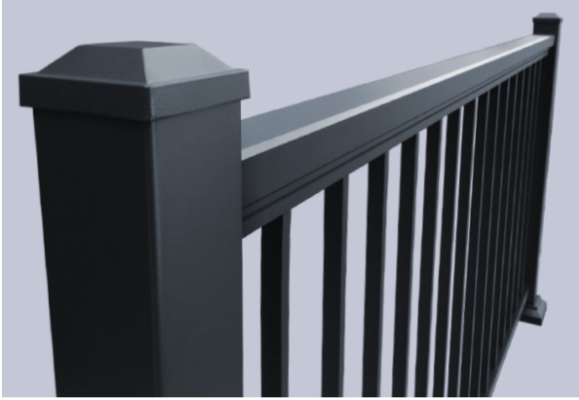
## Metal Deck Railing– Color: Black

### Why OPTIMA™ Plus Rail for Your Deck Rail Options?

- **Pre-Assembled Panels for Fast and Easy Installation**
- **Durable aluminum construction with an Akzo Nobel AAMA 2604 powder-coat applied by certified AAMA painters**
- **Engineered, tested and approved to ICC-ESR 4813 and is IBC/IRC-compliant**
- **Flat Top Rail for a beverage-friendly surface**
- **Hidden Fastener System and No Welds**
- **Available in three textured powder coat colors: Black, White and Bronze.**
- **15-Year Limited Warranty**

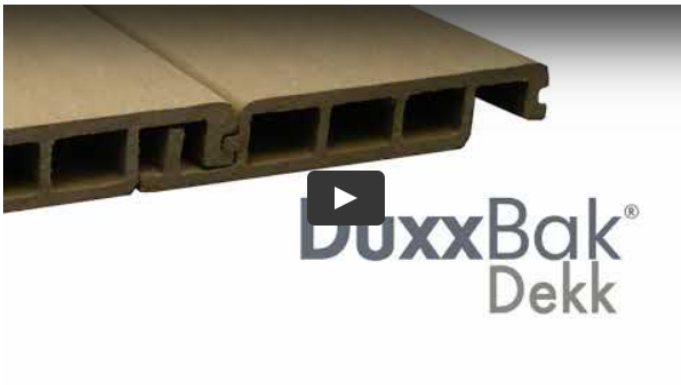
## New Rear Deck. Wood Grain Embossed. Color to be determined.

**DuxxBak® Dekk** is our revolutionary deck board that made us famous by combining our weather defying compound with a water-shedding, no drip profile that creates a dry space beneath your deck, walkway or balcony.

Rescue your family barbecue from an unexpected downpour or create a functional storage area underneath your deck with this premiere composite. Its unique water-shedding properties protect your home by channeling water away from the foundation. You will also protect your deck structure from rotting as a result of exposure to the elements, a major cause of deck failure. Available in both our beautiful, wood-grain embossed ArmorCap or more functional Traction finish, this no drip through composite decking will increase the functionality of your deck, and is increasingly being specified for use on multi-family housing projects where stacked decks are popular.

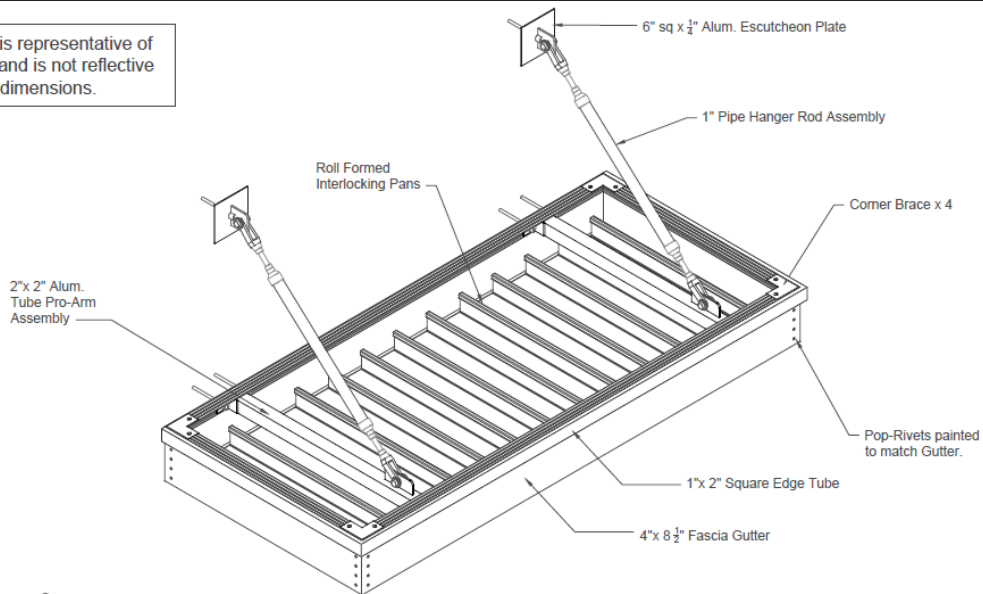
### 1 3D Model

Note: 3d Model is representative of canopy system and is not reflective of exact project dimensions.

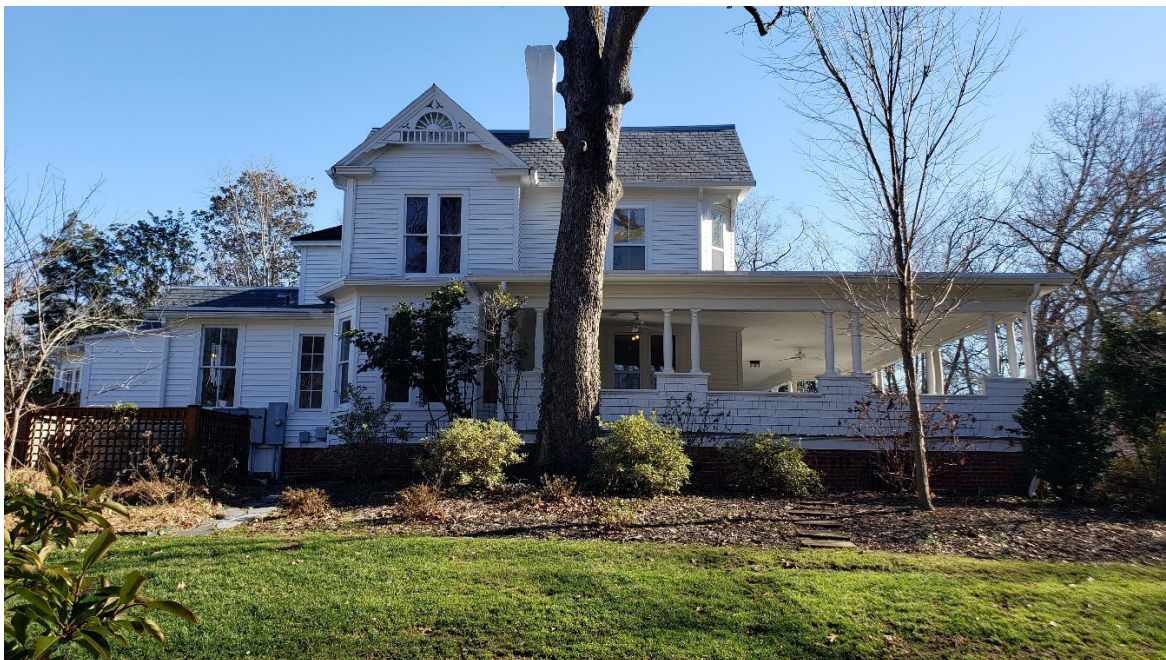
Existing House: View from Left Side

Area of Addition will replace the singled roof areas on the left side of this photo

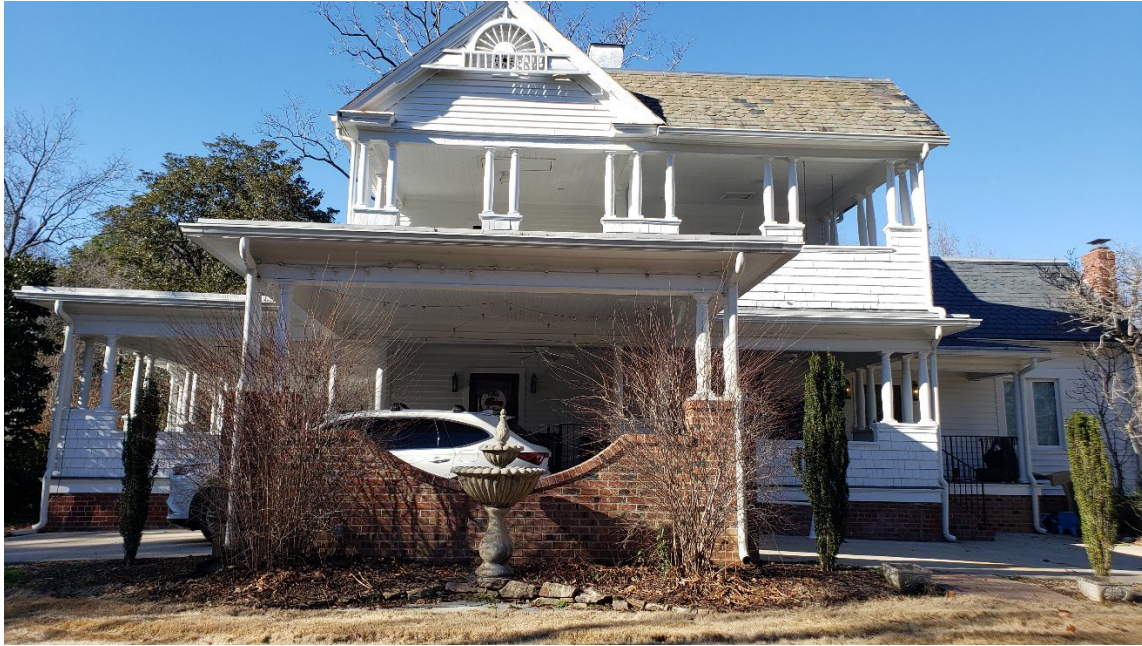
Existing House: View from Left Side

Area of Addition will replace the singled roof area on the right side of this photo

The only new work that will be visible from Union Street will be the new Screened Porch and Connector to the Kitchen.

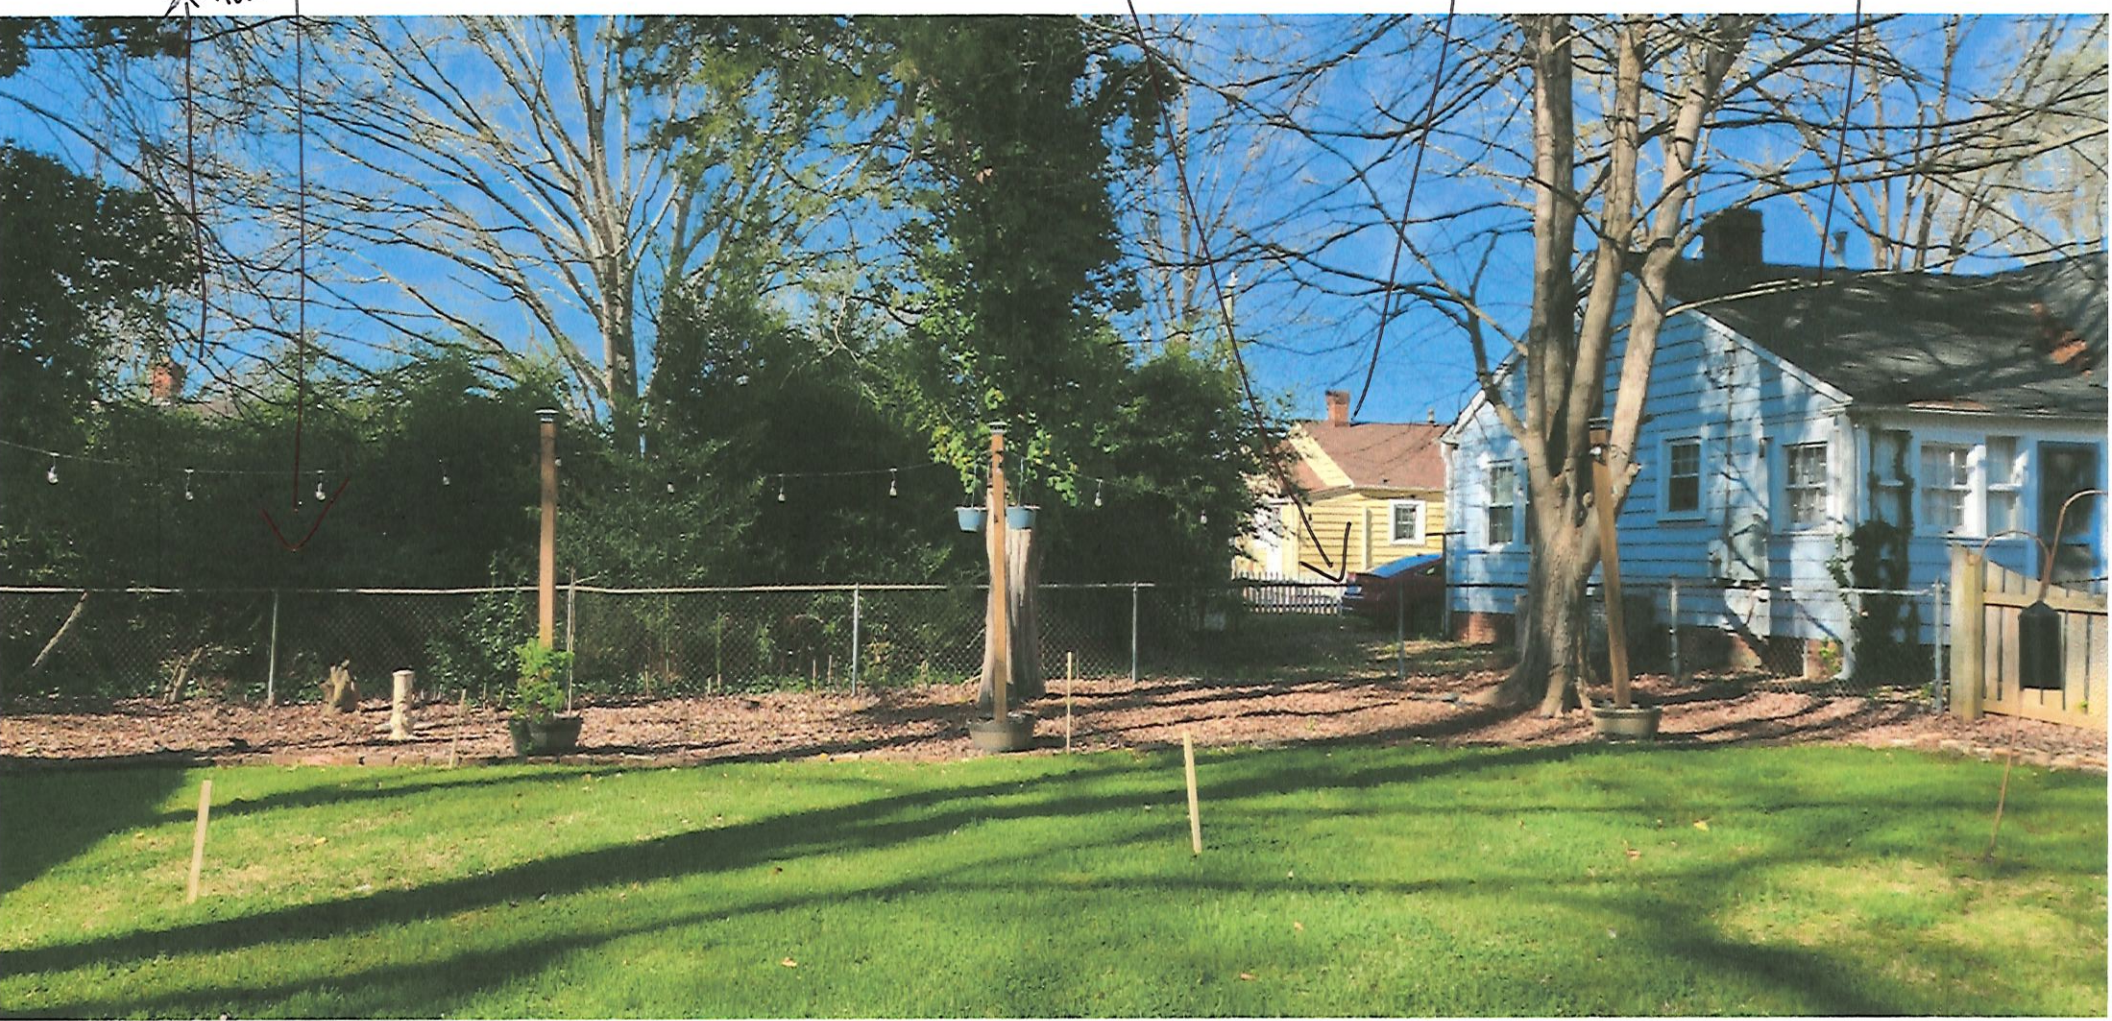
wood privacy fence to replace  
~~wood~~ chain link fence - 6ft. height

- On March 9th, 2023, Brian and Robin Dicka applied for a Certificate of Appropriateness requesting approval to remove the current chain link fence at the back of their property, in order to construct a 6’ wooden privacy fence. The fence would then be stained in order to match their existing home located at 216 Union St S. (Exhibit B)

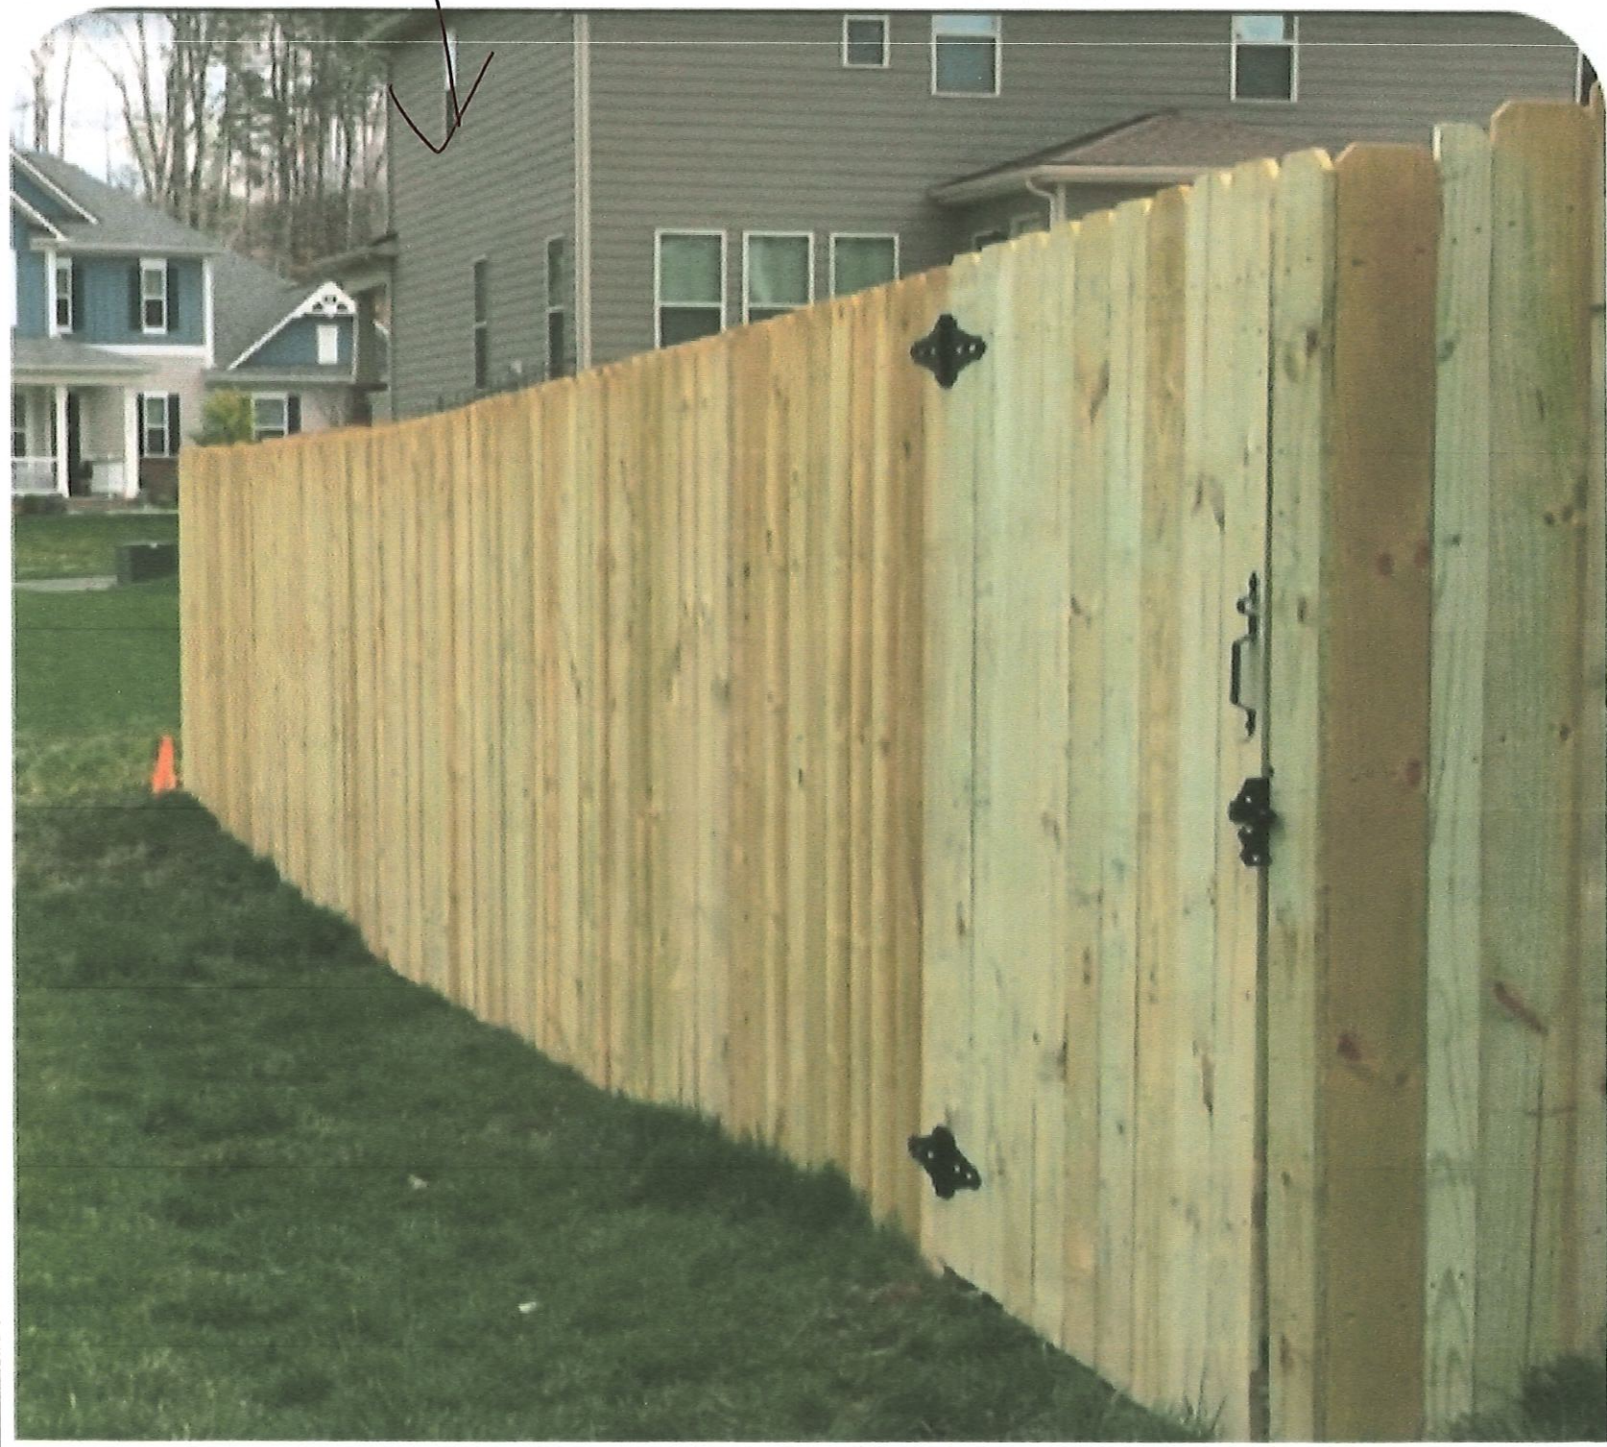
existing wood fence to stain/paint to preserve

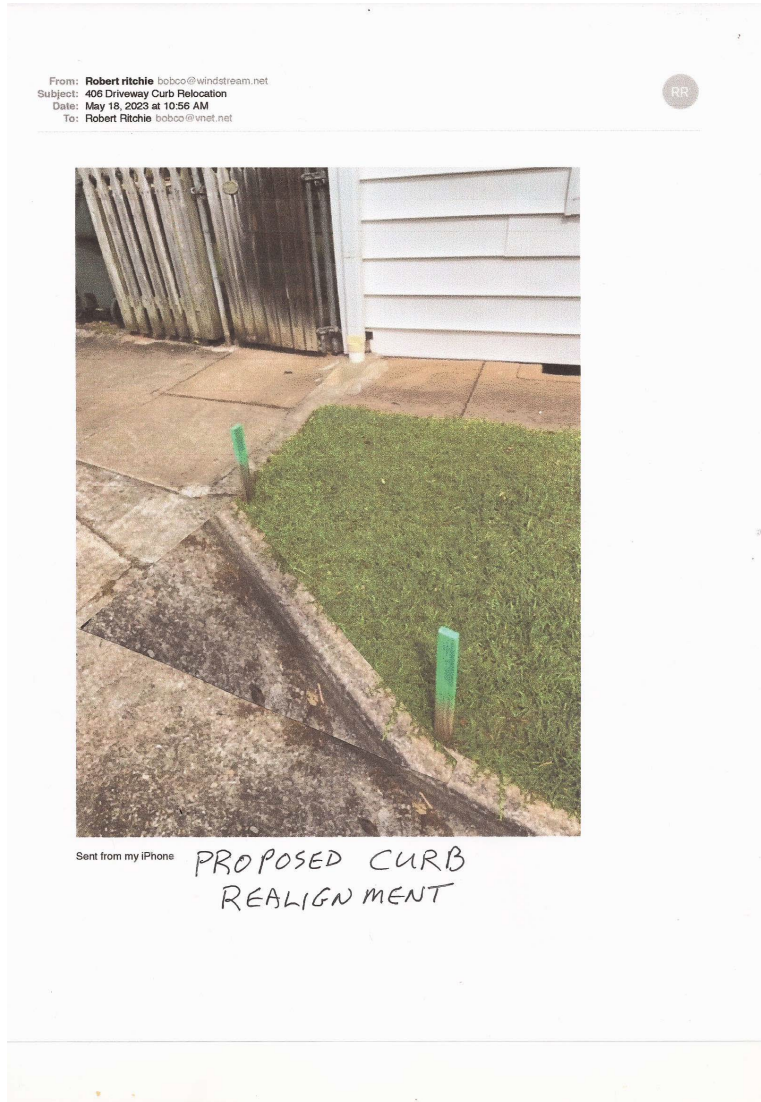
Sent from my iPhone PROPOSED CURB REALIGNMENT

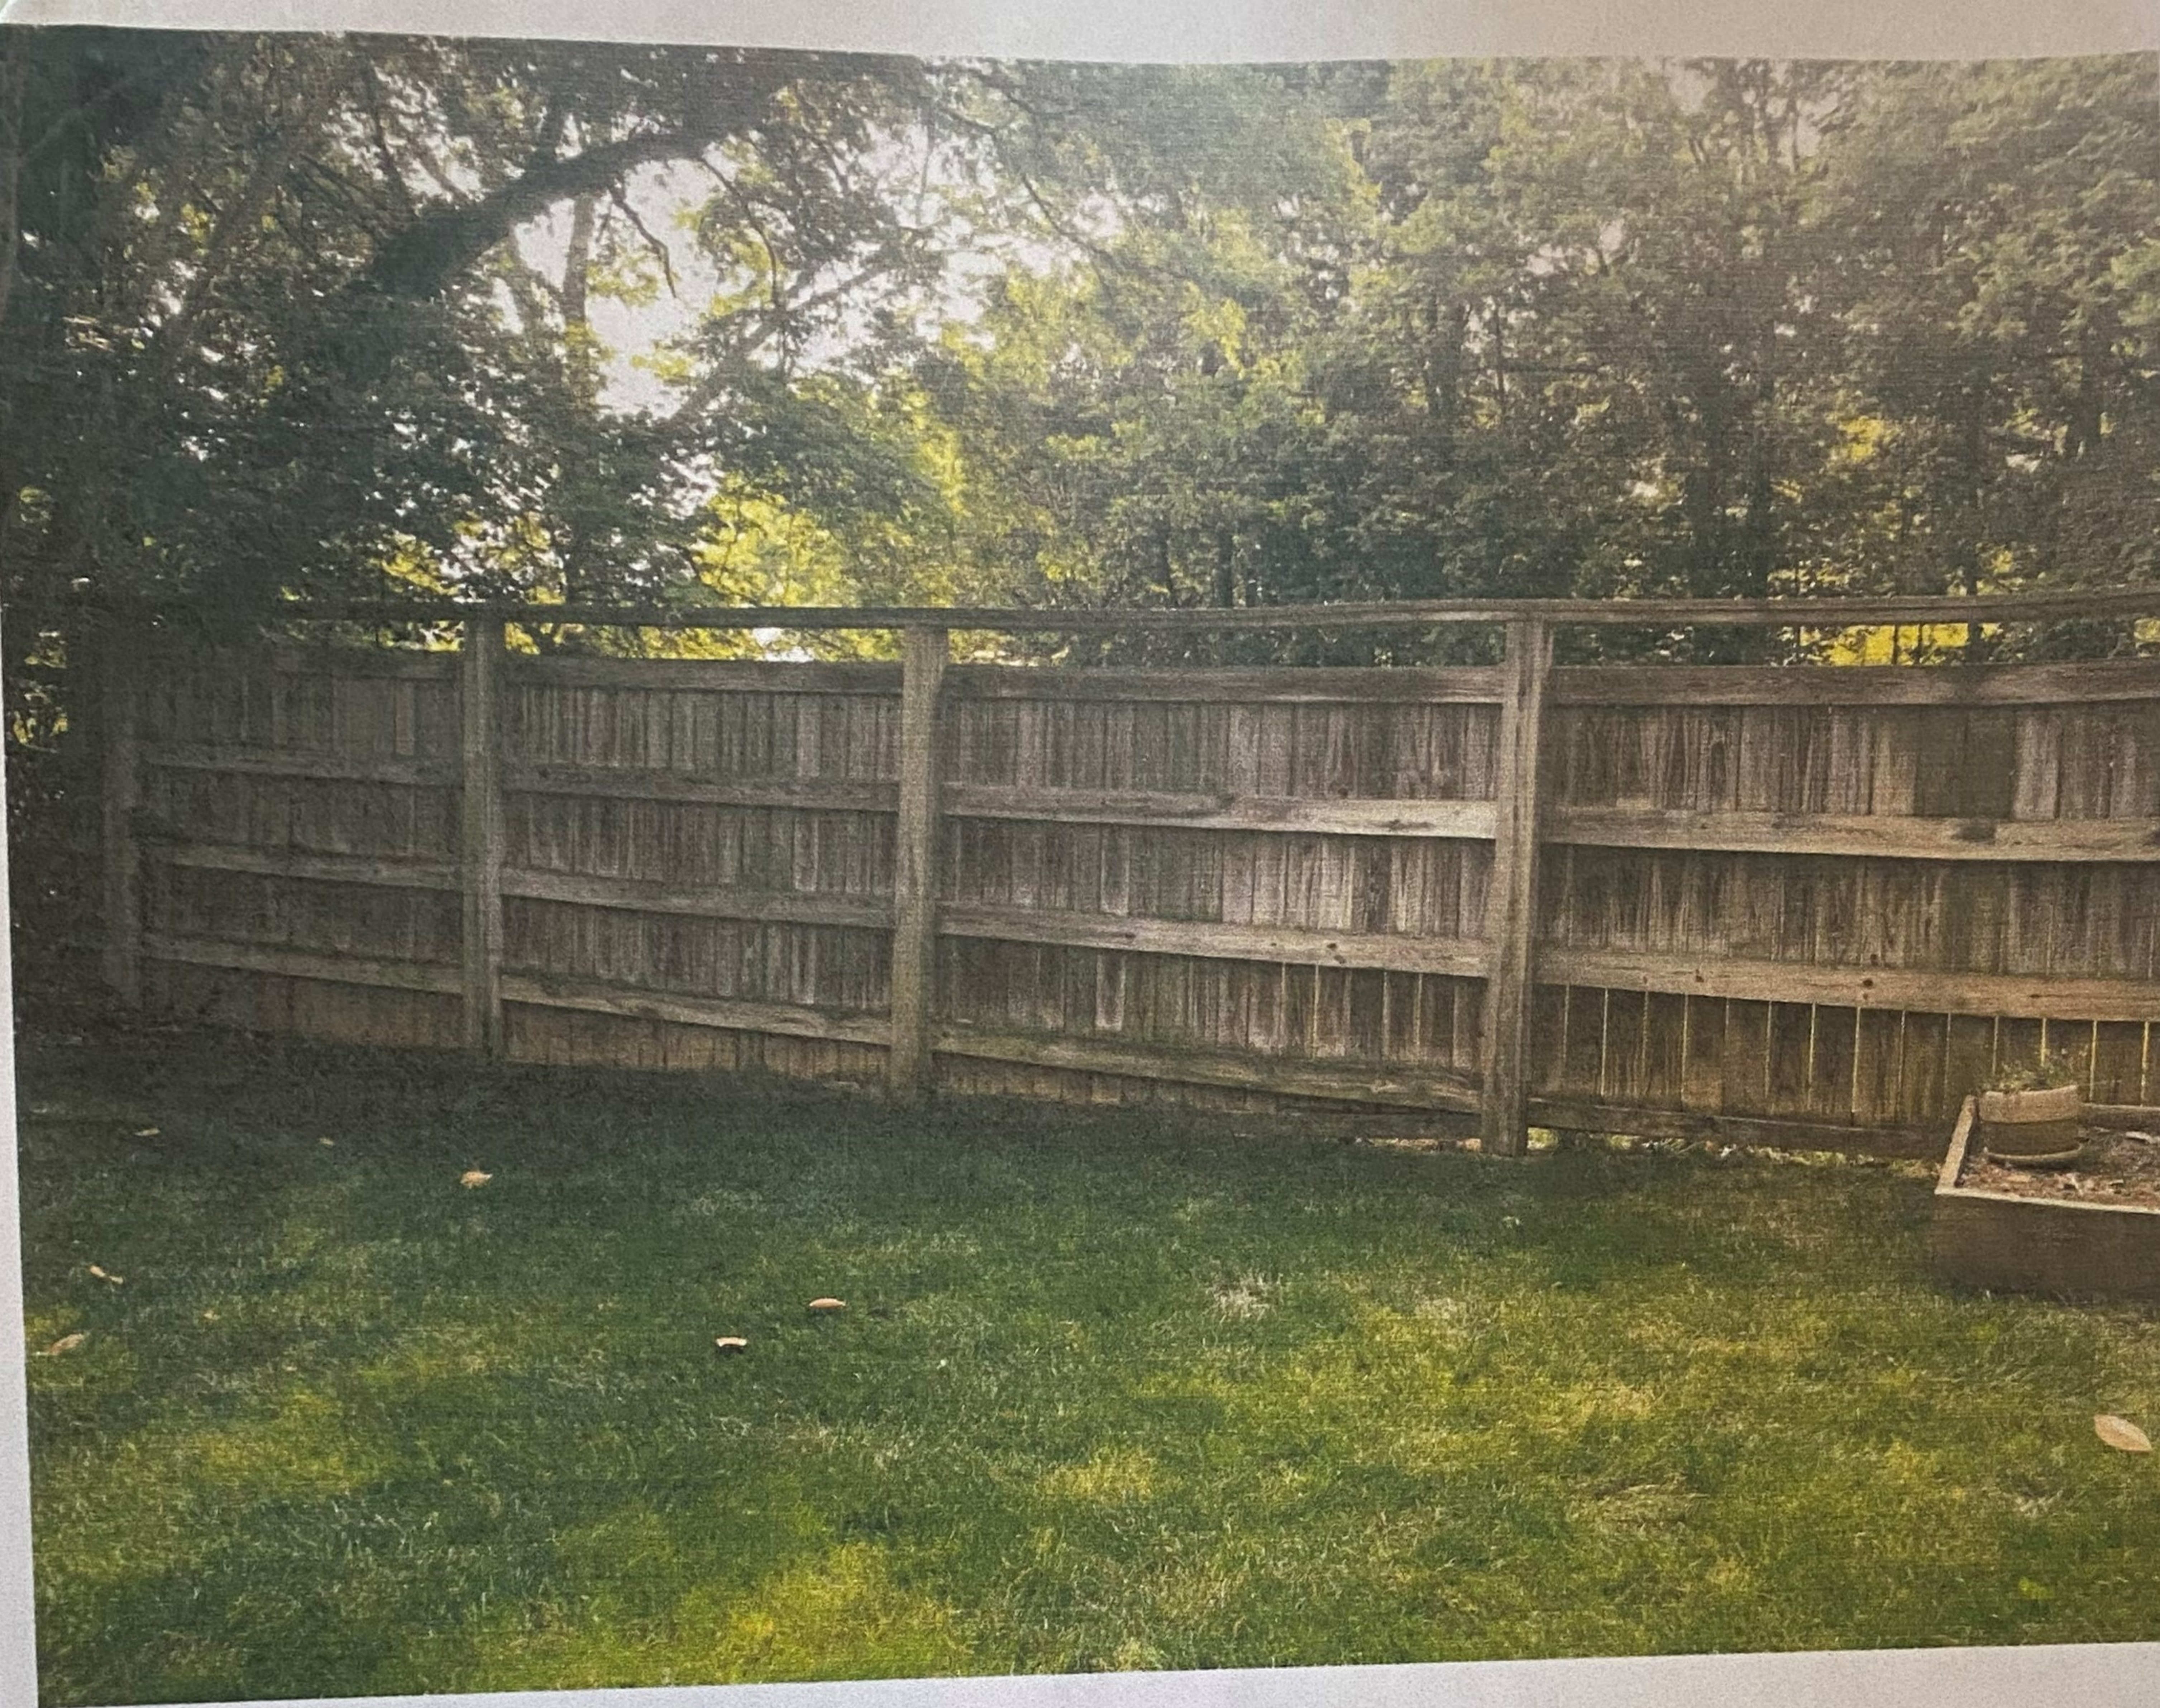
————— existing  
 XXXXXX proposed

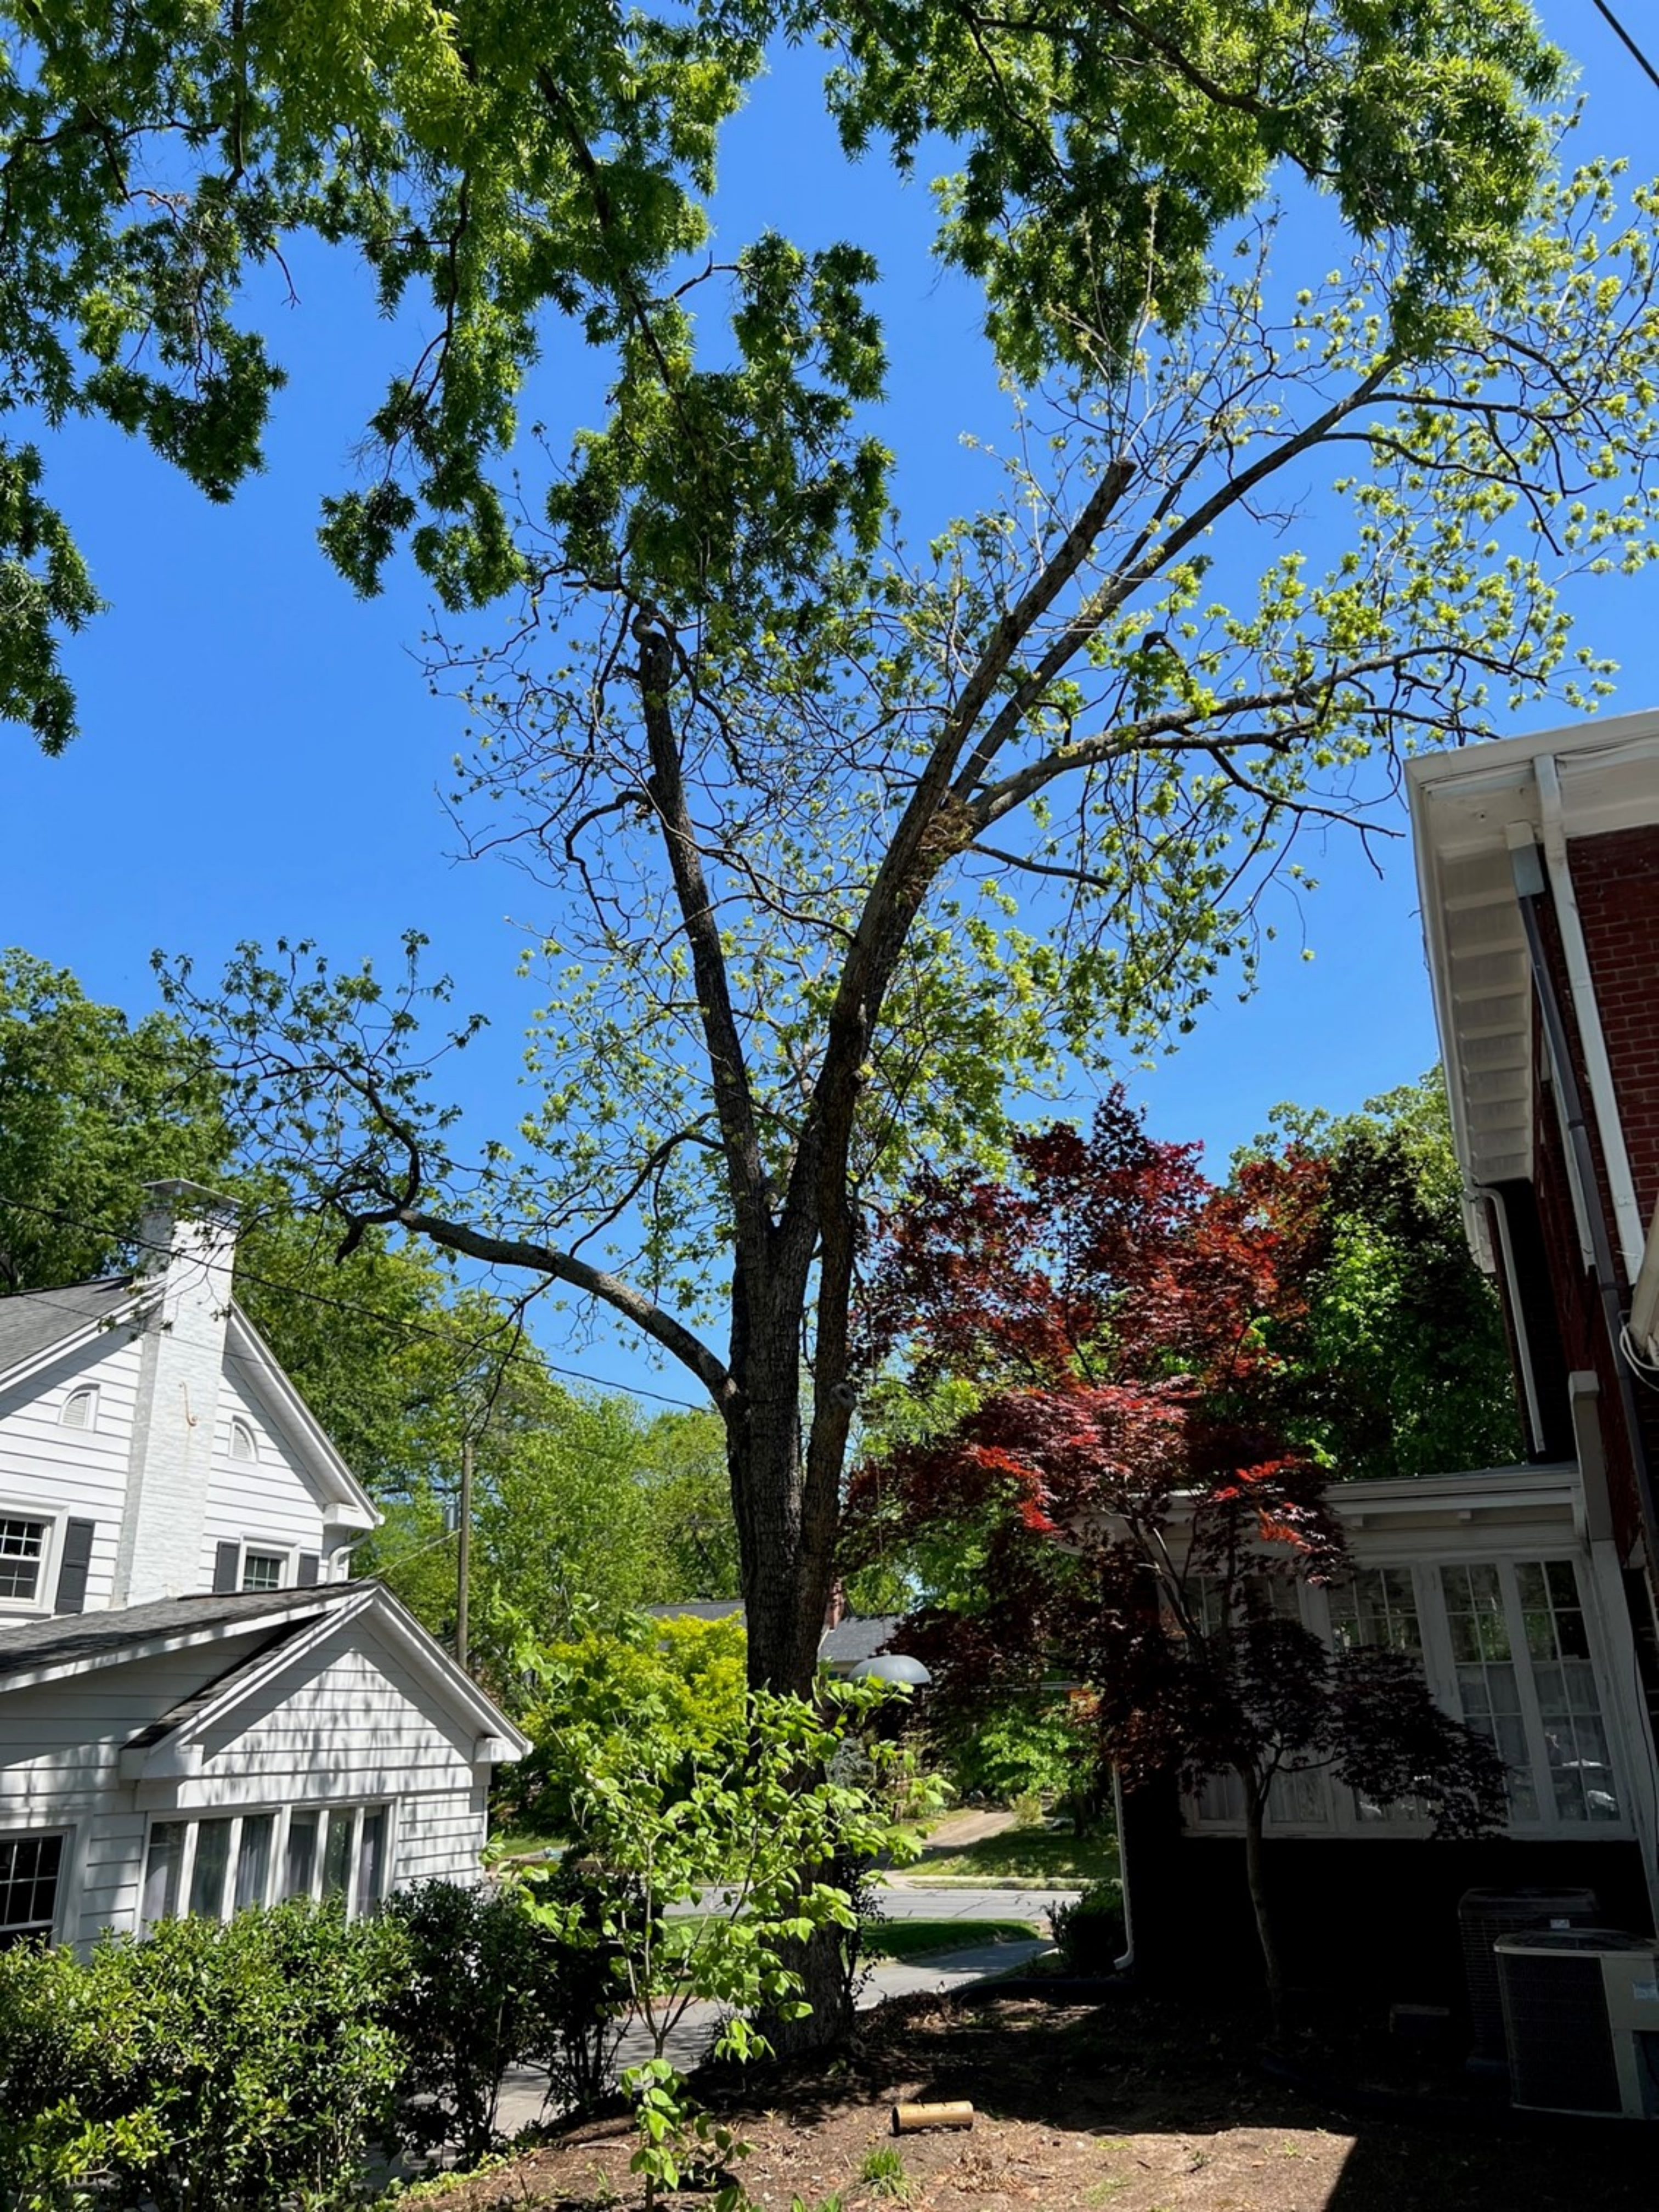
This tree has three over-extended scaffold limbs. It also has a small area of injury at the base of the trunk.
